7.0 Purgatory Creek Watershed

PURGATORY CREEK WATERSHED

PROPOSED PROJECTS

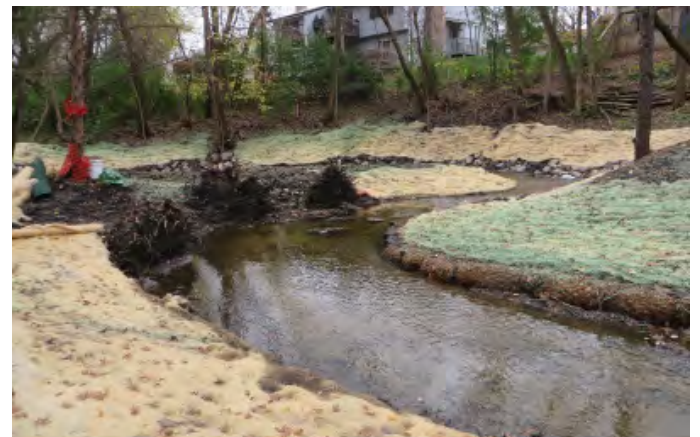
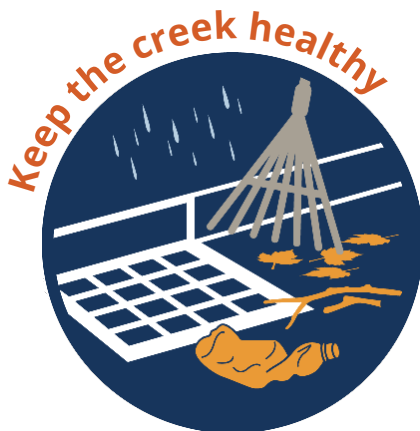
PURGATORY CREEK REACH RESTORED

In partnership with the City of Minnetonka, the district conducted its first-ever creek restoration in 2016. Near the intersection of County Road 101 and Townline Road, the partners stabilized eroding banks along close to 2000 feet of Purgatory Creek. The goal of the restoration is to improve water and habitat quality, and overall creek health. Staff will be returning in the spring of 2017 to check on the project and plant some additional native vegetation.

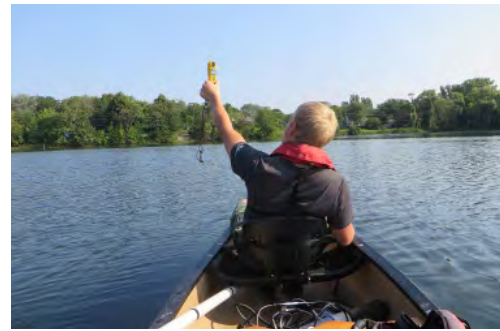
District staff collect environmental and water quality data at Duck Lake.

During the growing season (June - September), district staff visit Duck Lake every other week to collect water samples and take measurements. The water samples are sent to a lab where they are tested for several compounds including total phosphorous (TP) and chlorophyll a (Chl-a). Staff also measure how clear the water is using a disk that is lowered into the water until it can no longer be seen. All three of these parameters help indicate whether the water is clean.

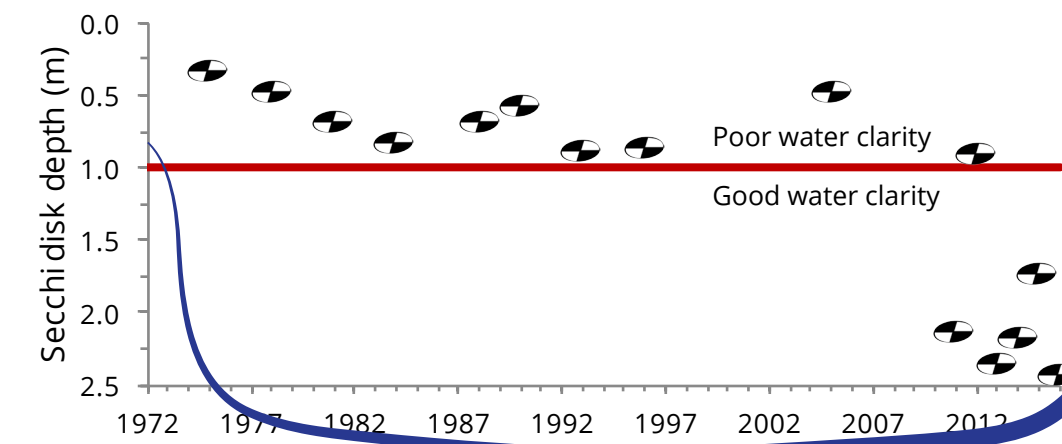
Water clarity is measured using a **Secchi Disk**, a black and white disk the size of a dinner plate. It is lowered into the water, and the depth at which it is no longer visible is recorded.

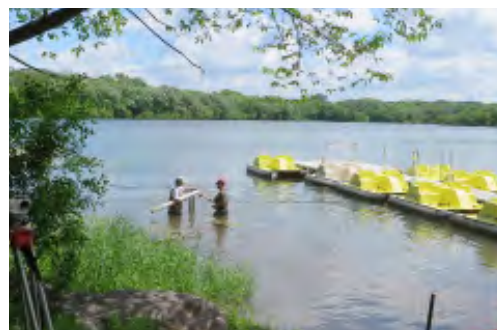
Staff install a water level sensor on Hyland Lake. The sensor tracks how high the lake gets.

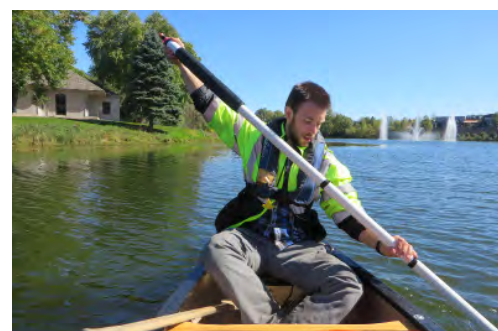
Collecting water samples on Lake Idlewild.

During the growing season (June - September), the city of Eden Prairie or the watershed district visits Lake Idlewild every other week to collect water samples and take measurements. The samples are sent to a lab to be tested for several compounds including total phosphorous (TP) and chlorophyll a (Chl-a). Staff also measures how clear the water is using a disk that is lowered into the water until it can no longer be seen. All three of these parameters help indicate whether the water is clean.

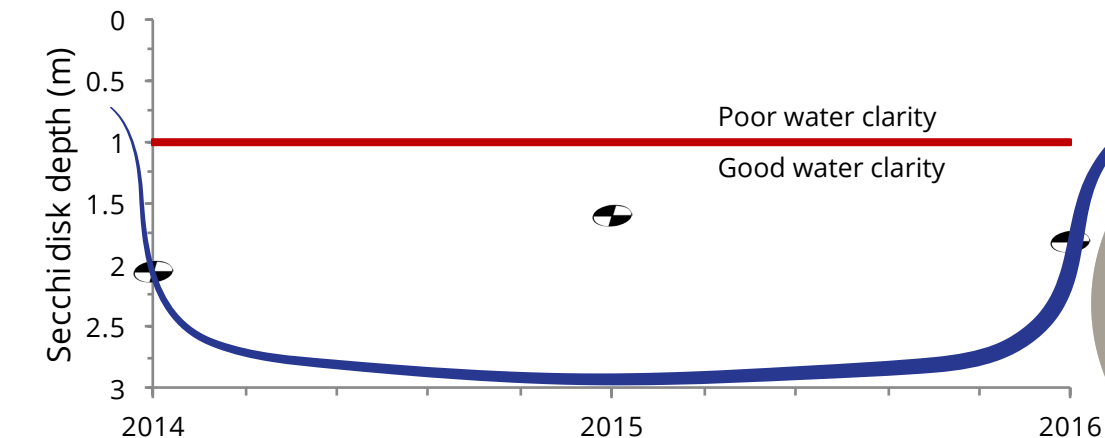
Points are growing season (Jun-Sep) averages. Thin lines are the min and max values for each year.

Phosphorus is a nutrient that plants and algae need for growth. It is often measured as total phosphorous (TP). Too much phosphorous can cause algae blooms.

Water clarity is measured using a **Secchi Disk**, a black and white disk the size of a dinner plate. It is lowered into the water, and the depth at which it is no longer visible is recorded.

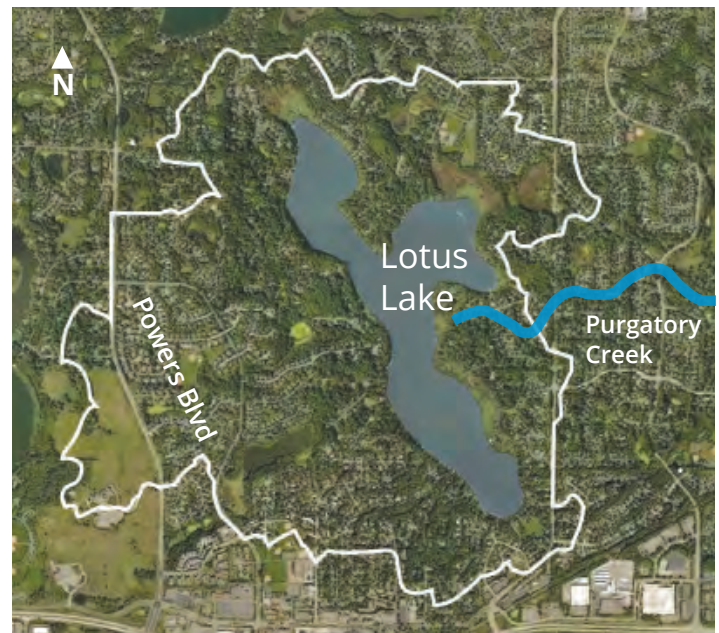
WATERSHED BOUNDARIES

Water that falls anywhere within the white border drains to Lotus Lake.

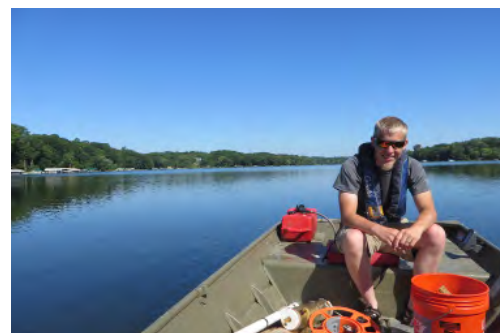
Staff collect water samples on Lotus Lake during a beautiful summer day.

During the growing season (June - September), district staff visit Lotus Lake every other week to collect water samples and take measurements. The samples are sent to a lab where they are tested for several compounds including total phosphorous (TP) and chlorophyll a (Chl-a). Staff also measure how clear the water is using a disk that is lowered into the water until it can no longer be seen. All three of these parameters help indicate whether the water is clean.

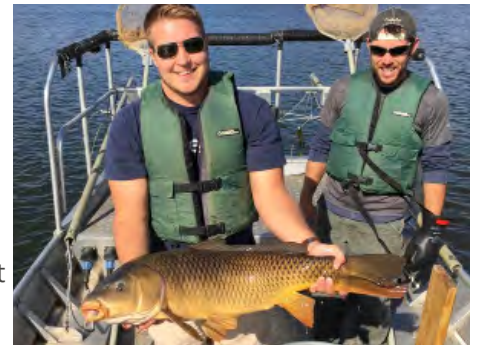
District staff completed two types of carp monitoring in summer and autumn. They conducted surveys to estimate carp numbers, and set out nets to estimate carp reproduction.

Electrofishing stuns fish momentarily, but doesn't harm them. Staff can then spot the carp, and capture them for measuring. Staff did not find any young carp in their trap nets. This means carp are spawning very little in Lotus, which is excellent news for the lake.

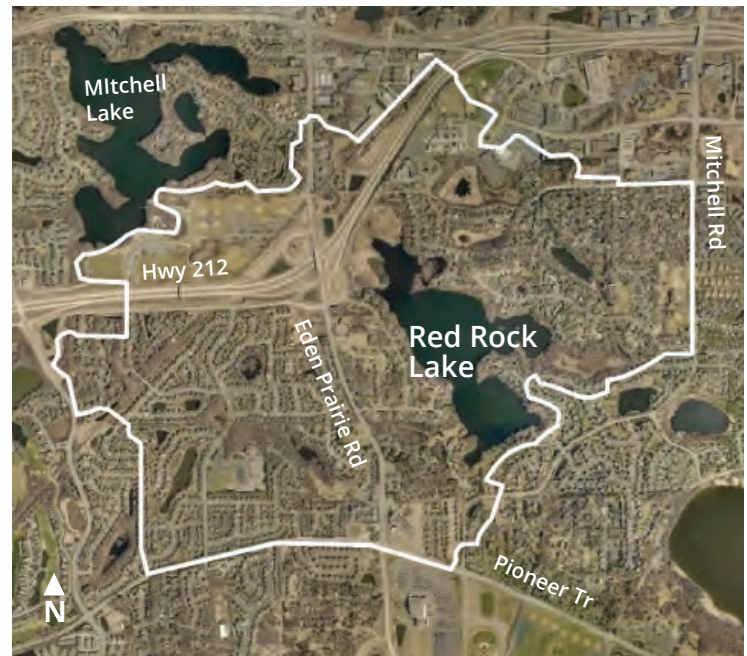
Water that falls anywhere within the white border drains to Red Rock Lake.

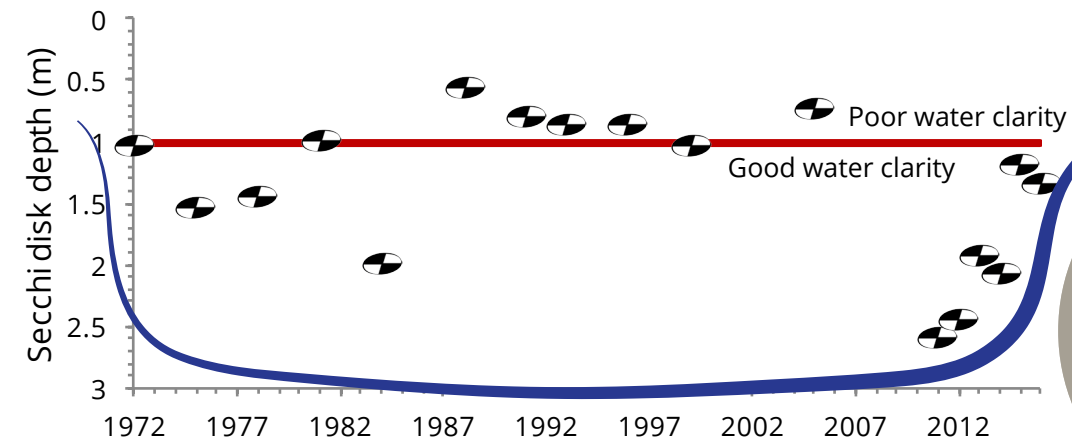
Points are growing season (Jun-Sep) averages. Thin lines are the min and max values for each year.

Phosphorus is a nutrient that plants and algae need for growth. It is often measured as total phosphorous (TP). Too much phosphorous can cause algae blooms.

Water clarity is measured using a **Secchi Disk**, a black and white disk the size of a dinner plate. It is lowered into the water, and the depth at which it is no longer visible is recorded.

After decades of failing to meet the clean water standards set by the Minnesota Pollution Control Agency (MPCA), Red Rock Lake has improved and been at or near standards for the last six years. Continued water sampling will help monitor whether the trend persists.

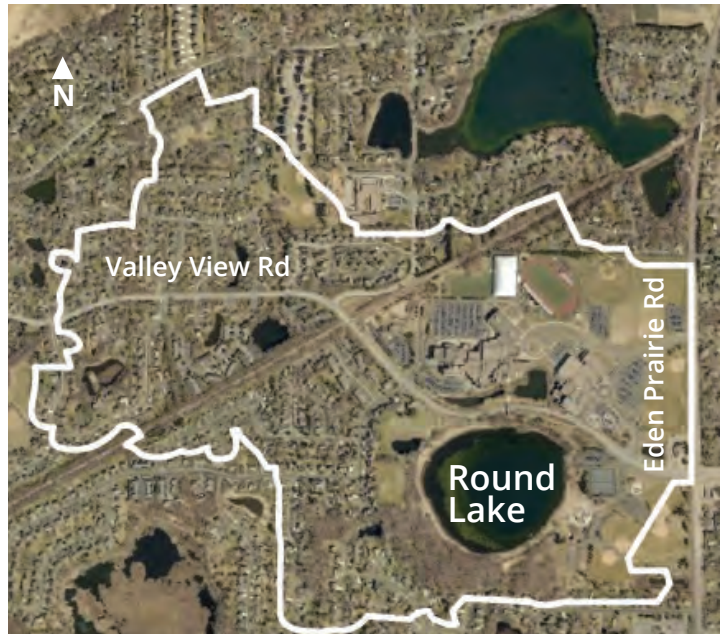
Water that falls anywhere within the white border drains to Round Lake.

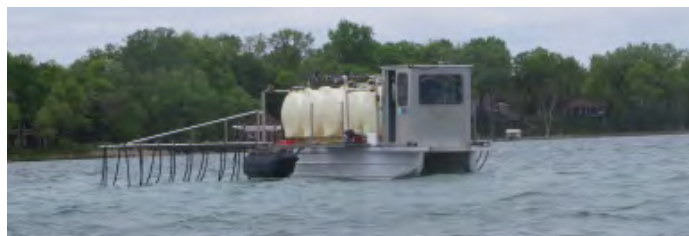
An alum barge treating a lake.

In November of 2012, the city of Eden Prairie conducted an Alum treatment in Round Lake. Aluminum phosphate (Alum) is one method that can be used to help protect clean water. Alum reduces the growth of algae by trapping the nutrient phosphorus - algae's food source - in sediments. Like most other plants, algae require phosphorus to grow and reproduce. Decreasing available phosphorus decreases how much algae can grow, and the likelihood of a thick, green blooms in the summer. Water samples taken since the treatment show improvements for Round Lake! In fact, the lake met all three water quality standards in 2016 (see inside pages for data). Continued sampling will help monitor how the treatment responds over time.

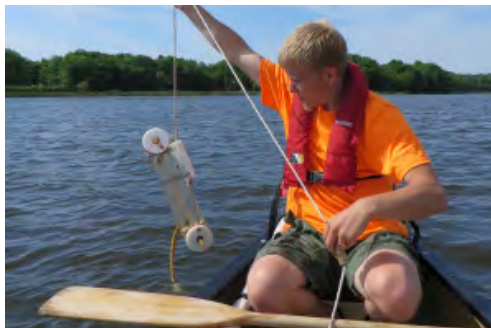
A staff member prepares to collect a water sample using a Van Dorn sampler.

During the growing season (June - September), district staff visit Silver Lake every other week to collect water samples and take measurements. The water samples are sent to a lab where they are tested for several compounds including total phosphorous (TP) and chlorophyll a (Chl-a). Staff also measure how clear the water is using a disk that is lowered into the water until it can no longer be seen. All three of these parameters help indicate whether the water is clean. Find out more about each on the next page.

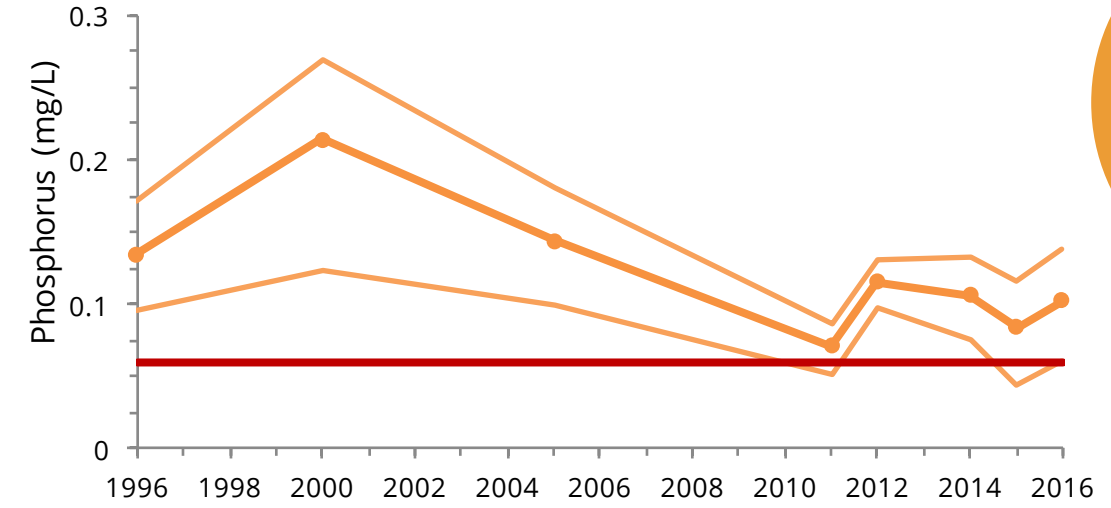
Points are growing season (Jun-Sep) averages. Thin lines are the min and max values for each year.

Phosphorus is a nutrient that plants and algae need for growth. It is often measured as total phosphorous (TP). Too much phosphorous can cause algae blooms.

Water clarity is measured using a **Secchi Disk**, a black and white disk the size of a dinner plate. It is lowered into the water, and the depth at which it is no longer visible is recorded.

Silver Lake water quality has been monitored since 1996. Since that time, it has consistently failed to meet the clean water standards set by the Minnesota Pollution Control Agency (MPCA). In recent years, water quality has improved, but still does not meet standards.

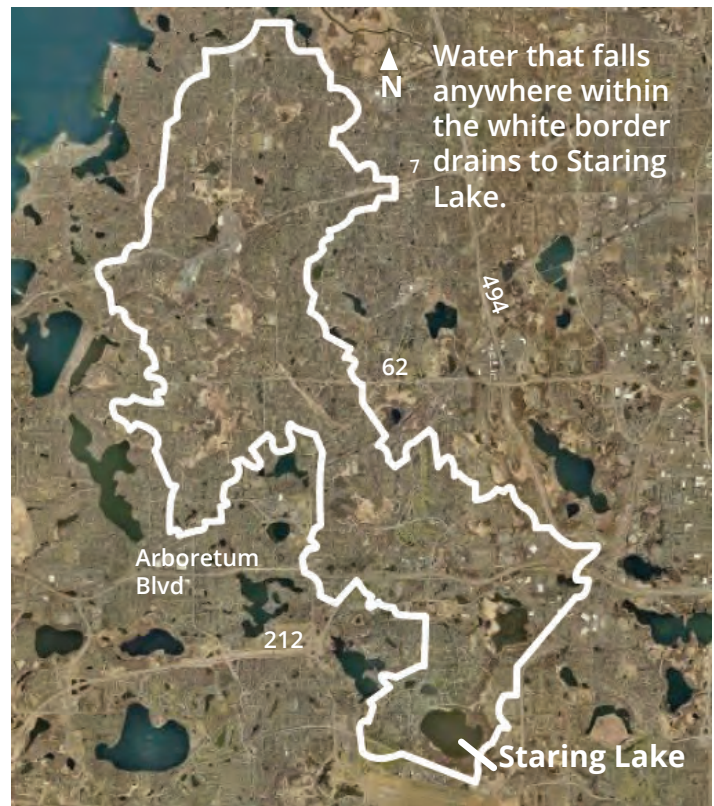
WATERSHED BOUNDARIES

Size	166 acres
Volume	1,220 acre-ft
Average depth	7 ft
Max depth	16 ft
Watershed size	10,206 acres
Land draining directly into	314 acres
MPCA lake classification	Shallow
Impairment listing	Mercury & Nutrients
Trophic status	Hypereutrophic
Common fish	Bluegill, Black Crappie, Black Bullhead
Invasive species	Curlyleaf Pondweed, Eurasian Watermilfoil, Common Carp

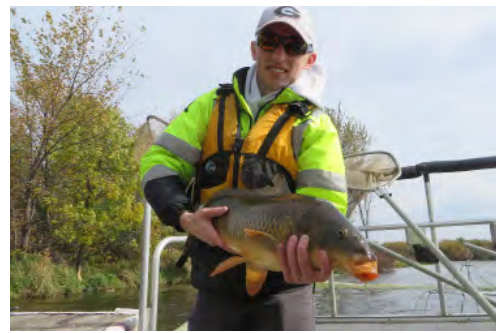
Common Carp are an invasive species. They can negatively impact water quality and lake health. The district works to manage carp in the lake.

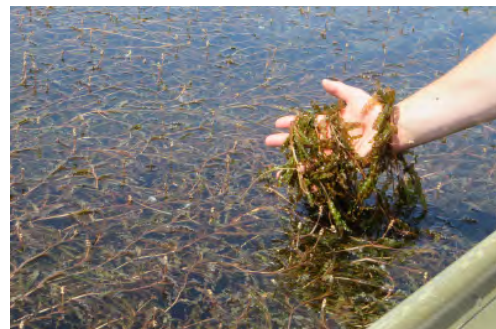
Curlyleaf pondweed is another invader that the district works to manage. It can form dense mats and competes with native plants.

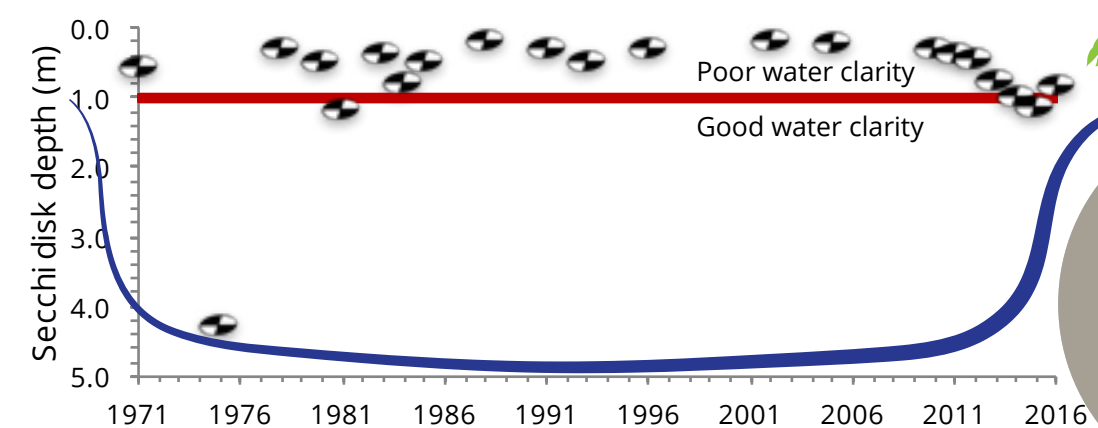
Water clarity is measured using a **Secchi Disk**, a black and white disk the size of a dinner plate. It is lowered into the water, and the depth at which it is no longer visible is recorded.
