Round Lake

Round Lake Water Quality by the Numbers

Water Quality Graphs, 1972-present

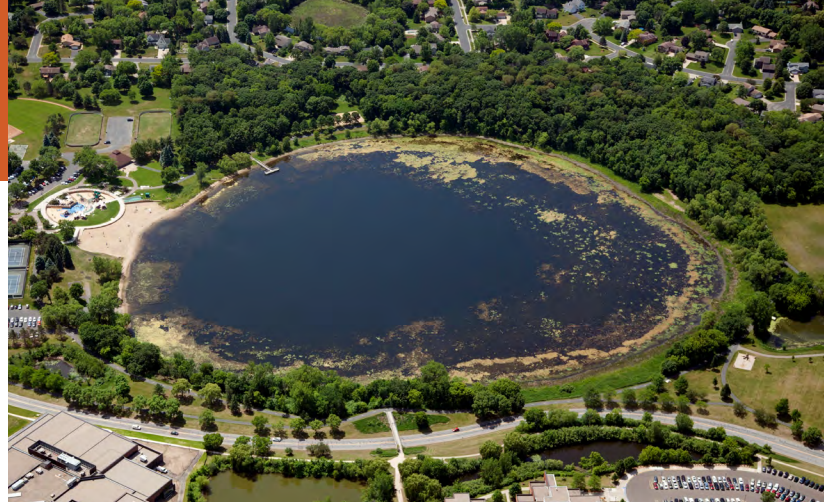
Watershed Boundary

Lake size	30 acres
Average lake depth	11 feet
Maximum lake depth	37 feet
MPCA lake classification	Deep lake
Watershed size	440 acres
Impervious surface	32% of watershed
Impairment listing	Mercury
Common fish	Bluegill, Yellow Bullhead, Black Bullhead, Black Crappie
Invasive species	Curly-leaf Pondweed, Eurasian Watermilfoil, Brittle Naiad

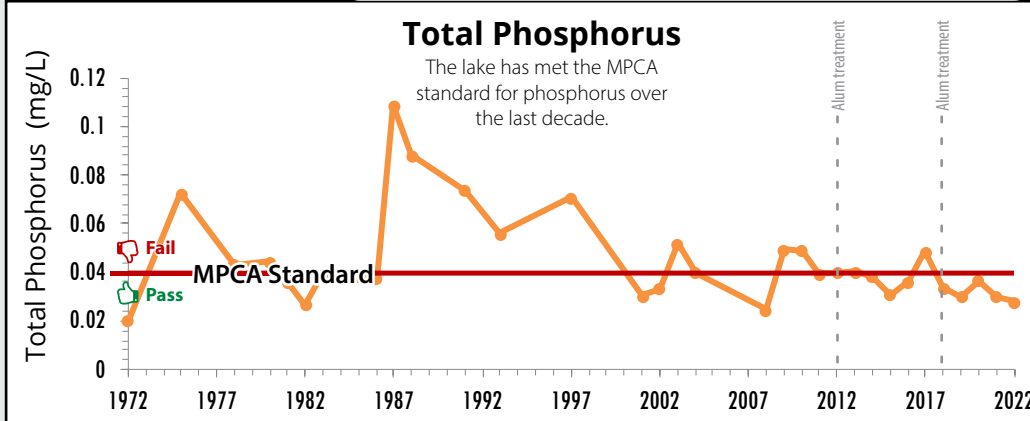
Round Lake received an alum treatment in 2012 and 2018. Alum limits the availability of phosphorus in lakes to control algae growth & improve water clarity.

Phosphorus is a nutrient plants and algae need to grow. Too much phosphorus may cause algae blooms.

Total Phosphorus: Since the alum treatment in 2012 the average TP concentrations have been consistently below the MPCA deep lake standard. In 2022, Round Lake had an average TP concentration of 0.028 mg/L.

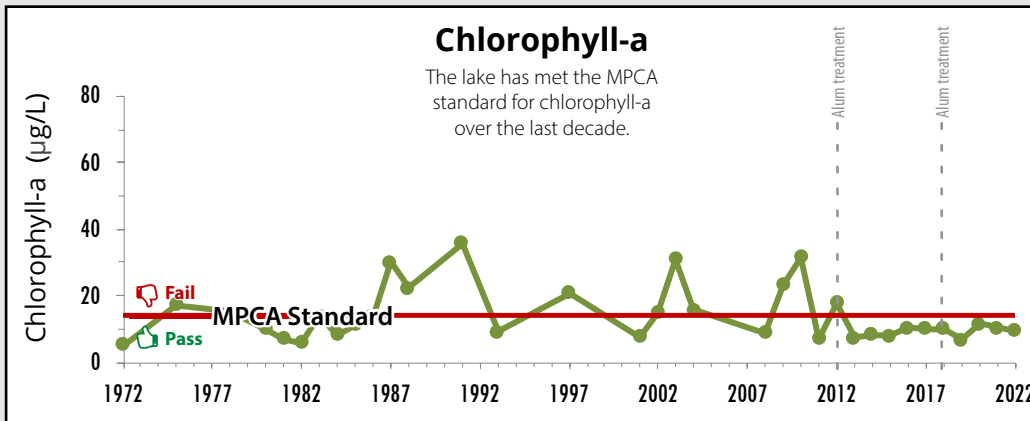
Chlorophyll-a is the main pigment in algae and indicates how much algae is growing in the water. High levels mean excess growth.

Chlorophyll-a: The average chlorophyll-a concentrations have consistently been below the MPCA deep lake standard. In 2022, the average chlorophyll-a concentration was 9.3 µg/L.

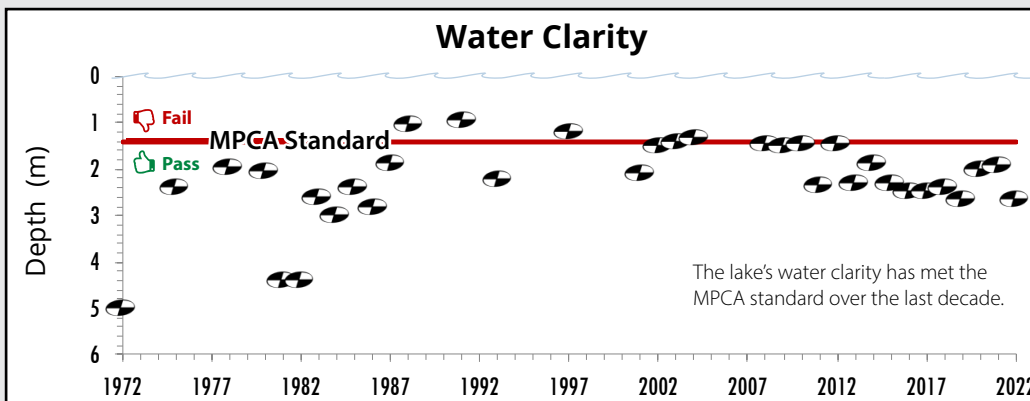
Water clarity is measured by lowering a Secchi Disk into the water. The depth at which the disk is no longer visible is the water's clarity measurement.

Water clarity: Since the alum treatment in 2012, the average Secchi disk depth has stabilized around 2.3 meters. In 2022, the average Secchi disk depth was 2.7 meters.
