Staring Lake

Staring Lake Water Quality by the Numbers

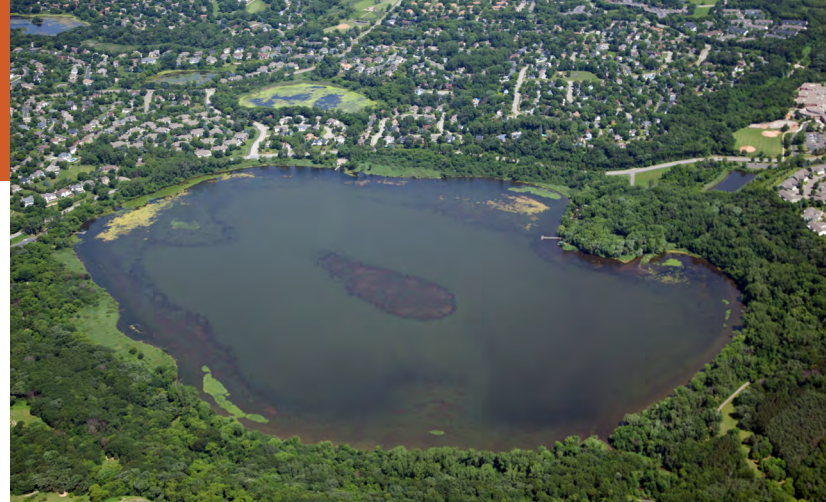
Watershed Boundary

Lake size	166 acres
Average lake depth	7 feet
Maximum lake depth	16 feet
MPCA lake classification	Shallow lake
Watershed size	10,158 acres
Impervious surface	21% of watershed
Impairment listing	Mercury & nutrients
Common fish	Bluegill, Black Crappie, Black Bullhead
Invasive species	Curly-leaf Pondweed, Eurasian Watermilfoil, Brittle Naiad, Common Carp

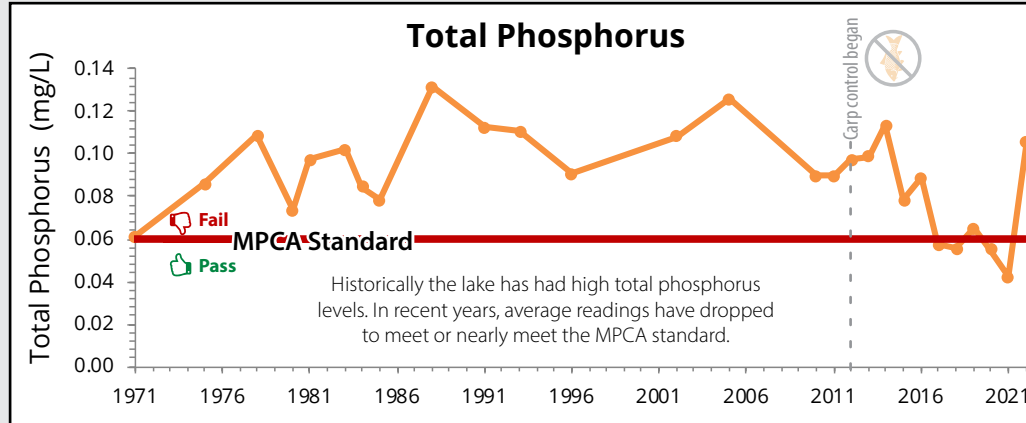
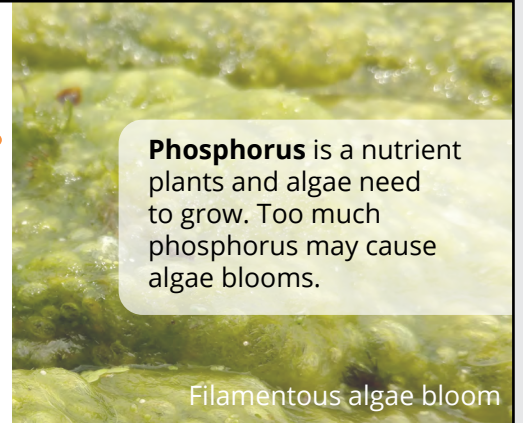
Phosphorus is a nutrient plants and algae need to grow. Too much phosphorus may cause algae blooms.

Total Phosphorus: Since carp management began in 2011, TP levels have decreased. In 2022, total phosphorus levels peaked (0.106 mg/L) following the Fluridone herbicide treatment combined with low water levels.

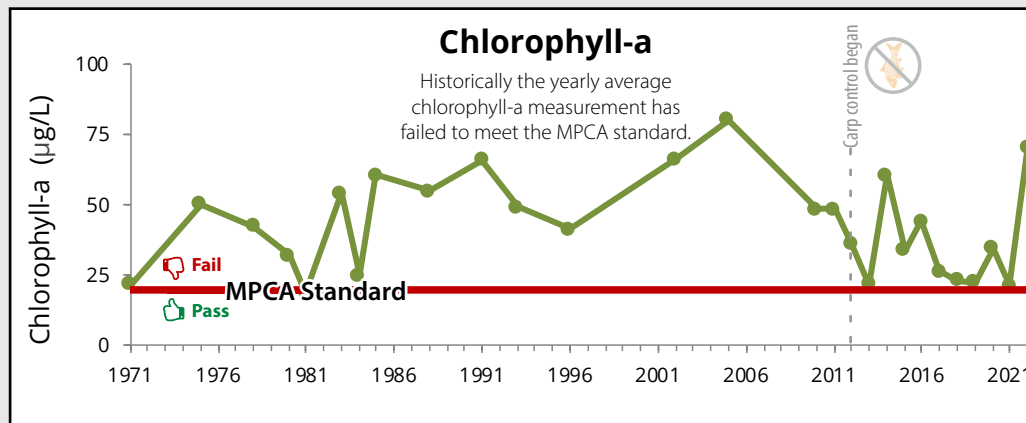
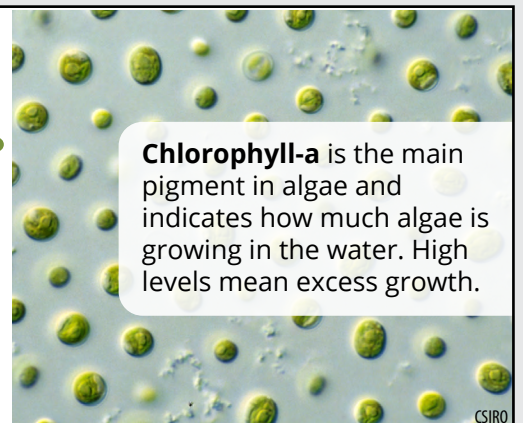
Chlorophyll-a is the main pigment in algae and indicates how much algae is growing in the water. High levels mean excess growth.

Chlorophyll-a: No significant trend. In 2022, the average reading for chlorophyll-a was 70.4 µg/L, which is significantly higher than recent years.

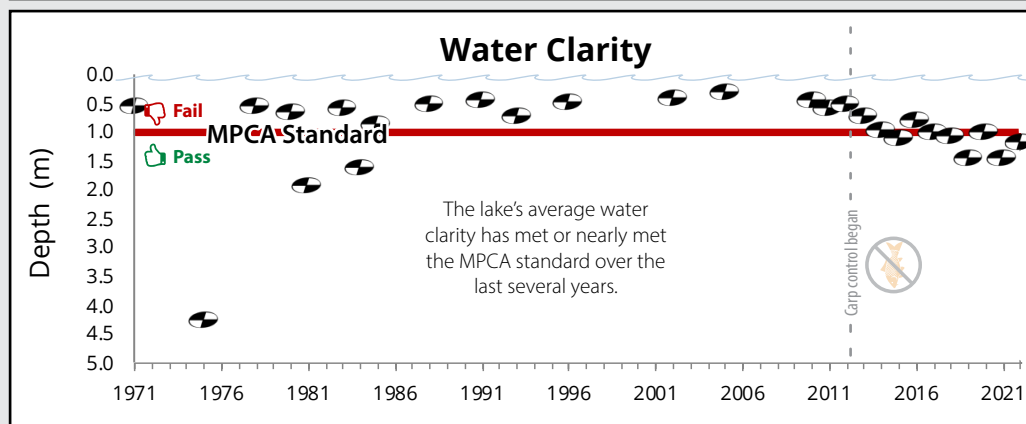
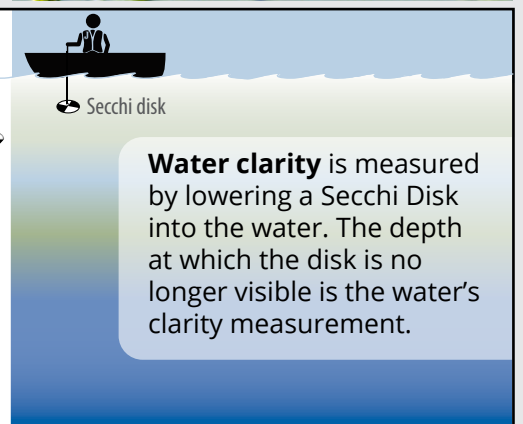
Water clarity is measured by lowering a Secchi Disk into the water. The depth at which the disk is no longer visible is the water's clarity measurement.

Water clarity: Since carp management began in 2011, clarity has improved. The average reading in 2022 was 1.2 meters, which exceeded the MPCA standard.
