# Feasibility Report

## Bluff Creek Reach 5 Ecological Enhancement Plan

June 2022

Prepared for  
Riley Purgatory Bluff Creek Watershed District

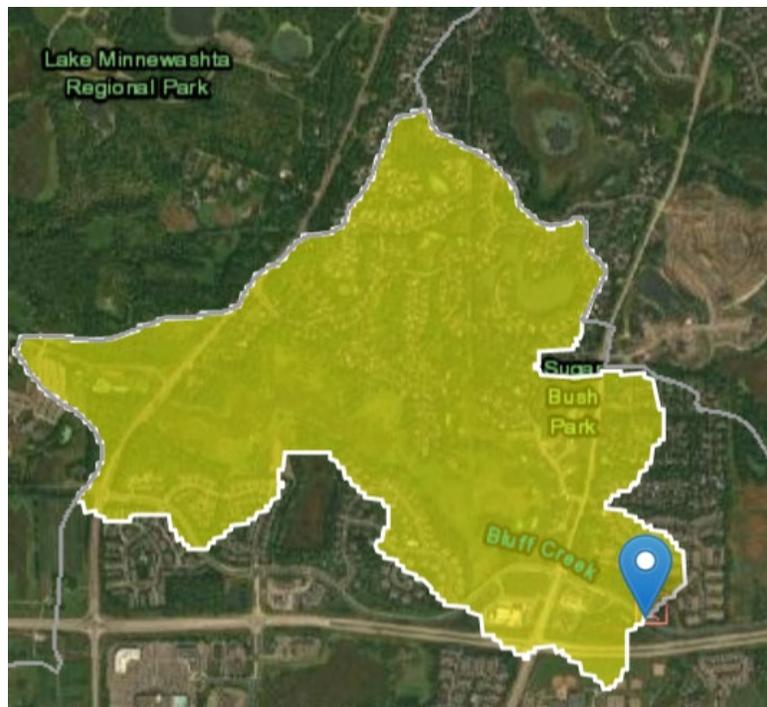
Figure 3-1 Bluff Creek Reach B5A-B5C watershed area

Reach B5A encompasses the headwaters of Bluff Creek which originates in the wetland complex between Highway 41 and Galpin Boulevard (Figure 3-1) and is primarily contained on property owned by the City of Chanhassen. Reach B5B is near the headwaters of Bluff Creek and is composed of the channel approximately 985 feet immediately upstream of Galpin Boulevard and ends at Galpin Boulevard. The reach is on private property but is located in an outlot that has been placed in a conservation easement with the city of Chanhassen.

Reach B5C is composed of the channel between Galpin Boulevard and ends at West 78<sup>th</sup> Street. It has a watershed area of 454 acres and is located on city owned property. Reach B5C on property owned by the City of Chanhassen.

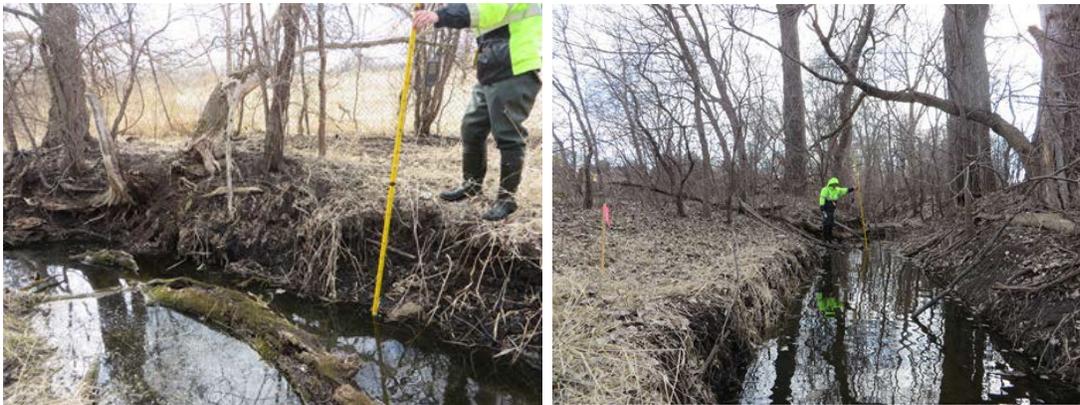
There is some bank erosion along much of Reach B5B, however it appears to still be connected with its floodplain. The lower third of this reach has taller banks with more active erosion but the channel does not appear to be significantly incised. The erosion is primarily on the banks and appears to be a response to the confined nature of this portion of the channel, which has less access to its floodplain. The banks within this portion of the reach are 3 to 5 feet tall. There is agricultural debris located in the left overbank. The upper third of the reach includes banks that are 1- to 3-feet tall and has a wide, active floodplain. This portion of the reach has minor erosion but appears to be historically straightened since at least 1945 (see Figure 4-1). Meander patterns typically redevelop in reaches that have been straightened, and there is evidence that such a phenomenon is occurring in this reach as erosion locations alternate between each bank. The channel in this reach has an average slope of approximately 0.25%, which is a relatively low slope that helps keep velocities low.

**Figure 4-1 Incised and straightened channel in Sub-Reach B5B**

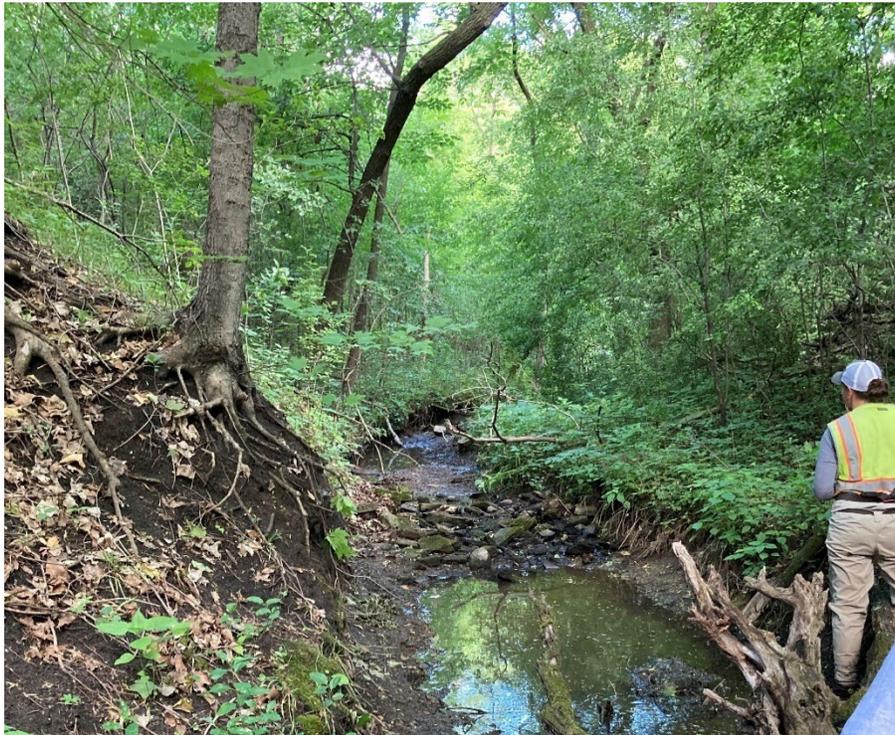
from about 1 to 2 feet bankfull height with total bank heights of 2 to 6 feet and width of about 6 to 12 feet (see Figure 4-2). The channel slope was estimated at about 0.75% slope. It fits best into the Rosgen B5C type which is a moderately steep, slightly entrenched and low sinuosity stream (Rosgen 1996) (Reference (4) ). The bed was a mixture of fine sediment, sand, and some gravel. The stream may have been a Type E5 prior to development. It likely evolved from increased runoff to become more entrenched with lower sinuosity. Currently the sinuosity is 1.2 while E type streams have greater than 1.5 sinuosity.

**Figure 4-2 Bluff Creek typical section of Bluff Creek, Reach B5C, July 2021.**

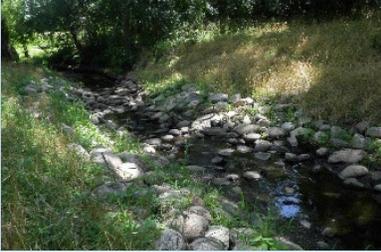
| Design Element | Purpose | Ecological Benefit |
|---|--|--|
| <b>Rock Riffles</b><br> | Gravel or cobble-sized material installed in the stream bed to create natural flow patterns and to control stream bed elevations. | The variety in flow and channel substrate size provides habitat diversity for aquatic species. |

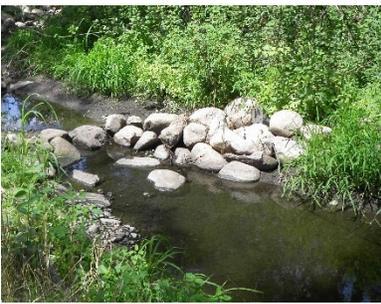
| Design Element | Purpose | Ecological Benefit |
|---|--|--|
| <b>Cross Vanes</b><br> | Boulders buried in the stream bed and extending partially (“vanes”) or entirely across the stream (“cross vanes”) to achieve one or more of the following goals: re-direct flows away from banks, encourage sediment deposition in selected areas, and control stream bed elevations. | Scour pools develop over time near the vane, which provide habitat diversity for species that prefer pools to faster flowing in-channel habitat. |

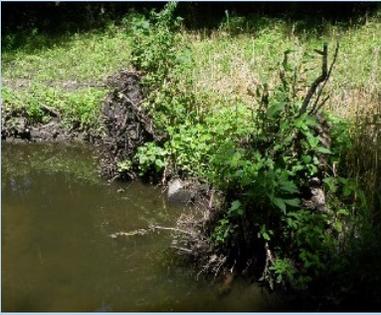
| Design Element | Purpose | Ecological Benefit |
|---|--|--|
| <b>Root Wads</b><br> | Tree trunks with the root ball attached, installed either singly (root wads) or in conjunction with additional large woody debris and toe wood to increase bank roughness and resistance to erosion, re-direct flows away from banks, and provide a bench for establishment of riparian vegetation | Creates undercut/overhanging bank habitat features. |

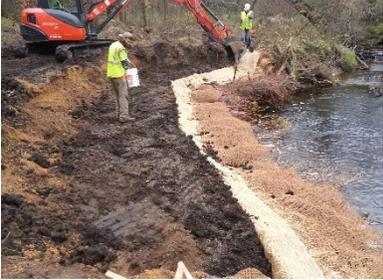
| Design Element | Purpose | Ecological Benefit |
|--|---|--|
| <p><b>VRSS/Toe Wood Bank Stabilization</b></p> | <p>Soil lifts created with a combination of root wads and long-lasting, biodegradable fabric and vegetated to stabilize steep slopes and encourage establishment of root systems for further stabilization.</p> | <p>Creates undercut/overhanging bank habitat features.</p> |

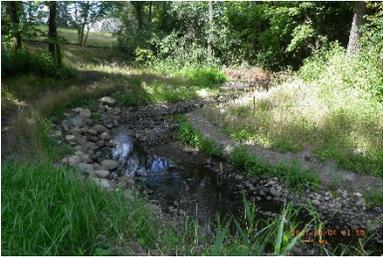
| Design Element | Purpose | Ecological Benefit |
|--|---|--|
| <p><b>Floodplain Connectivity</b></p> | <p>Active floodplain/vegetated bench—modifications made to the stream cross section to increase floodplain connectivity and decrease erosive stress during flood flows; for this project, constructed by raising the channel bed.</p> | <p>Provides a smooth transition between in-channel, riparian, and upland habitat.</p> |

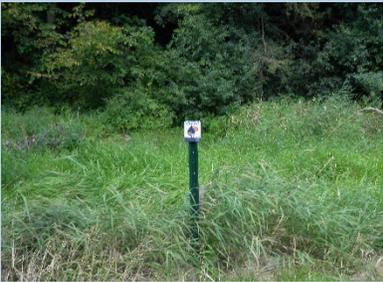
| Design Element | Purpose | Ecological Benefit |
|--|---|--|
| <p><b>Vegetation/Buffer</b></p> | <p>Established along a stream bank or overbank area to stabilize bare soils and increase resistance to fluvial erosion.</p> | <p>Using trees, shrubs, and a seed mix of grass and forbs provides a diverse array of vegetation strata and habitat types. Allows for more naturalized aesthetics, with emphasis on native species.</p> <p>Project would be designed to comply with District buffer rules.</p> |

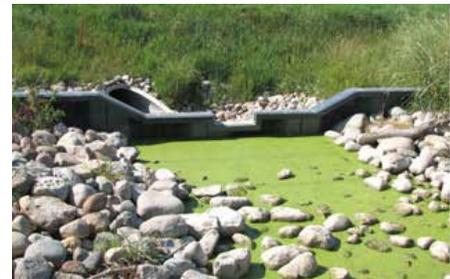
Example of a stage weir from the *Minnesota Wetland Restoration Guide* by the Minnesota Board of Water and Soil Resources (BWSR)

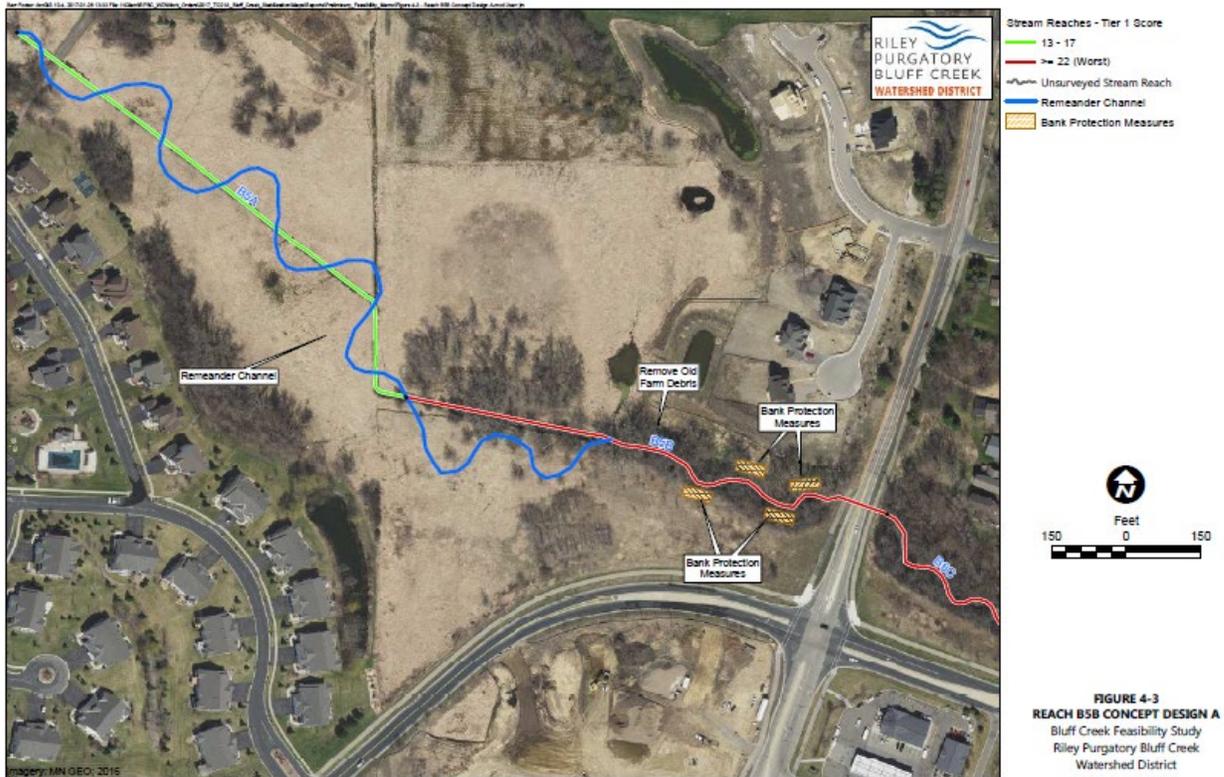
This concept includes restoring eroding banks on the downstream portion of the reach and construction of a new channel with an appropriate meander pattern to replace the section that was historically straightened (see Figure 5-3).

**Figure 5-3 Concept A: Restoration of Reach B5B by Remeandering**

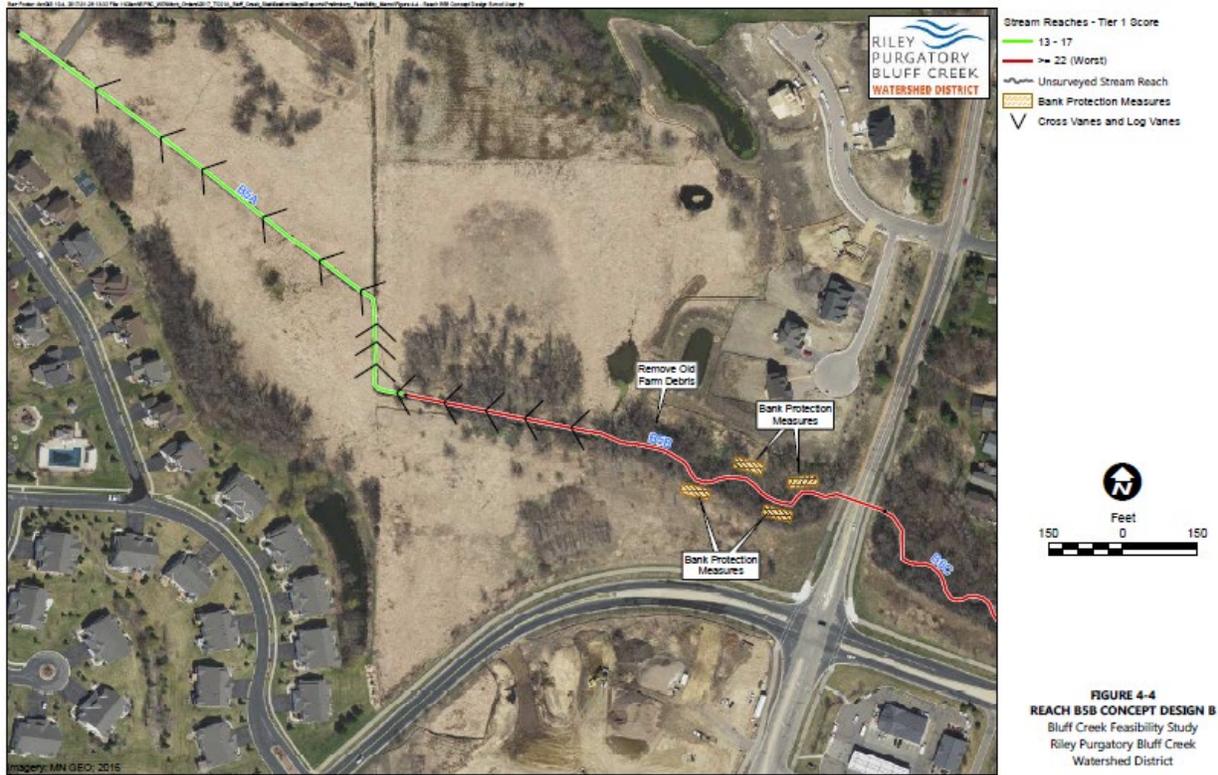
**Figure 5-4 Concept B: In-place Restoration of Reach B5B**

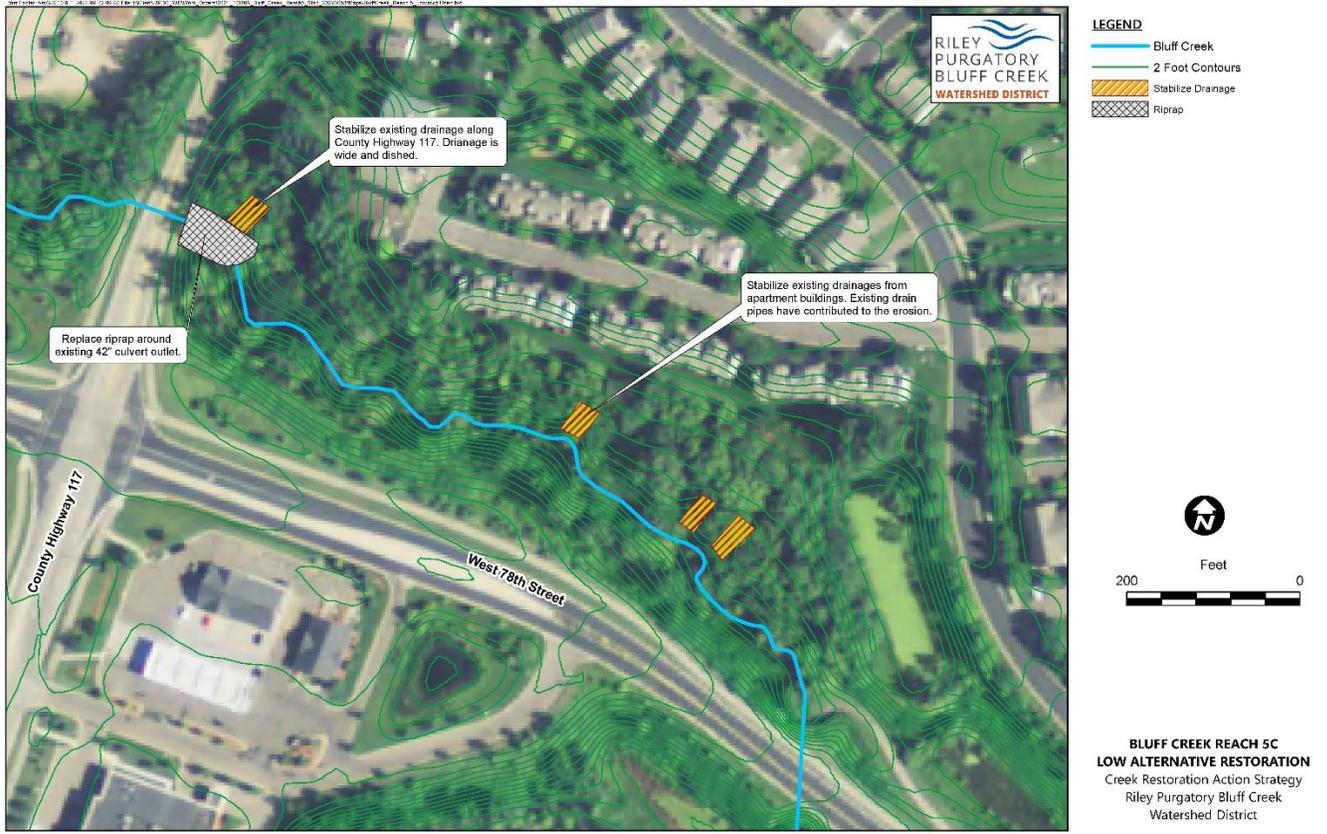
**Figure 5-5 Concept A: Low Concept Restoration of Reach B5C**

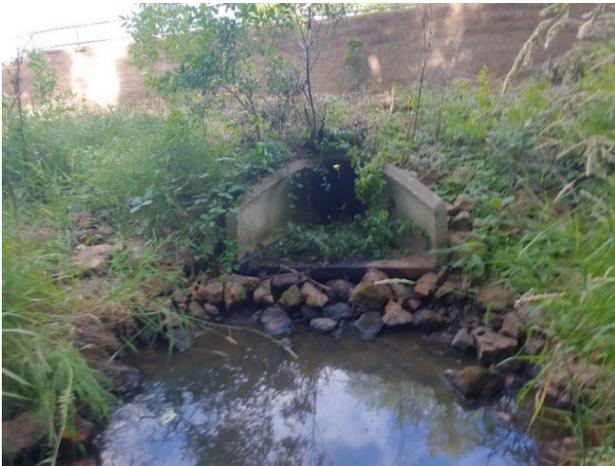
**Figure 5-6 Culvert at upstream end of Reach B5C, July 2021 photo**

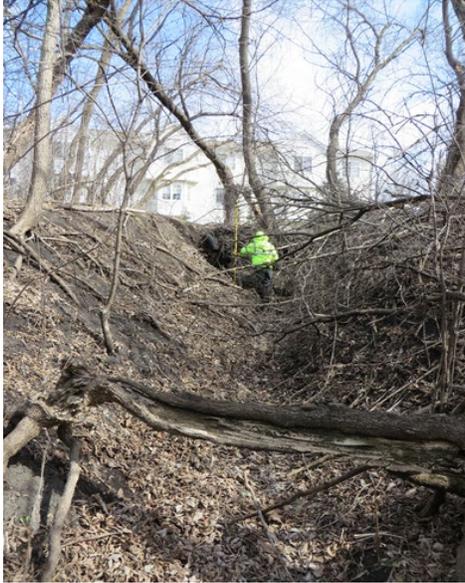
Drainage from the apartment buildings to the north of the reach have caused three gullies to form in the woods adjacent to the apartment lawn. There is another gully forming on the north side of the reach, just east of Galpin Avenue. This gully is wider and more dished than the gullies near the apartment buildings. One of the gullies is shown in Figure 5-7.

**Figure 5-7 Gully cutting into apartment yards north of Bluff Creek (2015 photo from RPBCWD)**

Gully stabilization practices would include grading back to a stable slope, placement of riprap at the top of the gully where there is active erosion and placement of erosion control fabric on the bare soil surfaces with seeding for revegetation. The culvert would be stabilized by replacing the riprap and the apron as needed. All strategies should include removal of buckthorn and planting of native shrubs and understory species to replace the invasives and increase groundcover. This not only improves the ecological value of the forest but can reduce understory erosion.

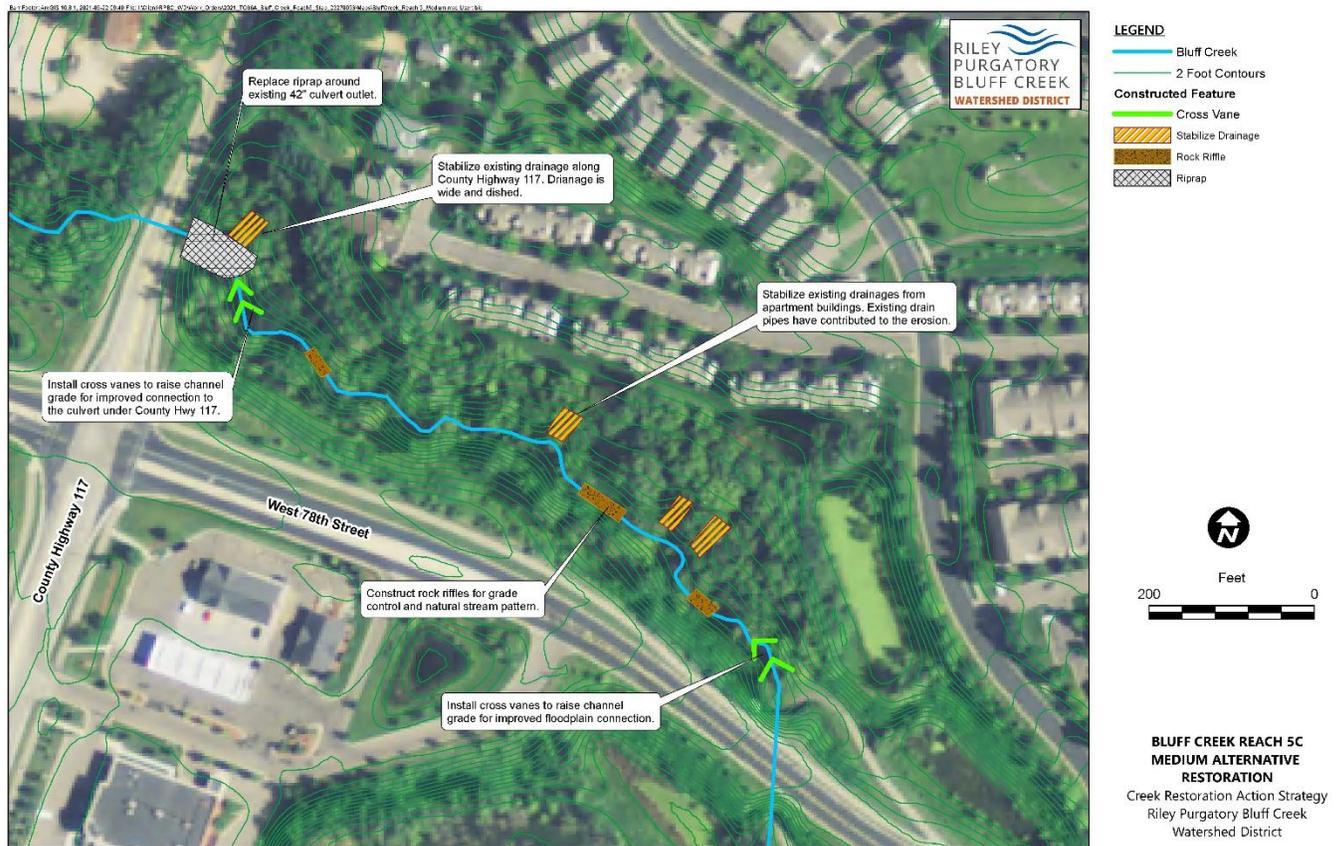
**Figure 5-8 Concept B: Moderate Concept Restoration of Reach B5C**

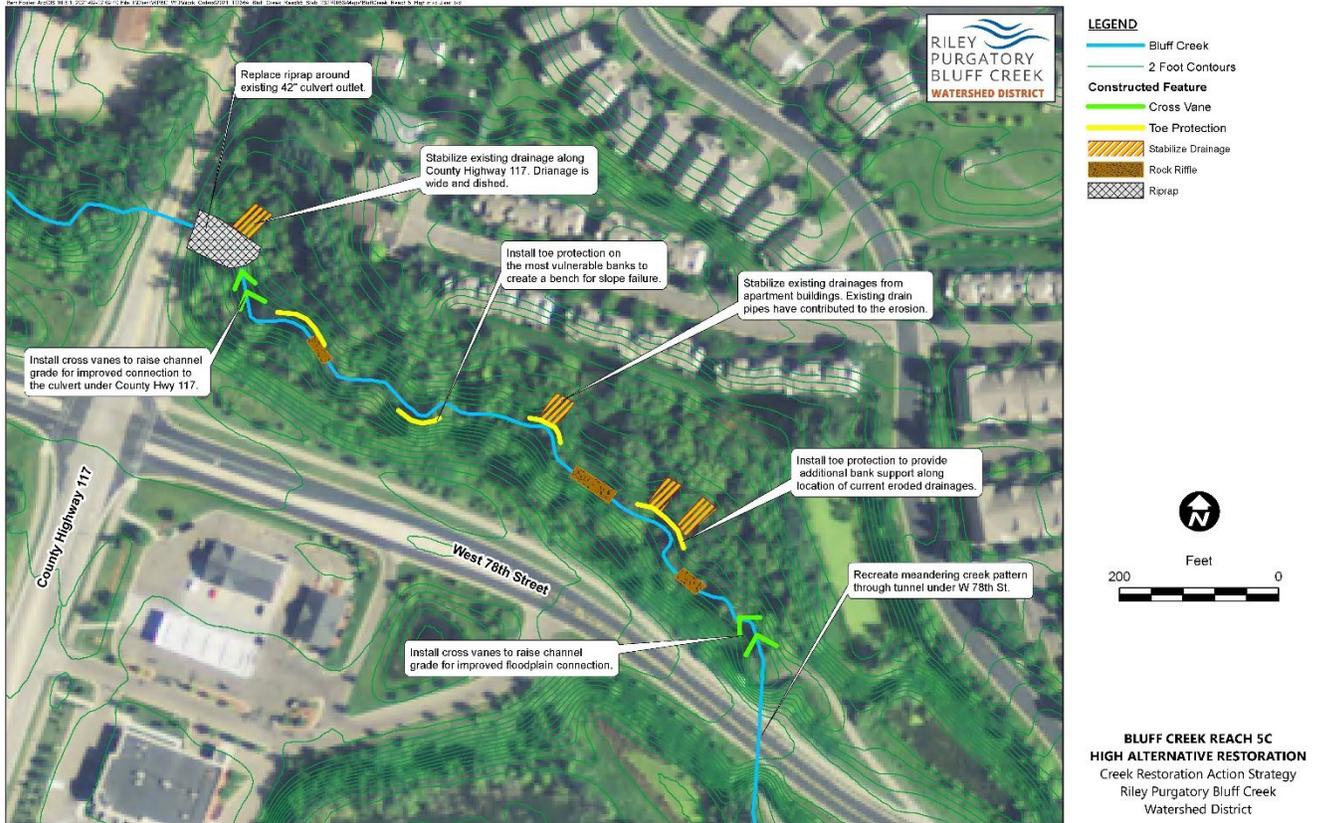
**Figure 5-9 Concept C: High Concept Restoration of Reach B5C**

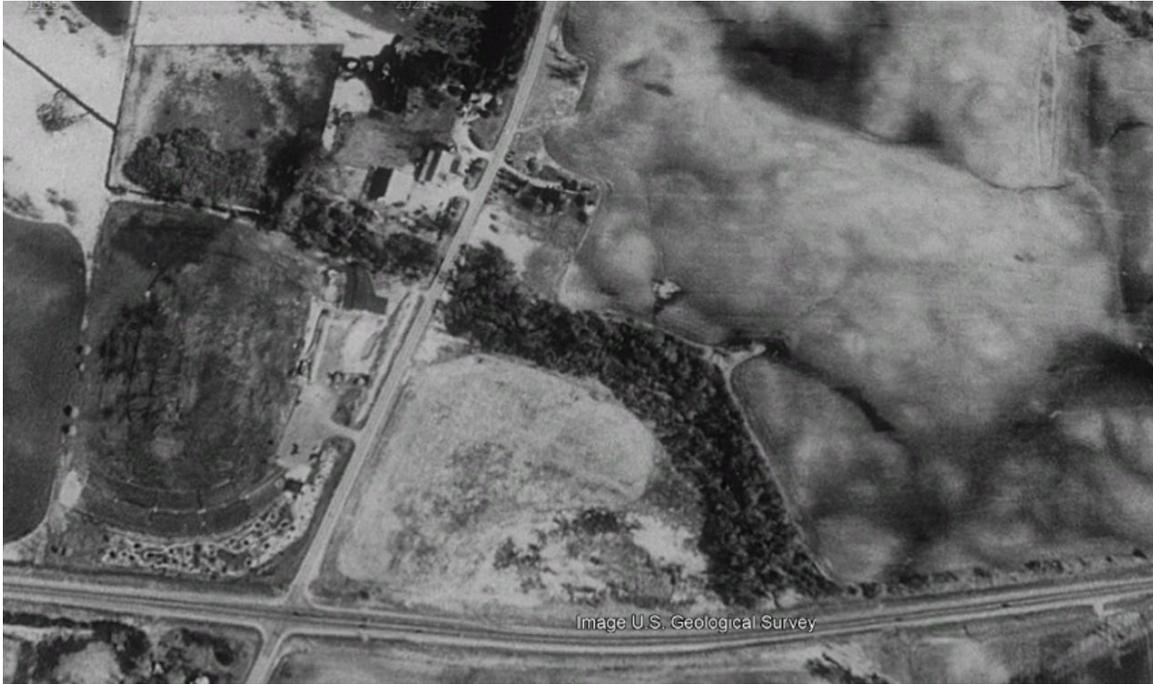
**1991**

The area surrounding Reach B5C of Bluff Creek underwent considerable change since the 1991 aerial photo shown below. There was development around the creek and a new road installed south of the creek. These changes would have reduced connectivity with the landscape, increased runoff leading to increased sediment and nutrient loading and degradation of the stream's water quality and ecological integrity.
