Lotus Lake Aquatic Vegetation Management Plan

RPBCWD Workshop
October 5, 2022

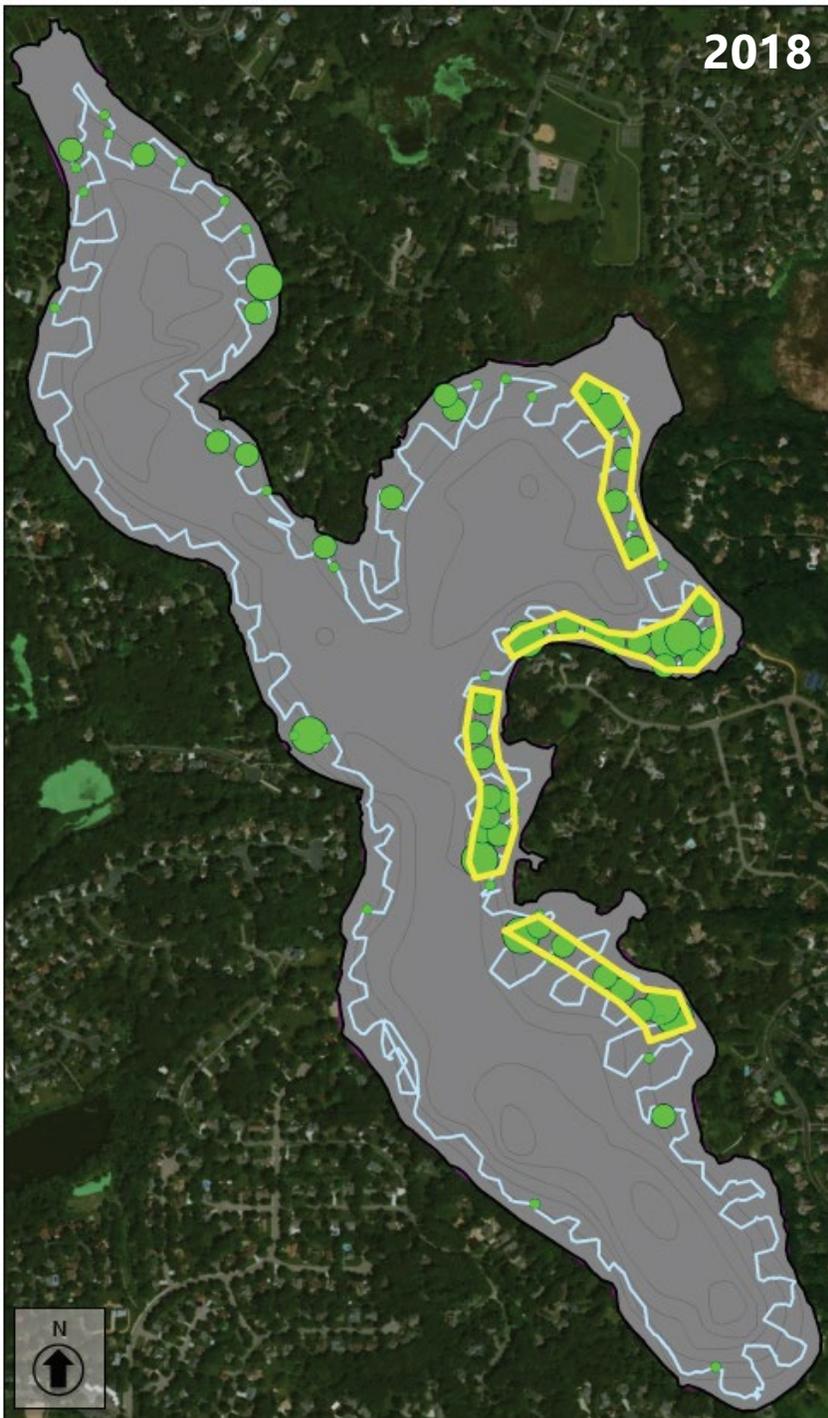
Year	Plant Targeted	Area Treated	Approach
2017	Brittle Naiad	2.42 acres	Diquat
2018	Curly-leaf Pondweed	15.3 acres	Diquat
2019	Curly-leaf Pondweed	20.6 acres	Diquat
2020	Curly-leaf Pondweed	12.8 acres	Diquat
2021	Curly-leaf Pondweed Eurasian Watermilfoil	22.8 acres	Diquat
2022	Curly-leaf Pondweed Eurasian Watermilfoil	20.8 acres	Diquat

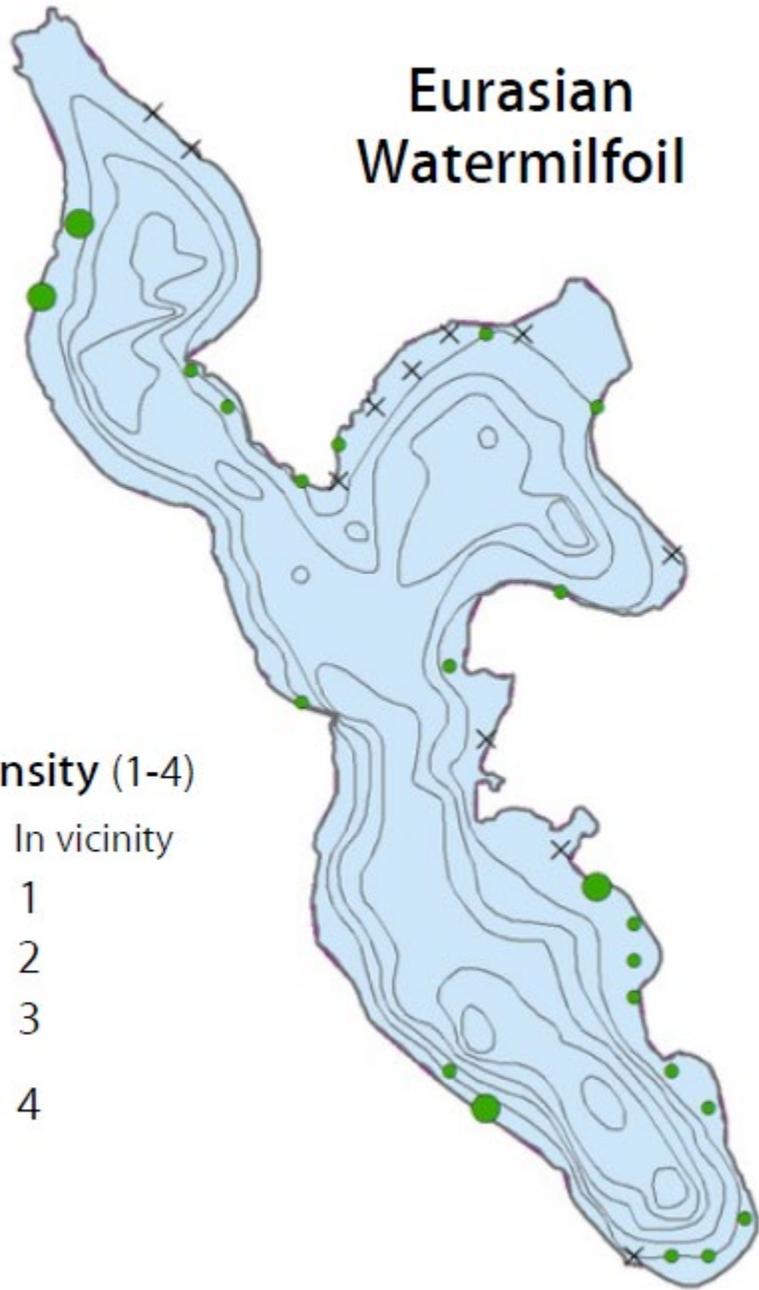
2017

Eurasian Watermilfoil

Density (1-4)

- x In vicinity
- 1
- 2
- 3
- 4

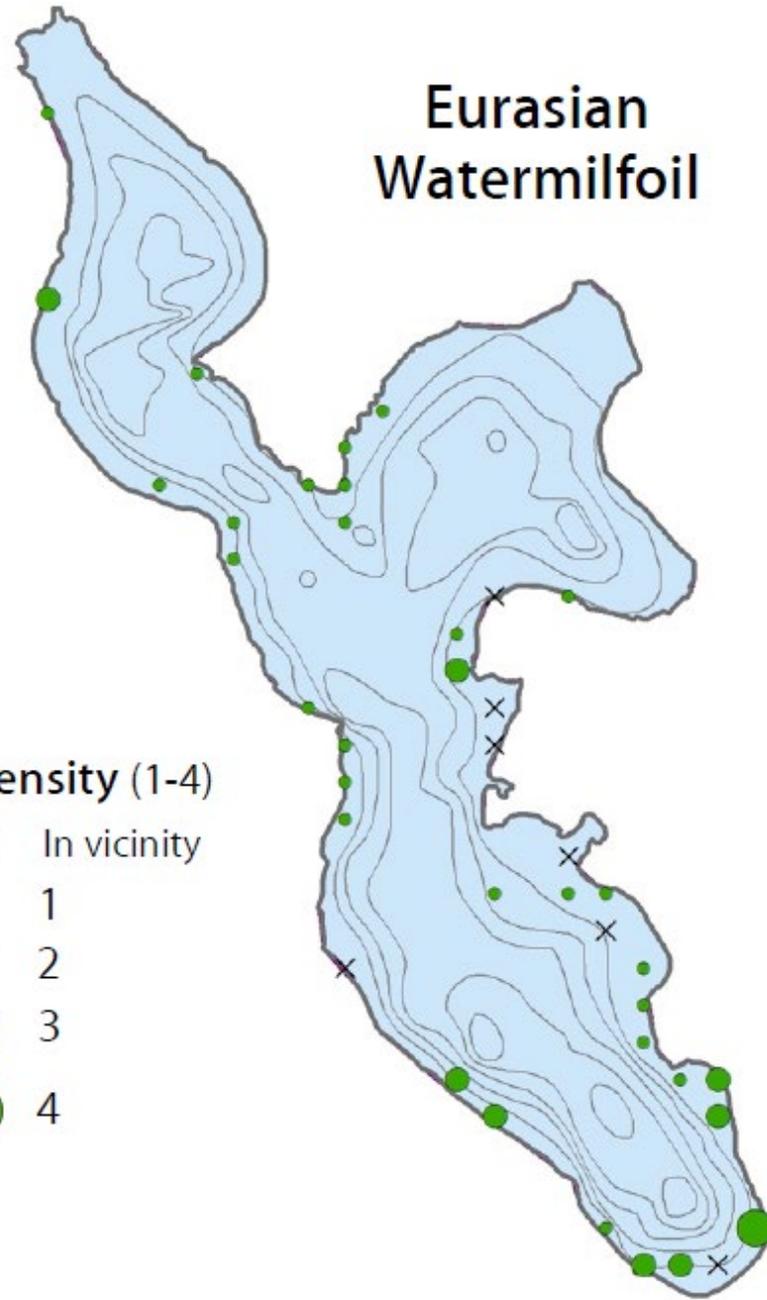
2019

Eurasian Watermilfoil

Density (1-4)

- x In vicinity
- 1
- 2
- 3
- 4

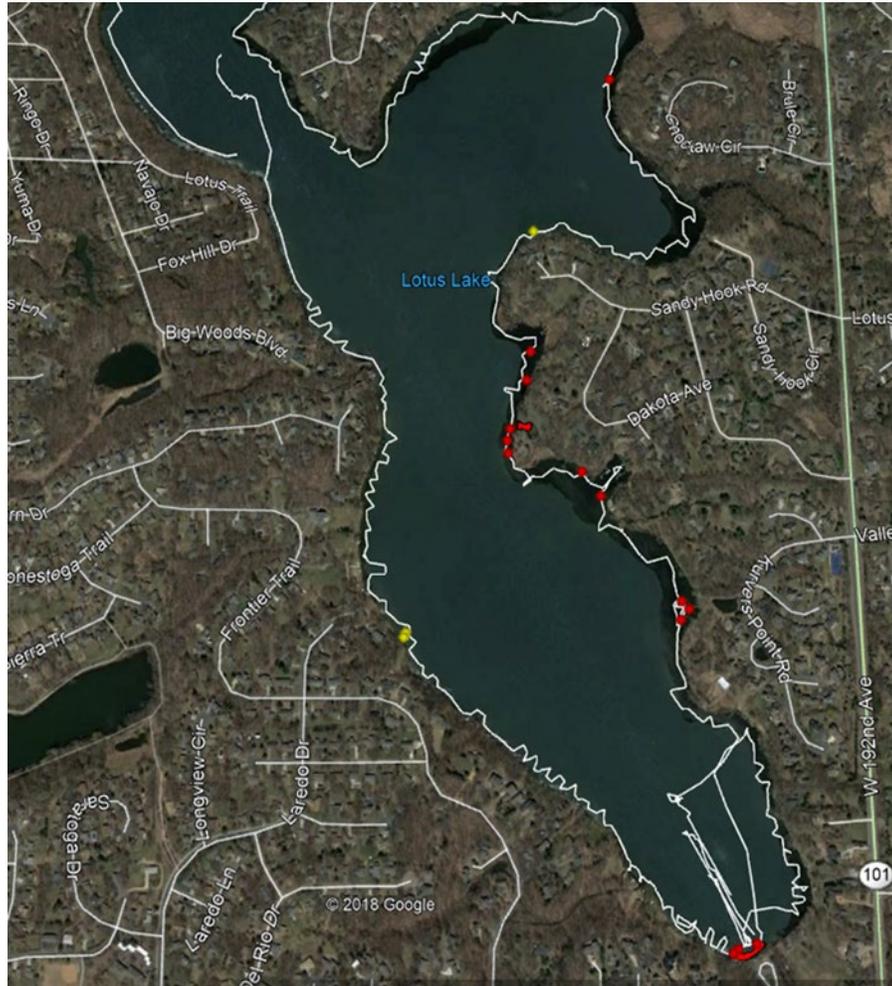
Brittle Naiad – 2017 versus 2020

- Brittle Naiad (floating)
- Brittle Naiad (rooted)
- Boat Path

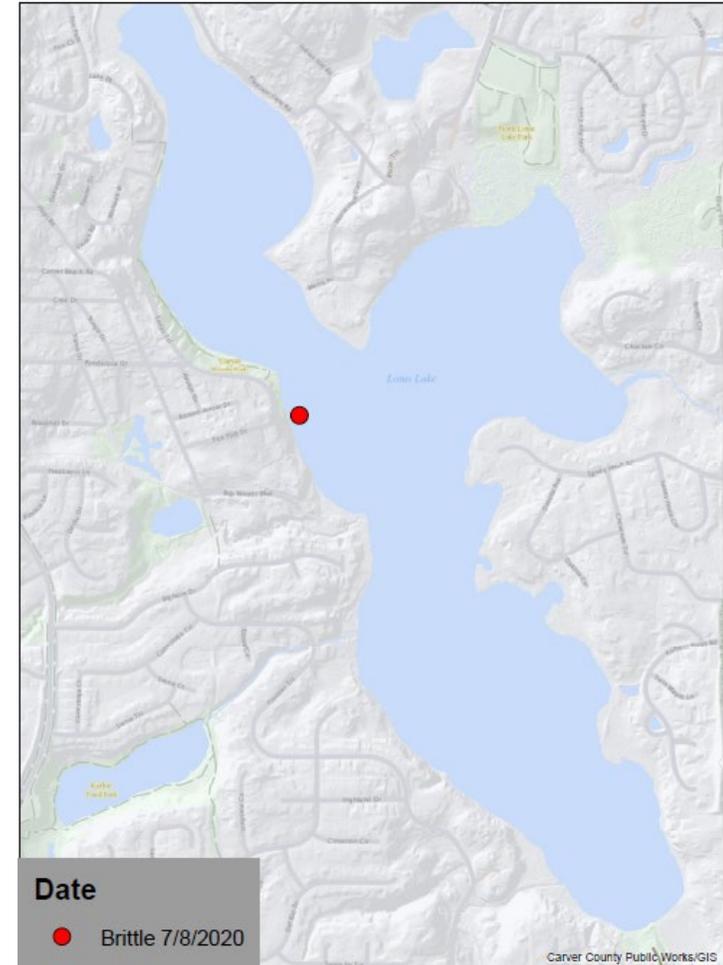
LOTUS LAKE Vegetation Survey Brittle Naiad

Date
● Brittle 7/8/2020

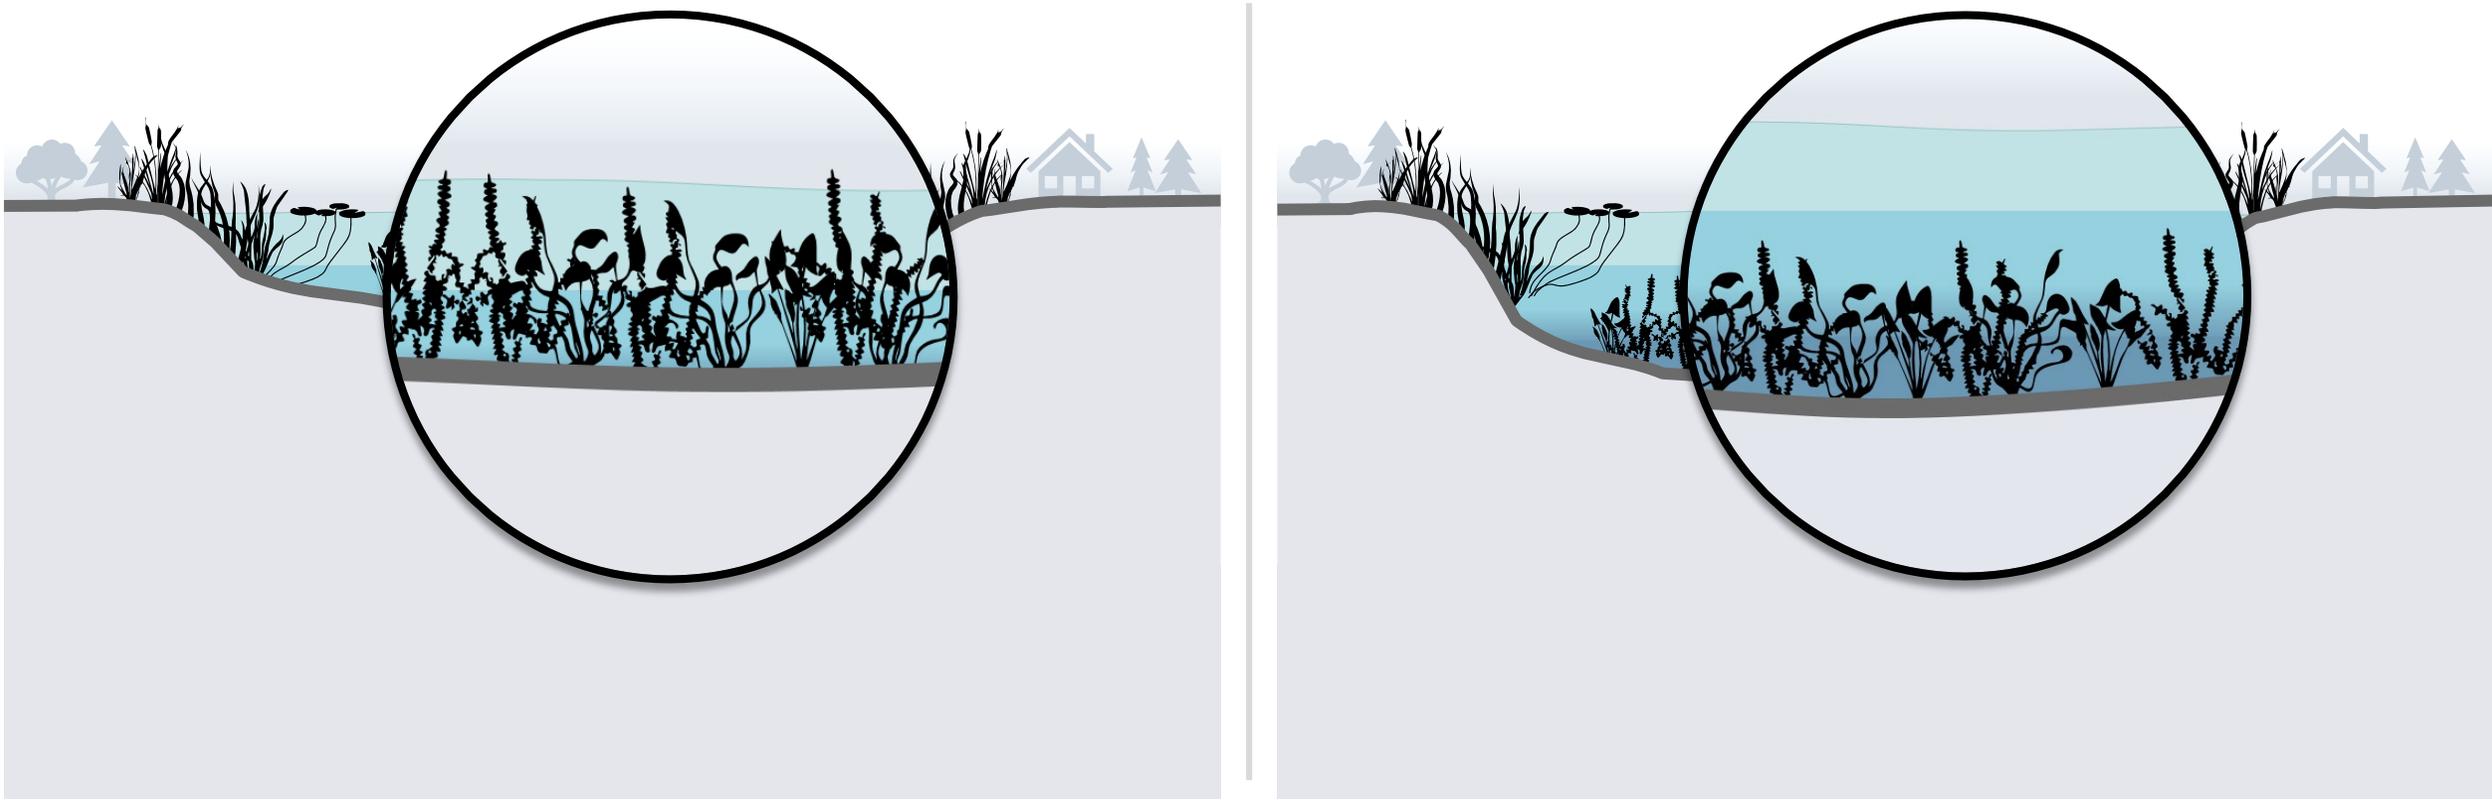
Importance of Depth

not all shallow lakes are created equal

- Depth is a key factor establishing the “level of effort” required to maintain boating as a recreational use

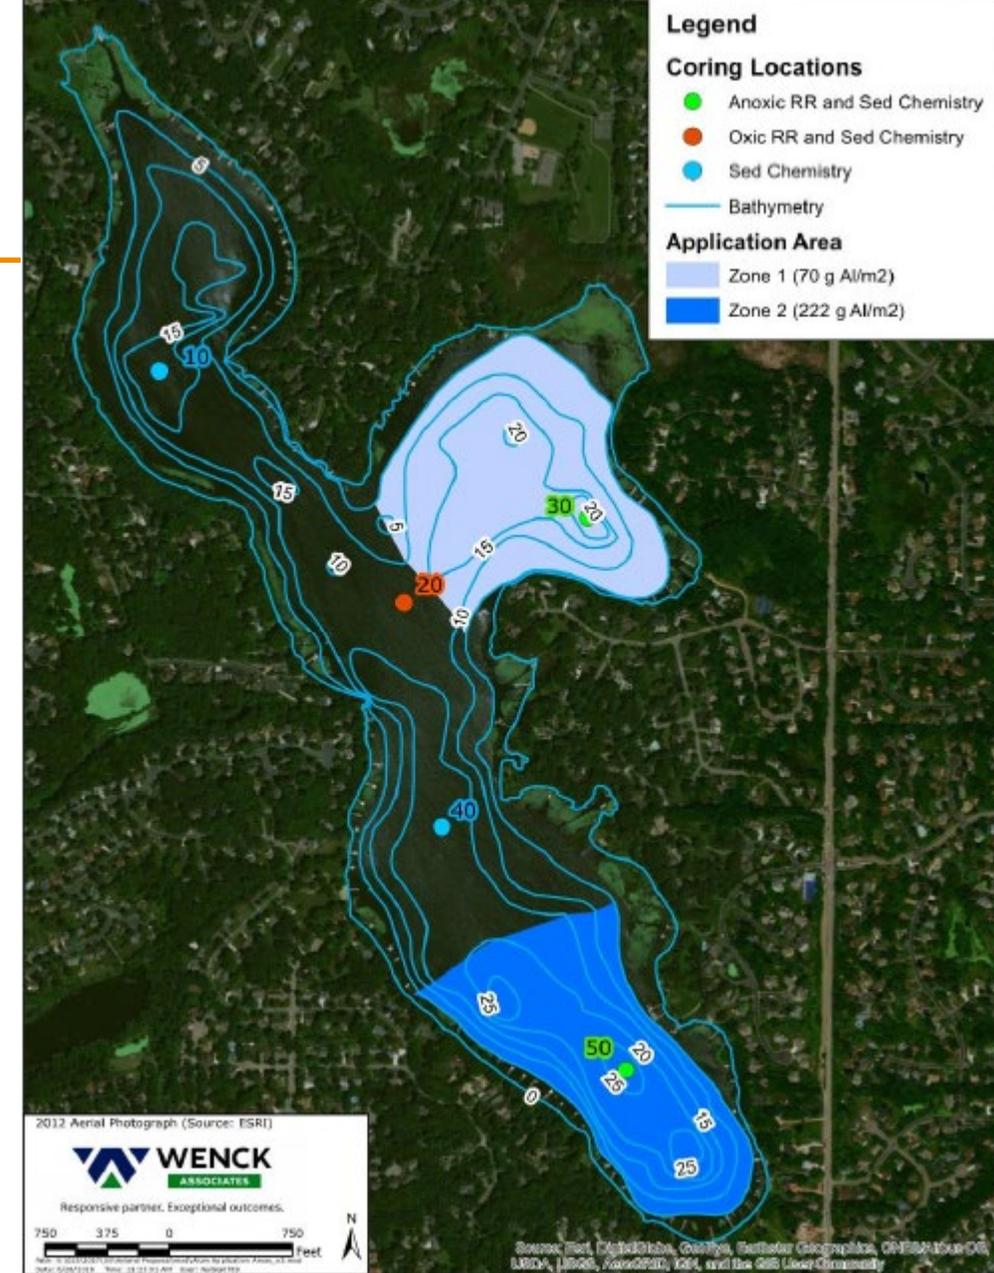
Lotus Lake Alum Treatment

- Application of alum should be applied in two areas at rates of 222 and 70 g-Al/m² as outlined in the alum dosing map

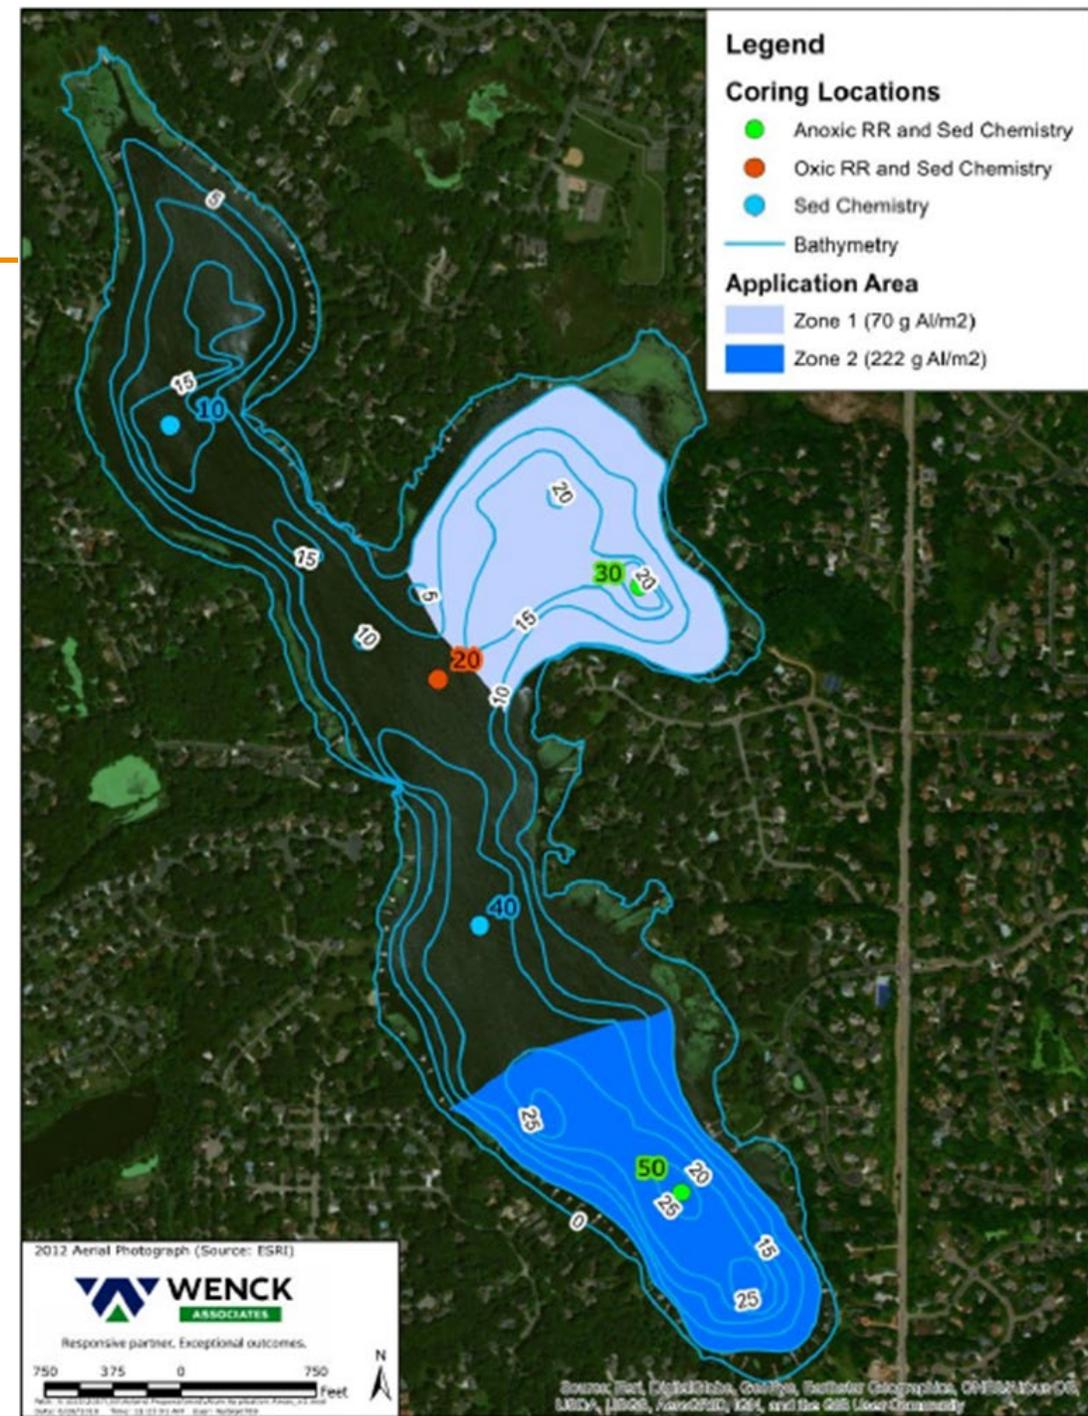
Lotus Lake Options

- Adjust current alum treatment plan
 - Consider shallow area treatment
 - Split remaining treatments
 - 15-foot contour in Zone 1
 - 15-foot contour in Zone 2
 - 15-foot contour in new Zone 3
- Need updated cost estimate and adjust application plan

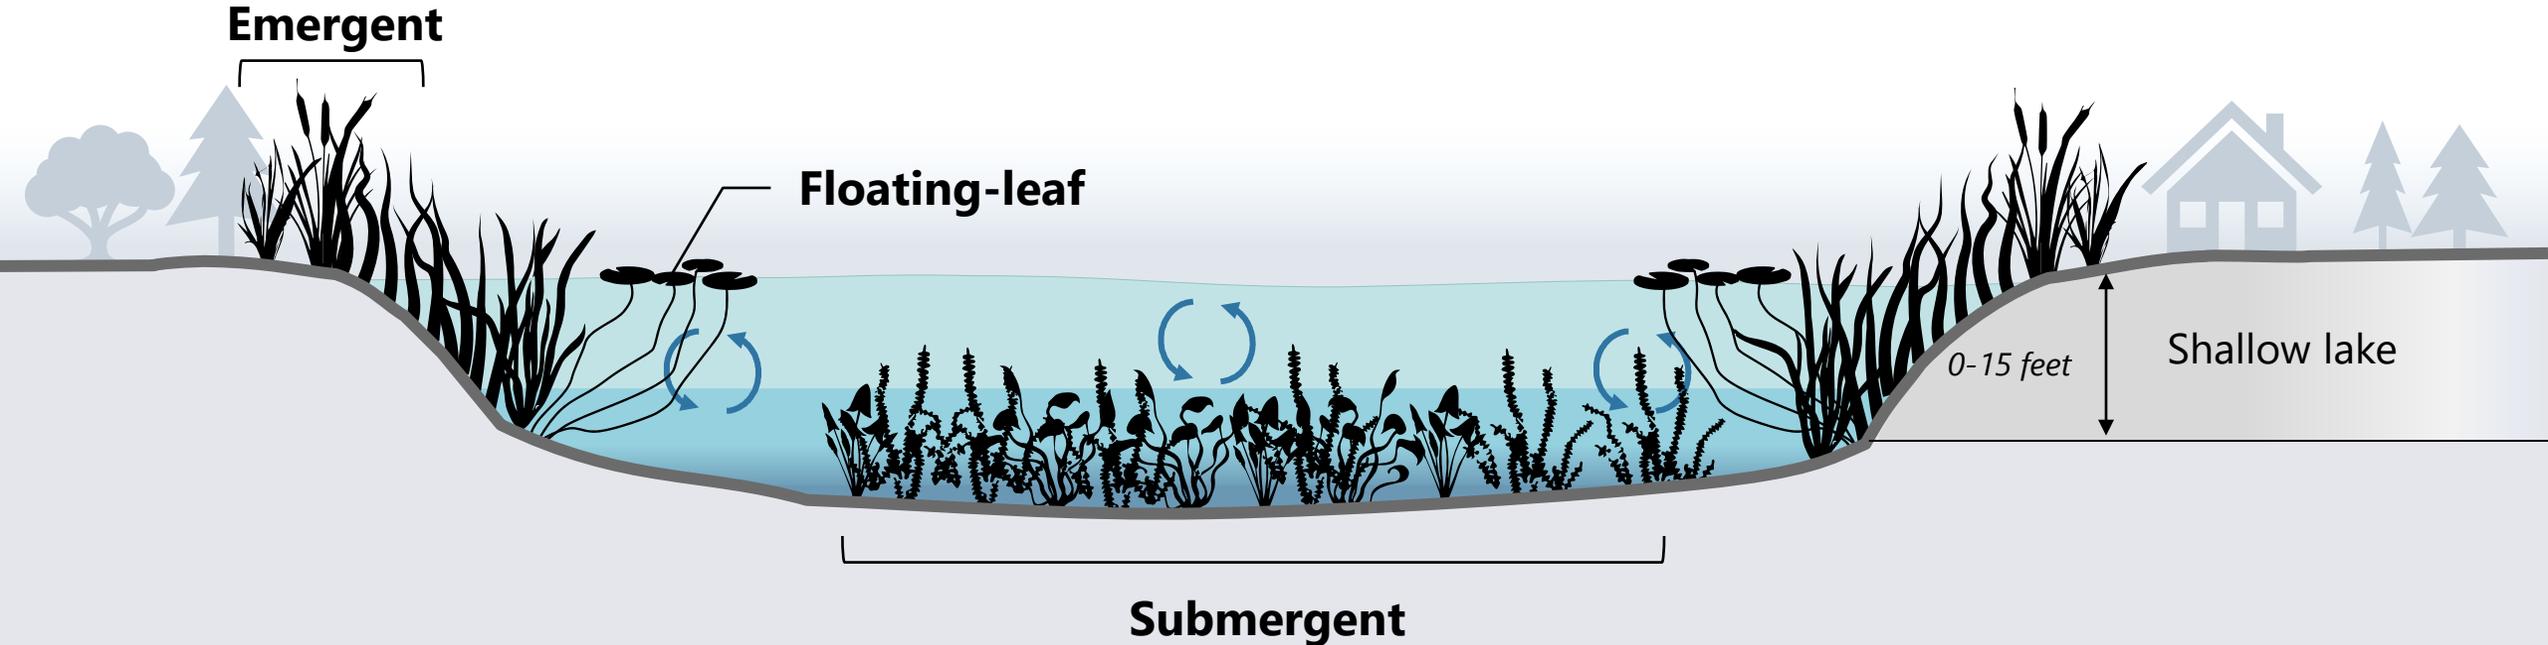
Physical Characteristics of Lakes

Diagram not to scale
