*Lake Riley Outlet Improvements and
Riley Creek Lower Valley Stabilization
Feasibility Study*

*Prepared for
Riley Purgatory Bluff Creek Watershed District*

March 20, 2007

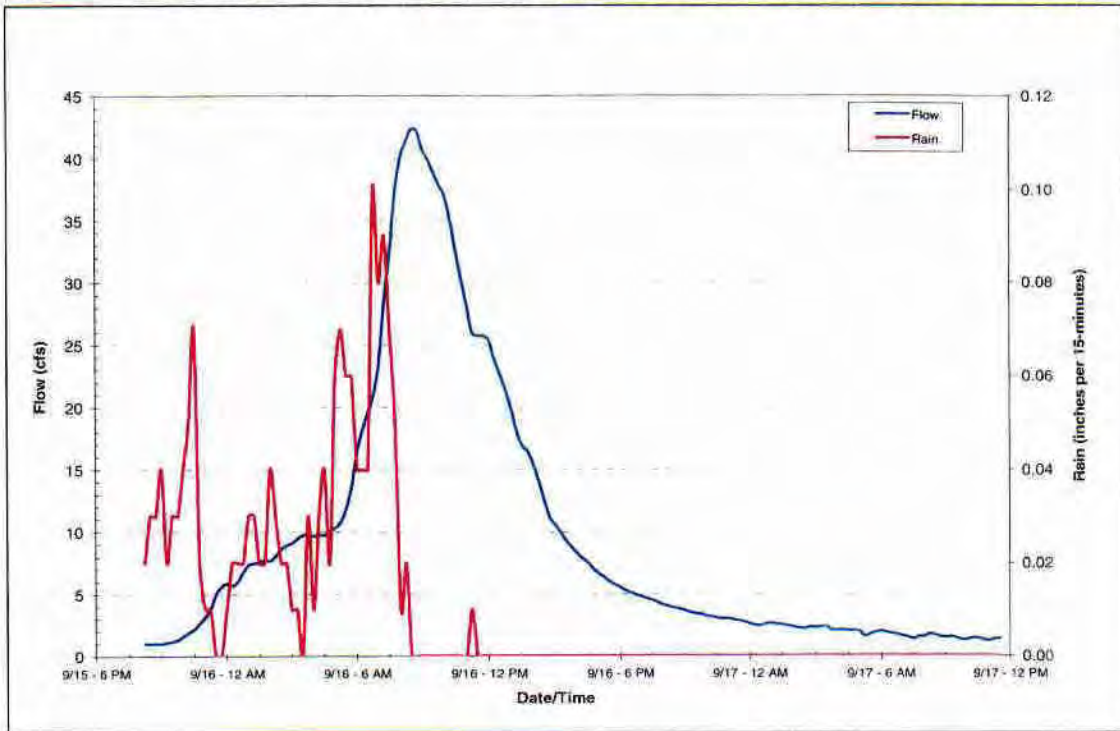
Figure 1. Riley Creek - Storm Event, September 15-16, 2004 (total rainfall 1.63 inches)

The September 15 and 16, 2004 storm event was a 1.63-inch event that took place over approximately 15 hours (Figure 1). Before the September 15-16 event, 0.89 inches of rain fell during the previous eight days, so the soils were somewhat saturated. To account for the moist soils conditions at the onset of the calibration event, the calibrated Horton initial infiltration rates (F_0) were divided by 3, which is consistent with recommendations in XP-SWMM reference material. Figure 2 compares the flows from the calibrated XP-SWMM model for the September 2004 event to the observed flows recorded at the flow monitoring station.

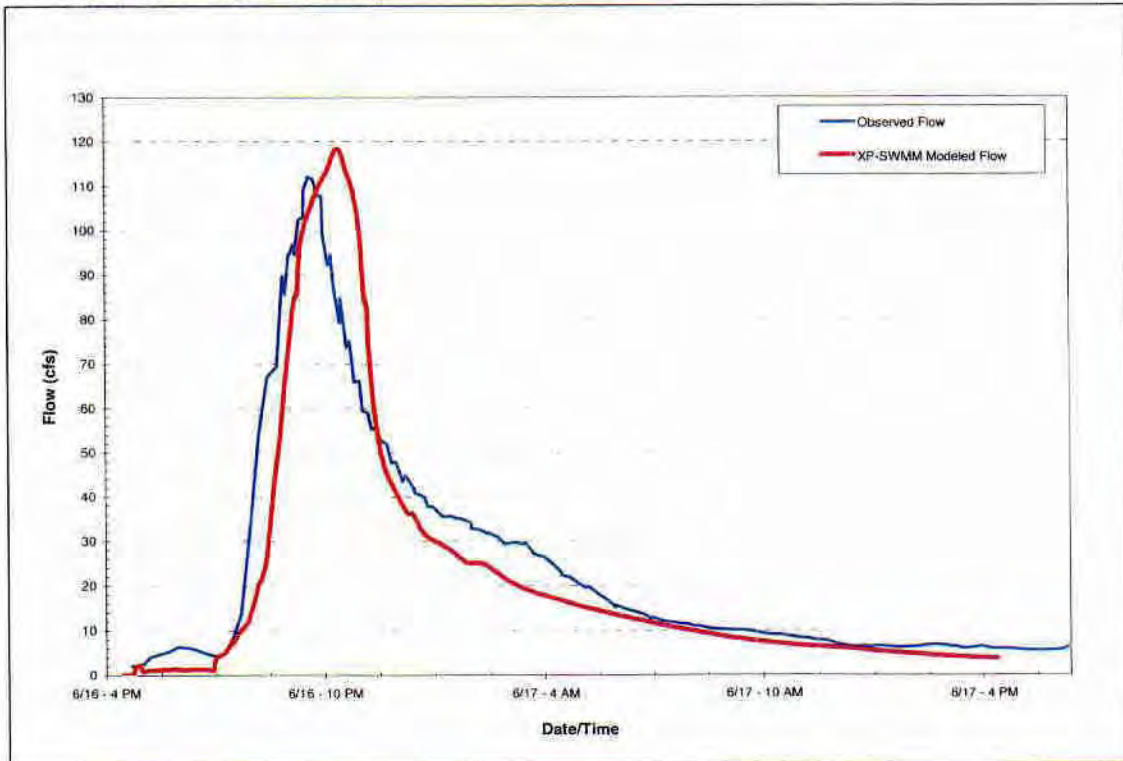
Figure 4. Observed flow from Hwy 212 flow monitoring station on Riley Creek compared to XP-SWMM modeled flow using calibration parameters for the June 16, 2006 storm event (2.5 inches)

were adjusted to be below the normal outlet elevations, based on regional evaporation estimates. Figure 4 compares the flows from the calibrated XP-SWMM model for the June 2006 event to the flows recorded at the flow monitoring station.

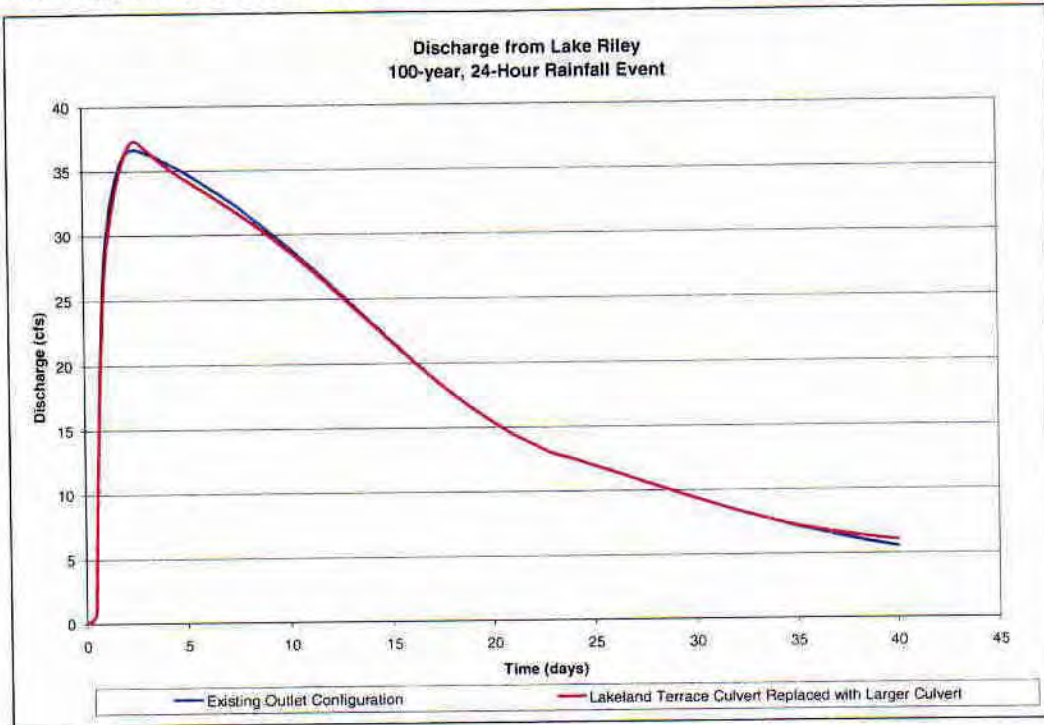
Figure 7. Comparison of Discharge for Existing Conditions versus Larger Culvert for 100-Year, 24-Hour Rainfall Event

To quantify the impact that the Lakeland Terrace culvert crossing has on the discharge from Lake Riley, the 100-year frequency, 24-hour rainfall event was modeled using the assumption that the Lakeland Terrace culvert was replaced with a significantly larger culvert (a 10-foot by 12-foot box culvert was assumed to ensure that the culvert would not be restricting the flow). The discharge from Lake Riley under this scenario was compared with the predicted discharge under existing outlet conditions (Figure 7). As shown in Figure 7, the discharge hydrographs from these two scenarios are nearly identical, with slight variations occurring as the surface water elevation approaches 865.8 M.S.L (Figure 8). This indicates that the Lakeland Terrace crossing does not restrict the discharge from Lake Riley when the lake is at elevations below 865.8 M.S.L. Modeling results indicate that the channel between Lake Riley and the weir outlet structure limits the discharge from the lake when the surface water elevation of Lake Riley is below this elevation.

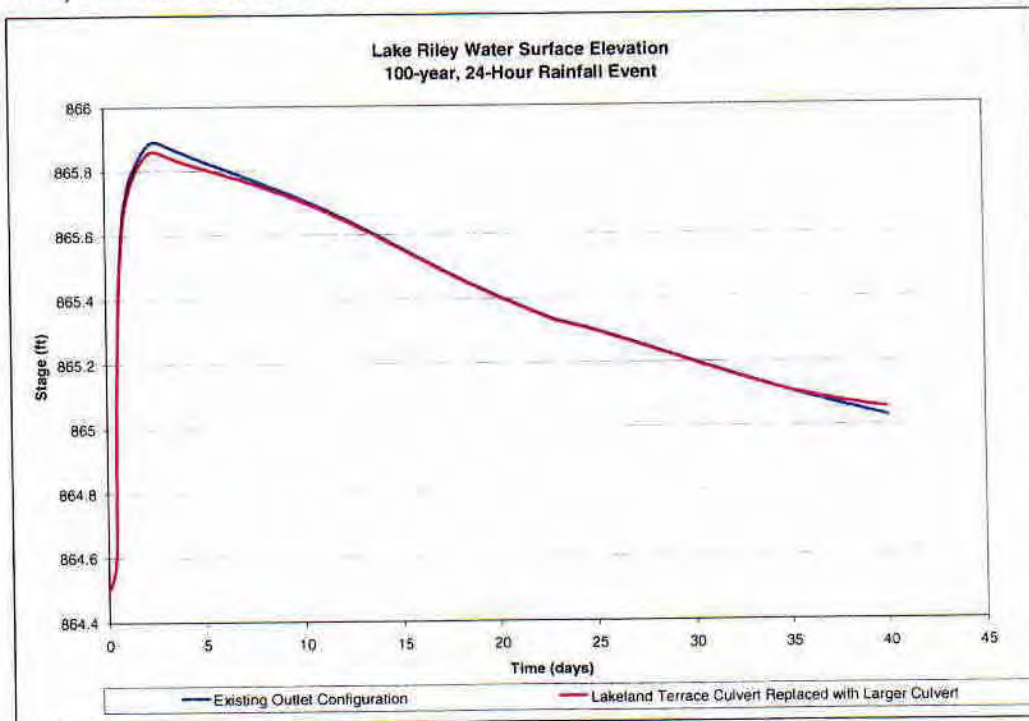
Figure 8. Comparison of Stage for Existing Conditions versus Larger Culvert for 100-Year, 24-Hour Rainfall Event

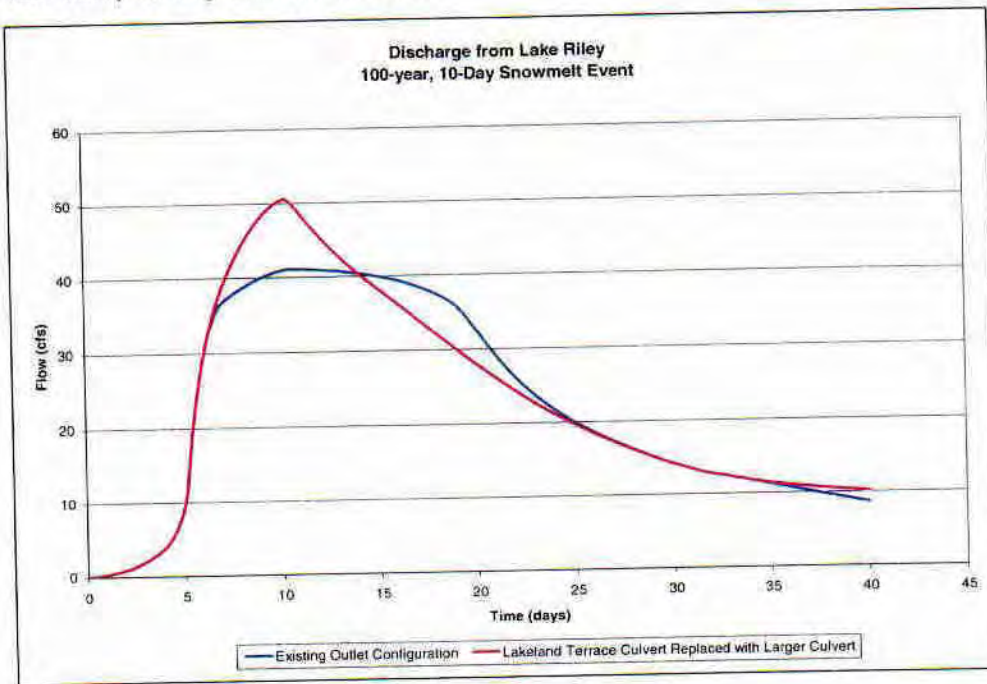
Figure 9. Comparison of Discharge for Existing Conditions versus Larger Culvert for 100-Year, 10-Day Snowmelt Event

The 100-year frequency, 10-day snowmelt event was also modeled using the assumption that the Lakeland Terrace culvert was replaced with a significantly larger culvert. The discharge from Lake Riley under this scenario was compared with the predicted discharge under existing outlet conditions (Figure 9). The discharge hydrographs from these two scenarios are identical until Day 6.5, when the discharge from the Lakeland Terrace culvert replacement scenario exceeds that of the existing conditions scenario. This variation in discharge from Lake Riley coincides with a surface water elevation in Lake Riley of approximately 865.8 M.S.L. (Figure 10), which indicates that the existing Lakeland Terrace culvert controls the discharge from Lake Riley when the lake level is at or above 865.8 M.S.L.

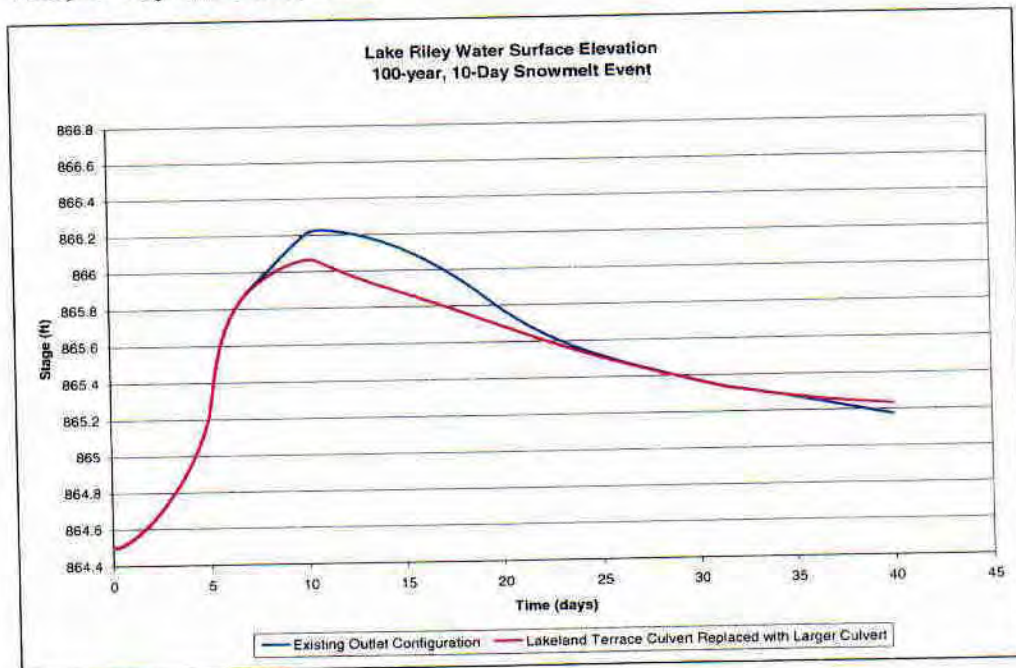
Figure 10. Comparison of Stage for Existing Conditions versus Larger Culvert for 100-Year, 10-Day Snowmelt Event

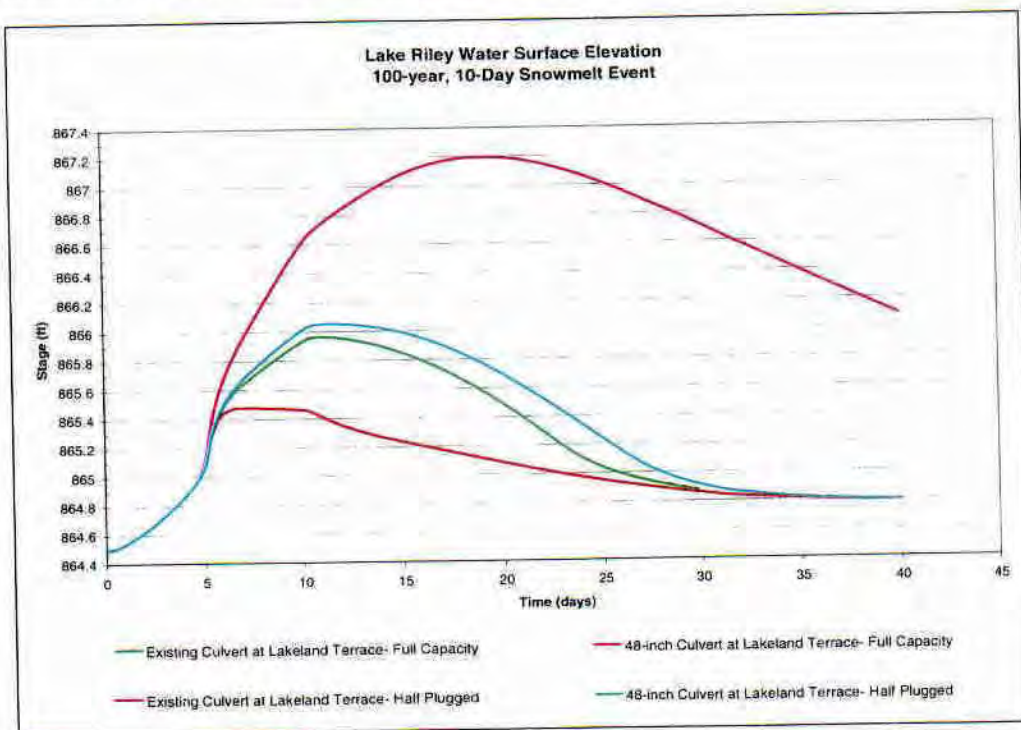
Figure 13. Predicted surface water elevations at Lake Riley assuming half-plugged conditions at the Lakeland Terrace crossing

The scenario assuming the existing Lakeland Terrace culvert is half-plugged (shown in pink in Figure 13) results in a peak surface water level of 867.2 M.S.L., which is 1.2 feet higher than the predicted high water level under full flow capacity (assuming the stream channel between Lake Riley and the weir structure is widened). This scenario results in a 100-year flood level that is approximately 1.0 feet higher than the 100-year flood level of 866.2 M.S.L., based on existing outlet conditions. In addition to the increase in flood level predicted under partially-blocked conditions, the duration of high water levels also increases significantly.

The scenario assuming that a 48-inch culvert at Lakeland Terrace is half-plugged (shown in cyan blue in Figure 13) results in a peak surface water level of just over 866.0 M.S.L., which is 0.5 feet higher than the predicted high water level under full flow capacity through the 48-inch culvert (assuming the stream channel between Lake Riley and the weir structure is widened). This scenario results in a 100-year flood level that is approximately 0.2 feet lower than the existing conditions 100-year flood level of 866.2 M.S.L. The duration of high water levels predicted with a partially blocked 48-inch culvert is approximately 5 days longer than under full-flow conditions.

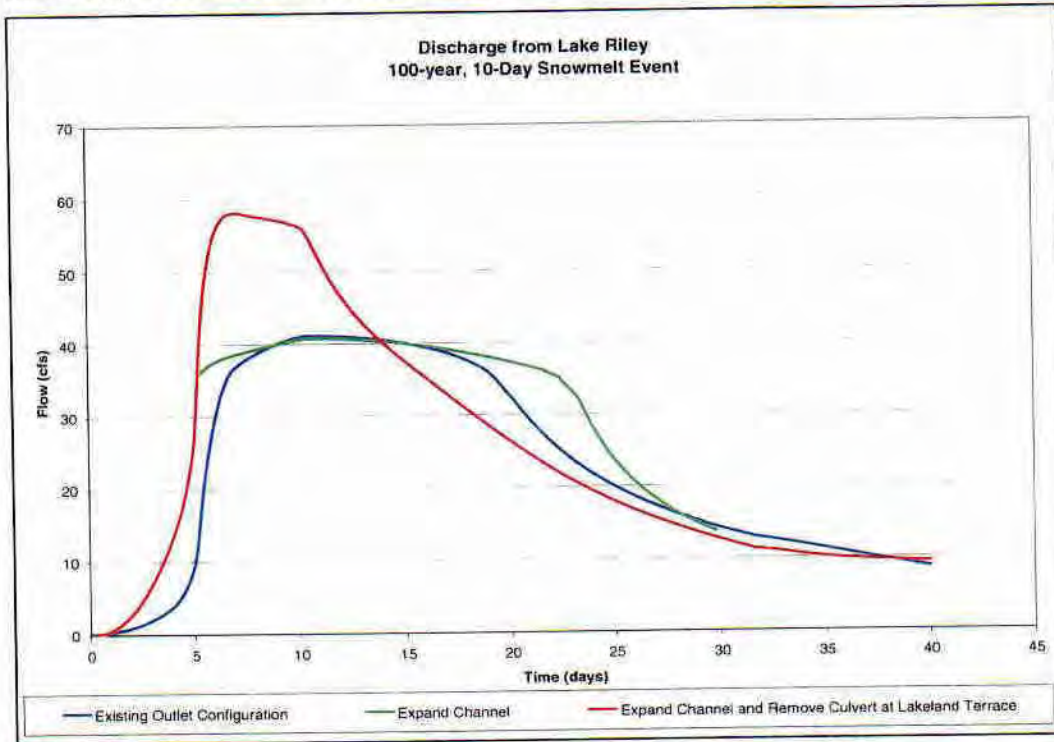
Figure 15. Predicted 100-year Frequency Discharge from Lake Riley for the 10-day Snowmelt Event based on Recommended Outlet Modifications

The predicted flows from Lake Riley for the recommended outlet modifications for the 100-year frequency, 10-day and 24-hour runoff events are shown in Figures 15 and 16, respectively. Modeling results indicate that widening the channel between Lake Riley and the weir structure would result in peak discharges (shown in green) of 41 cfs for the 10-day snowmelt event and 40 cfs for the 24-hour rainfall event, which are similar to the discharges predicted under existing conditions (shown in blue). However, when the channel is widened, the discharge capacity from Lake Riley is controlled by the culvert at Lakeland Terrace, resulting in a longer period of high flow, and a faster drawdown of the lake level. If the capacity of the culvert at Lakeland Terrace is increased, in addition to widening the restrictive channel, the peak of the predicted discharge hydrograph (shown in red in Figures 15 and 16) increases to approximately 58 cfs for the 10-day snowmelt event and 66 cfs for the 24-hour event. Under this scenario, the shape of the discharge hydrograph from Lake Riley is controlled by the weir structure downstream of Lake Riley. Although this scenario results in higher peak flows, the duration of high flows is decreased from existing conditions.

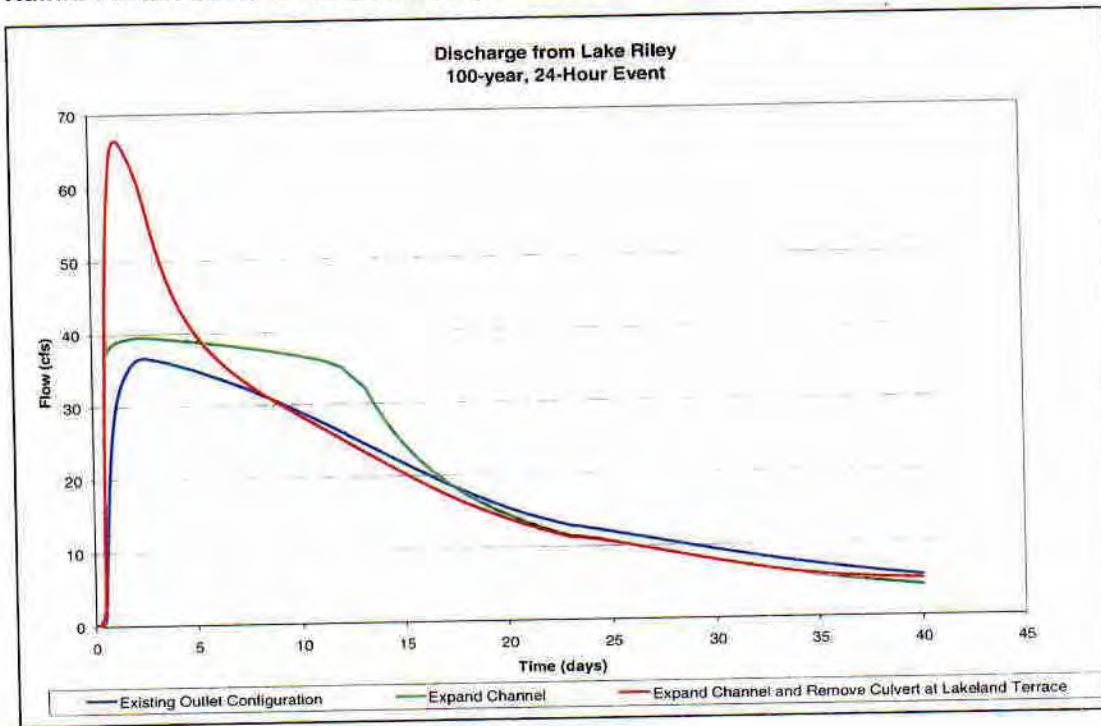
Figure 16. Predicted 100-year Frequency Discharge from Lake Riley for the 24-hour Rainfall Event based on Recommended Outlet Modifications.

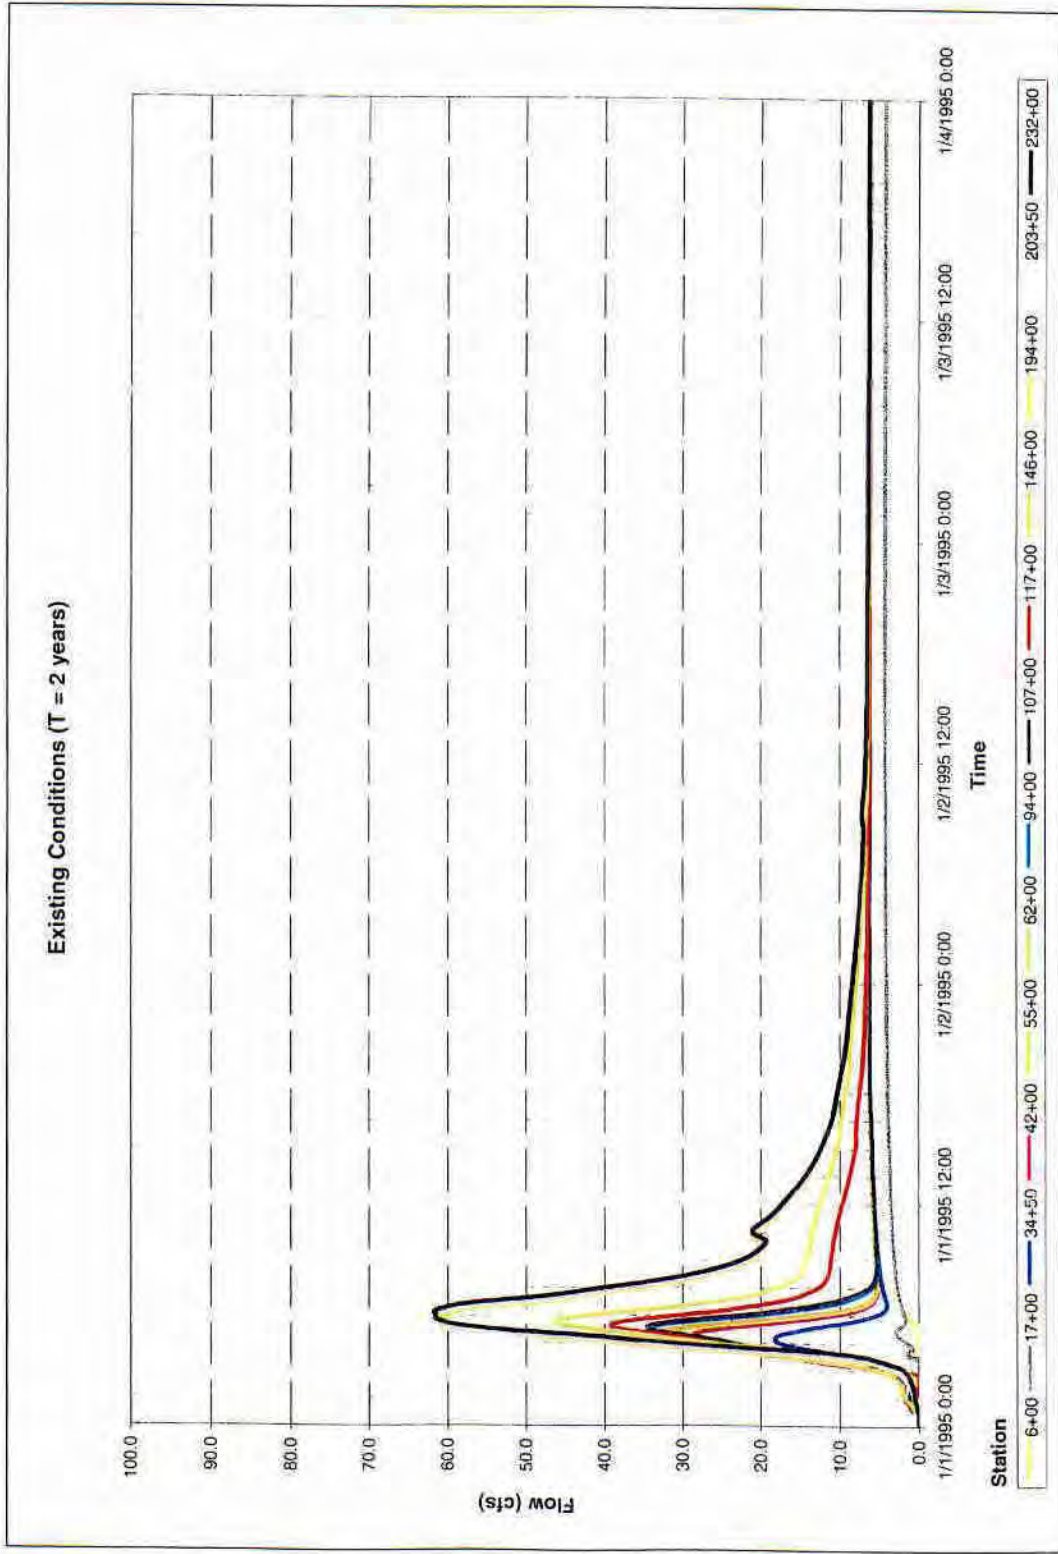
Figure 17. Modeled Flood Hydrograph, Existing Conditions, 2-Year Event

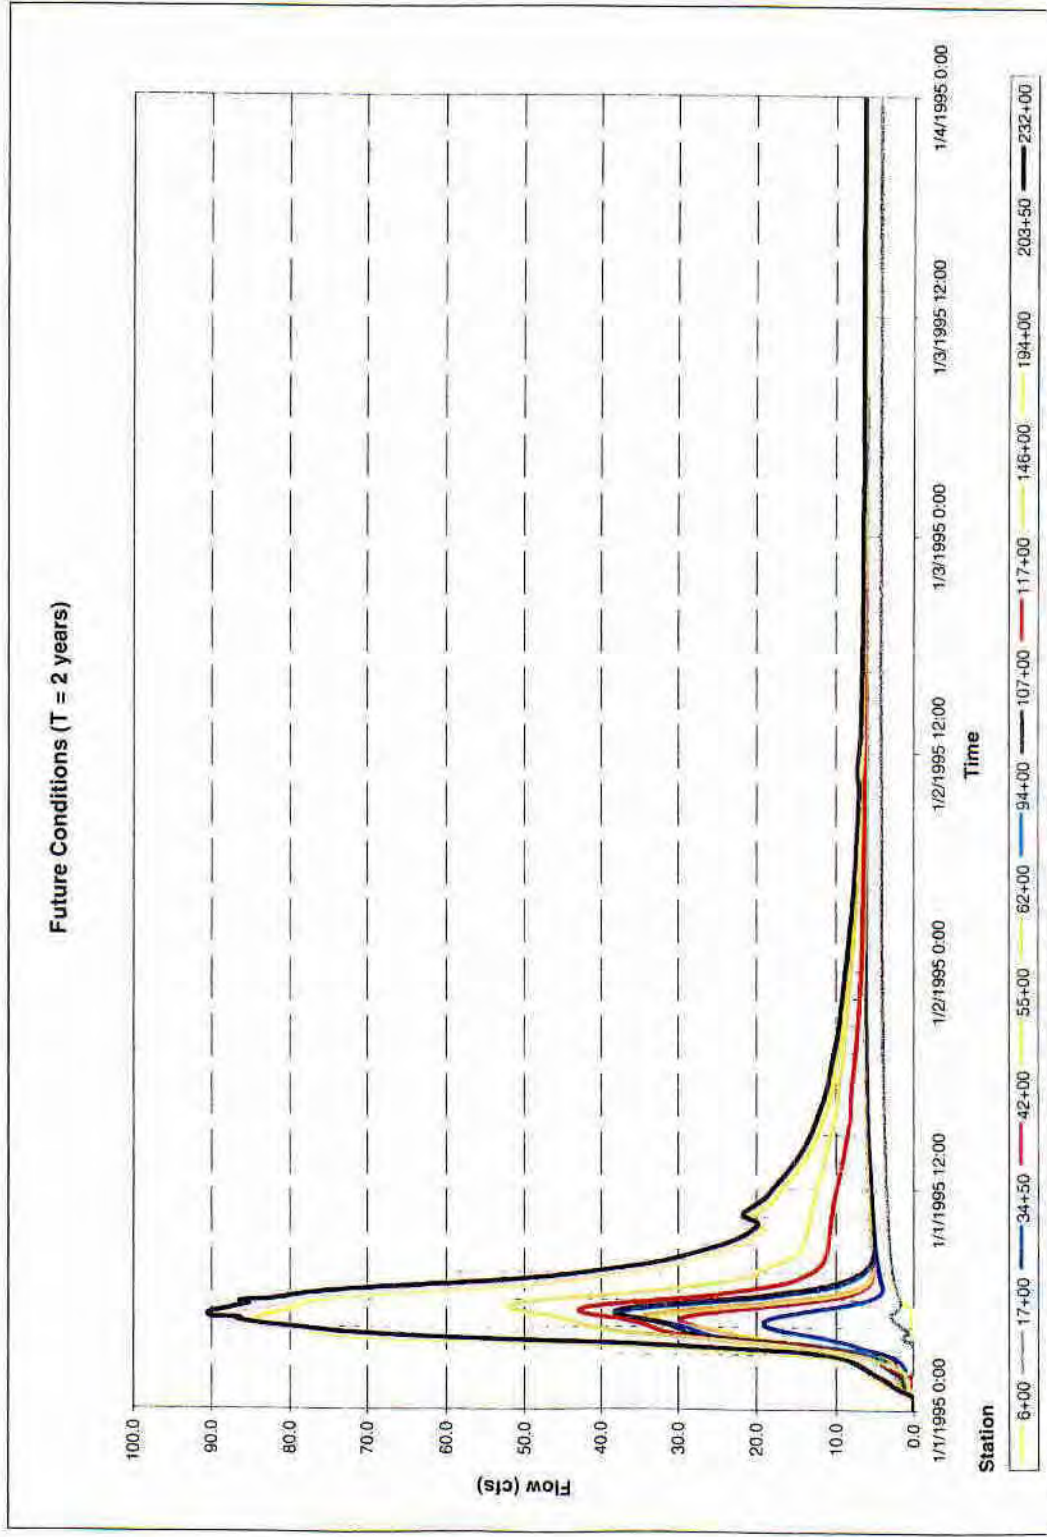
Figure 19. Modeled Flood Hydrograph, Future Conditions, 2-Year Event

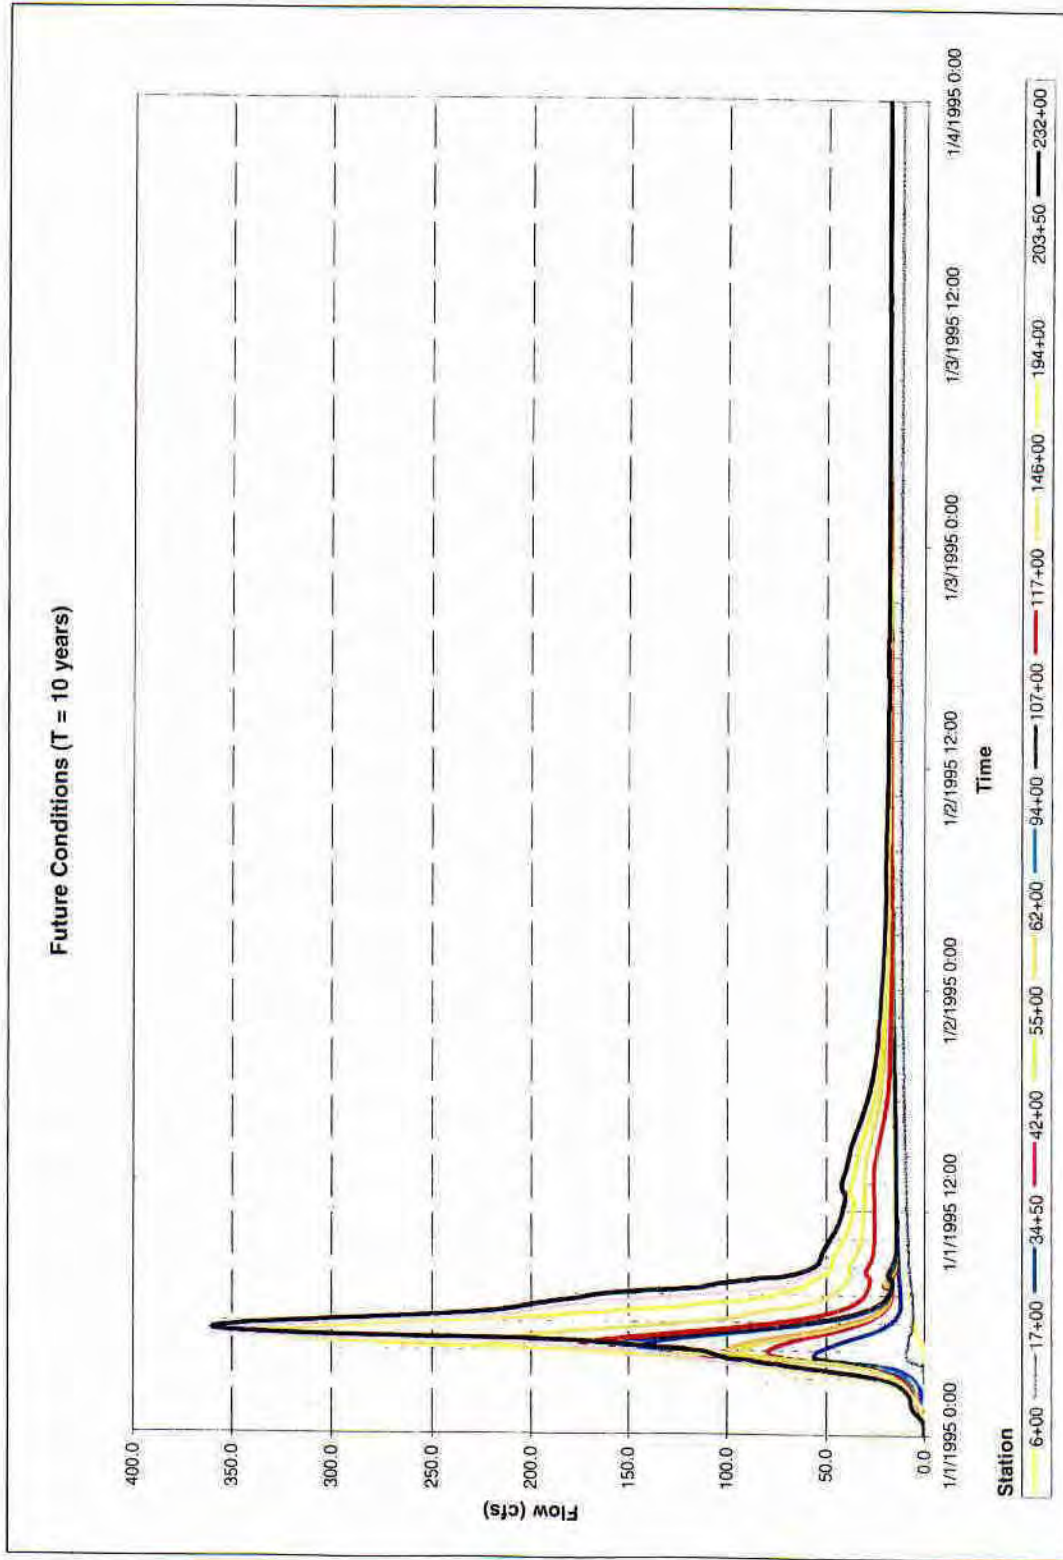
Figure 20. Modeled Flood Hydrograph, Future Conditions, 10-Year Event

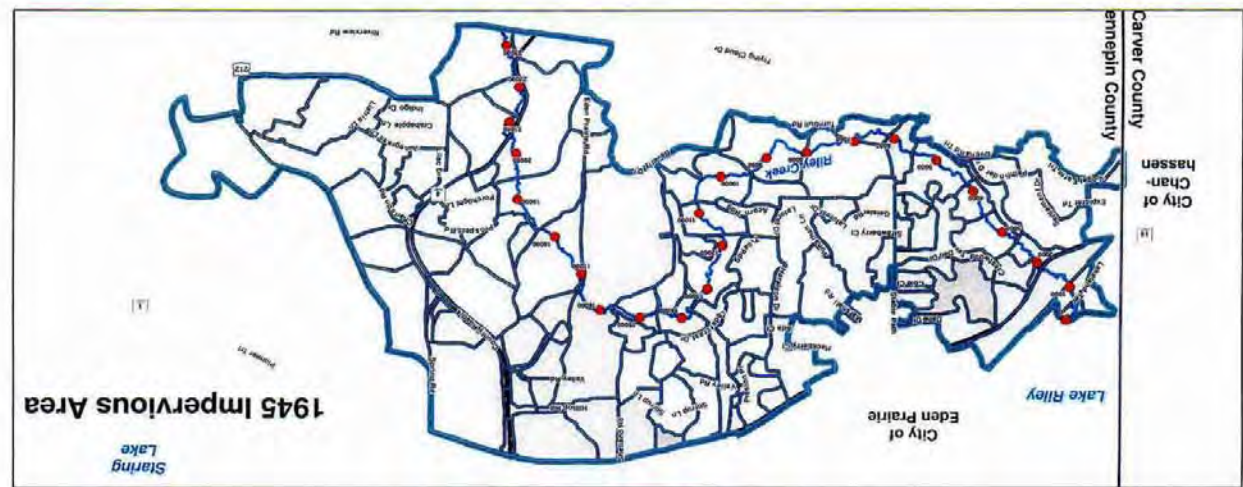
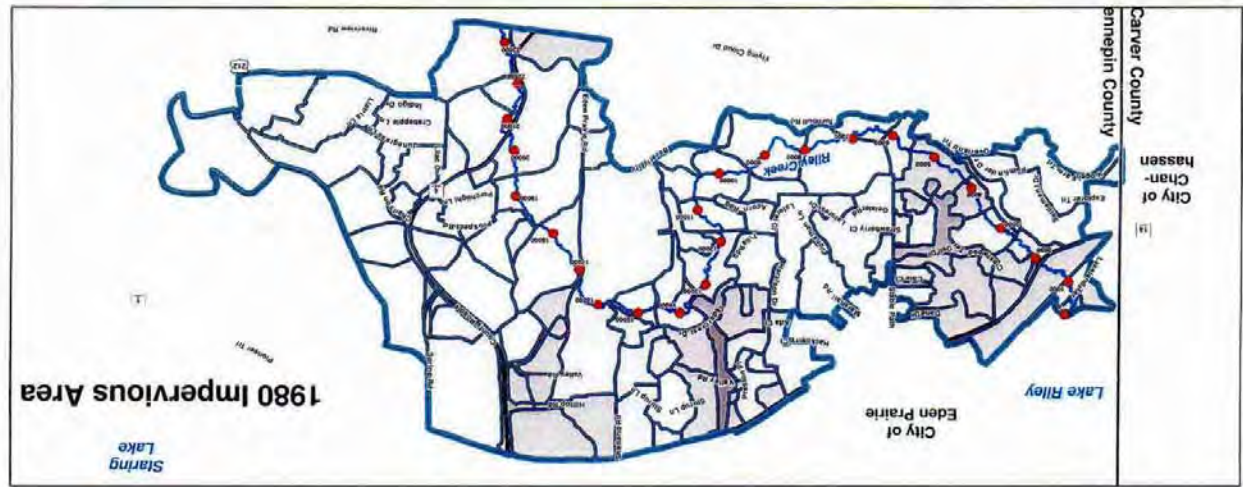
Map 11
 HISTORIC IMPERVIOUS AREA (1945, 1980, 1991)
 Lake Riley Outlet Improvements & Riley Creek
 Lower Valley Stream Stabilization Feasibility Study

Percent Impervious
0 - 5%
5 - 10%
10 - 20%
20 - 30%
30 - 40%
40 - 50%
50 - 60%
70 - 80%
80 - 90%

Data Sources:
 1945 Aerial Photographs
 1980 Aerial Photographs
 1981 USGS DOCS
 TLG Street Centerline Data
 2006 Barr Riley Creek XPSWMM Modeling
