Bluff Creek Reach 5 Ecological Enhancement Plan

Project Vision & Approach

RECOMMENDED STREAM RESTORATION

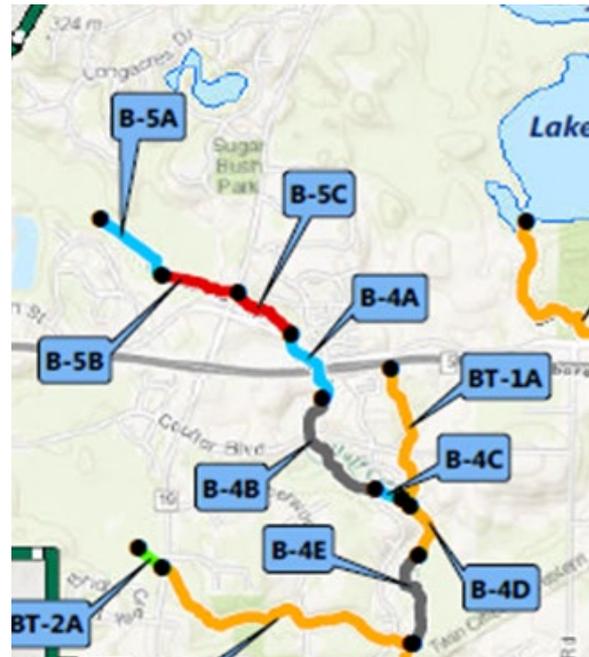
High Priority Reach for RPBCWD

RPBCWD assesses creek reach restoration by assessing

- Infrastructure
- Erosion/channel stability
- Ecological benefits
- Water quality

Stream Reaches - Erosion and Channel Stability

Reach	Description	Infrastructure	Erosion/ Channel Stability	Ecological Benefits	Water Quality Summary	Tier I Score	Tier I Priority
B5A (2015)	Ridgeview Road Recreational Trail to 985 feet Upstream of Galpin Boulevard	1	1	7	7	16	Low
B5B (2016)	985 Feet upstream of Galpin Blvd to Galpin Blvd	3	5	5	7	20	High
B5C (2015)	Galpin Blvd to West 78 th Street	5	7	5	7	24	Severe
B5C (2020)	Galpin Blvd to West 78 th Street	5	7	5	5	22	Severe

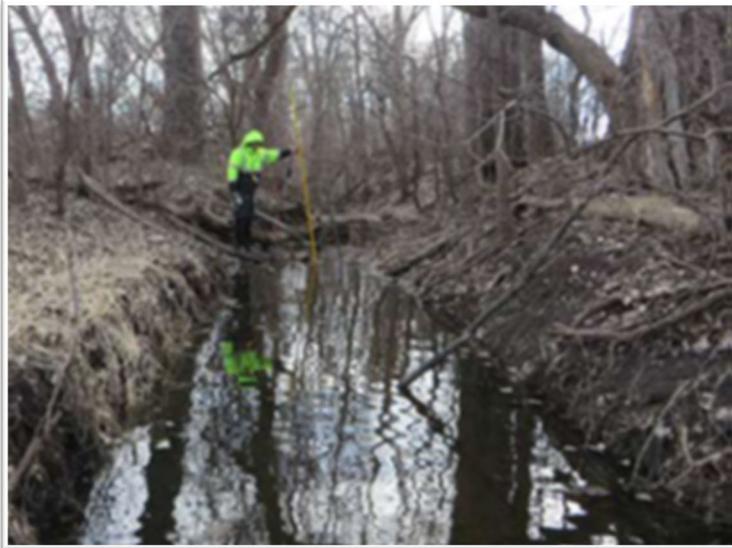
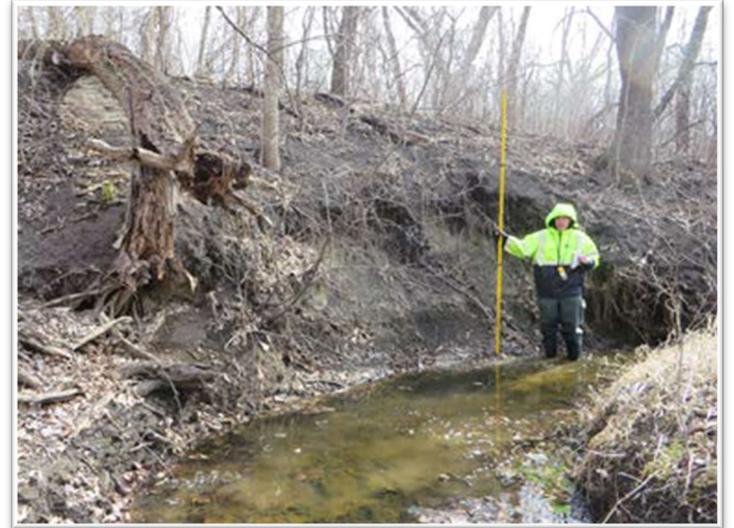
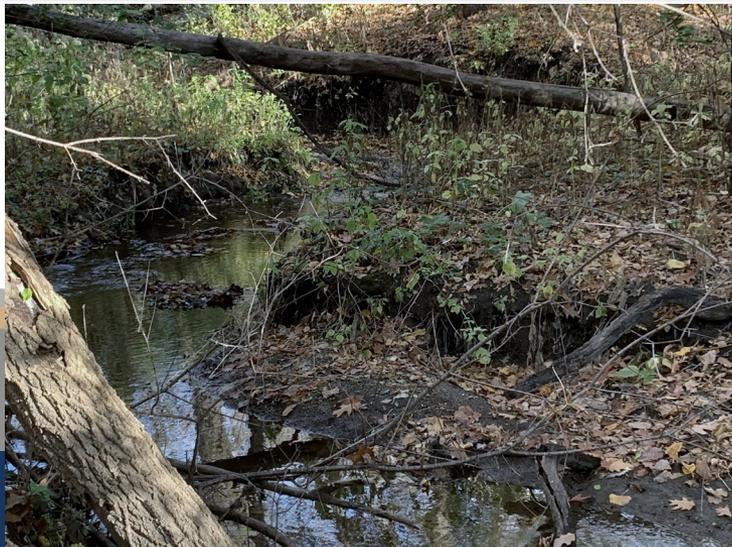
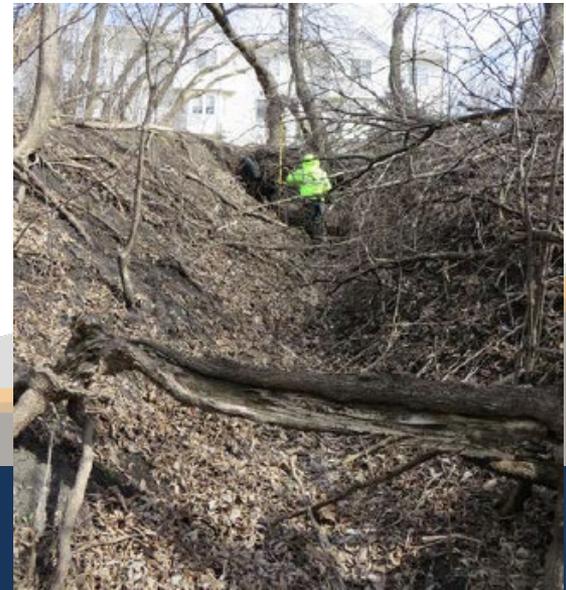
Incised Channel, Disconnected from Floodplain, & Bank and Gully Erosion

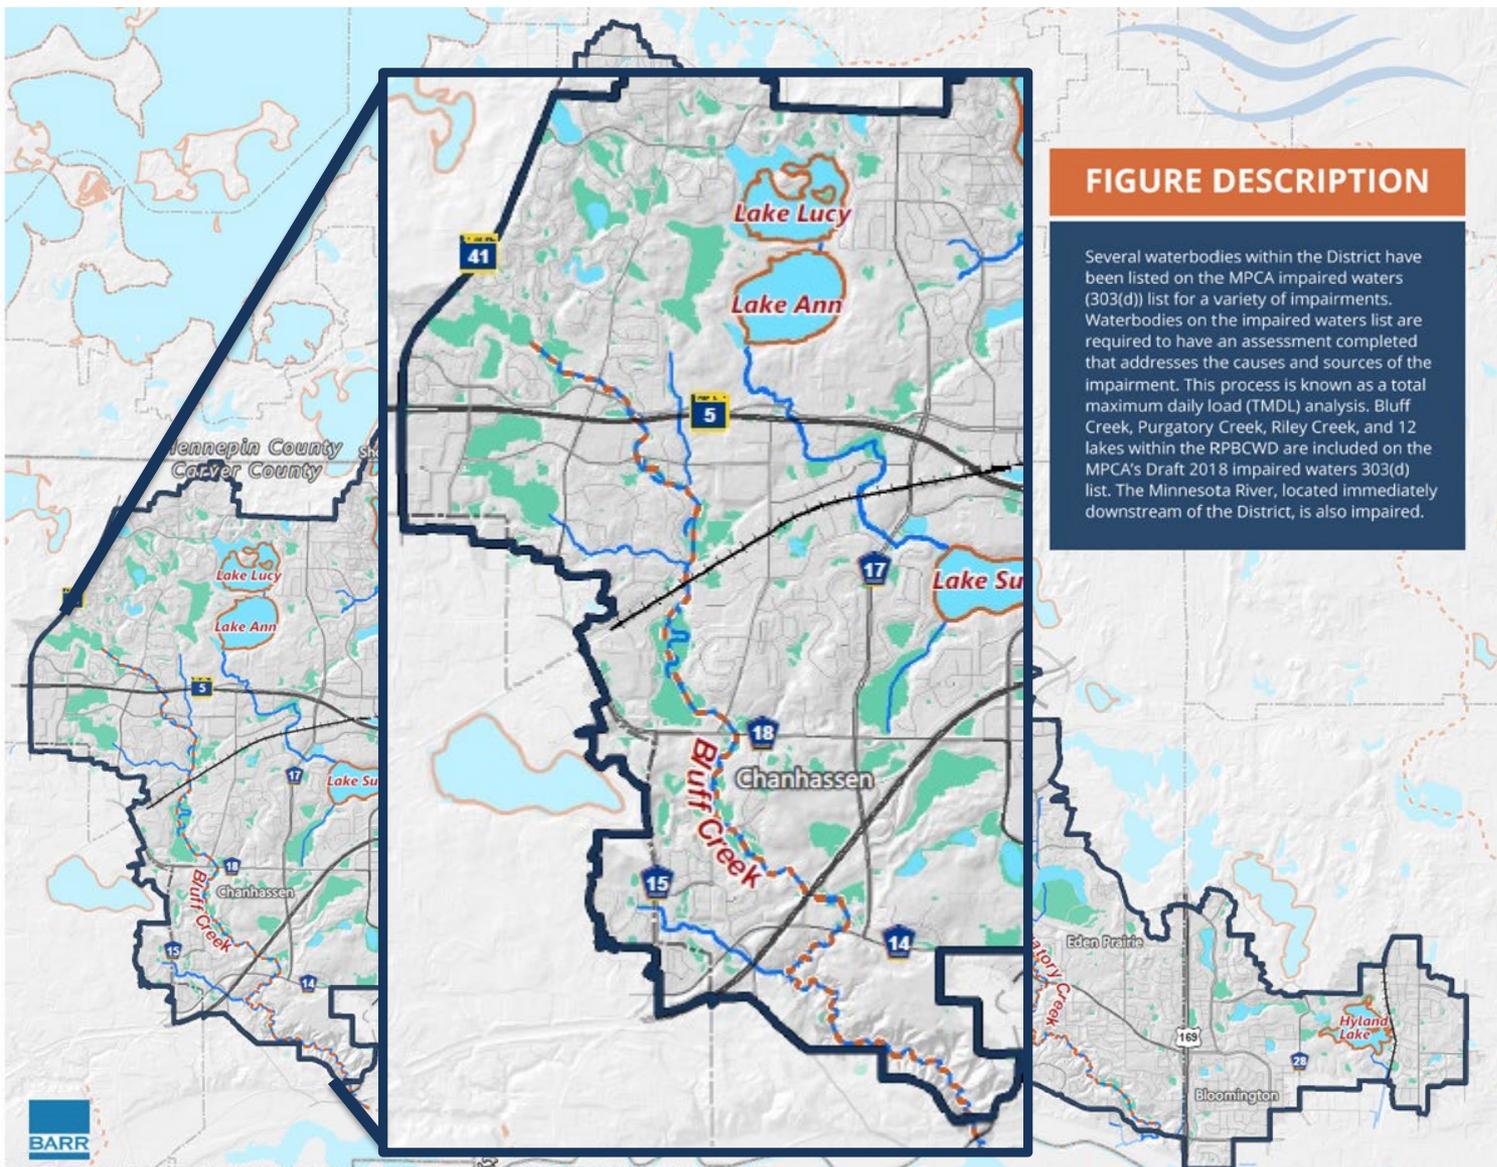
FIGURE 5-9

Several waterbodies within the District have been listed on the MPCA impaired waters (303(d)) list for a variety of impairments. Waterbodies on the impaired waters list are required to have an assessment completed that addresses the causes and sources of the impairment. This process is known as a total maximum daily load (TMDL) analysis. Bluff Creek, Purgatory Creek, Riley Creek, and 12 lakes within the RPBCWD are included on the MPCA's Draft 2018 impaired waters 303(d) list. The Minnesota River, located immediately downstream of the District, is also impaired.

IMPAIRED WATERS

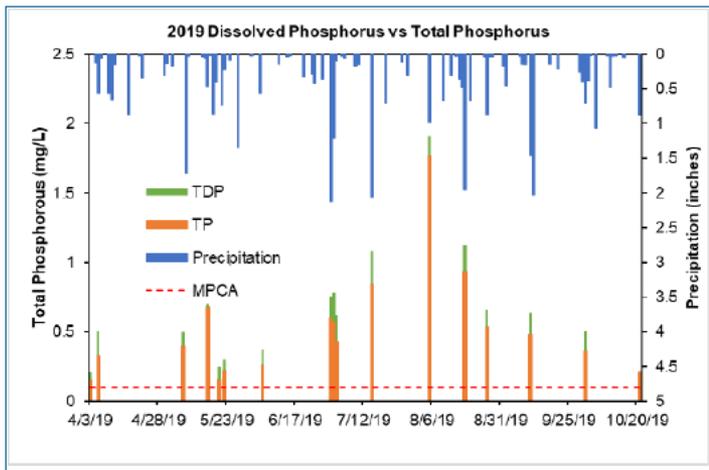
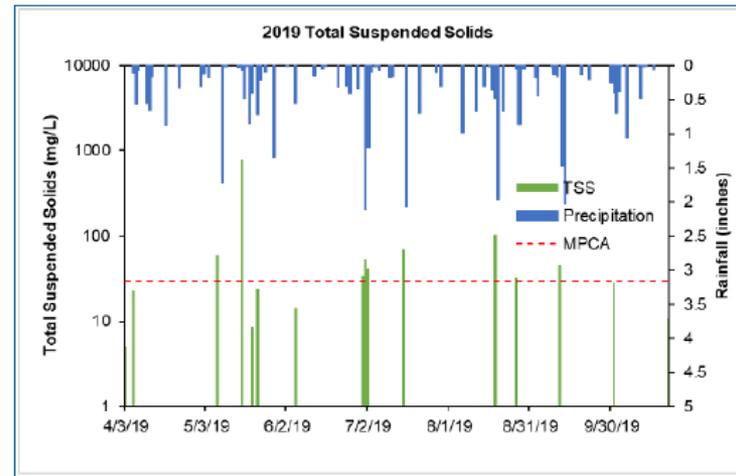
Figure 4-4 Bluff Creek TP and TDP Measurement at Galpin Avenue (2019) and 78th Street (2021) (5)

- District monitoring indicates Bluff Creek does not meet MPCA water quality standards

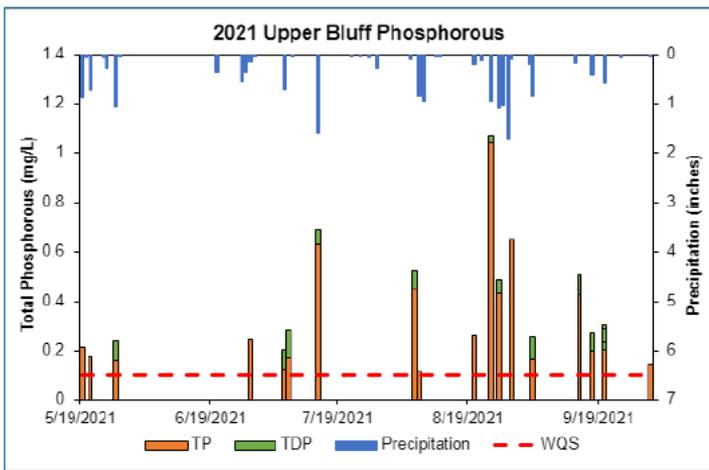
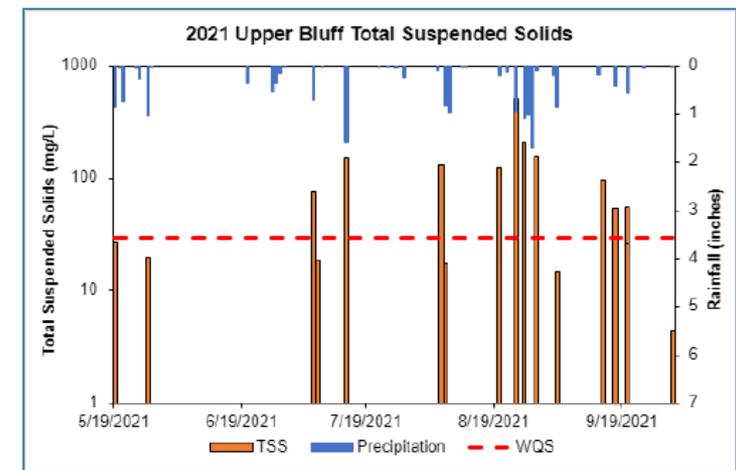
Figure 4-5 Bluff Creek TSS Measurements at Galpin Boulevard (2019 above and 2021 below)

- District monitoring indicates Bluff Creek does not meet MPCA water quality standards

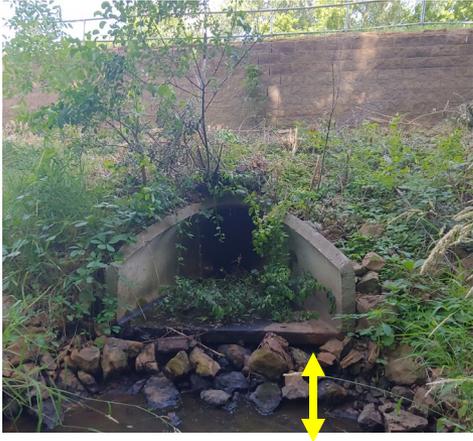
- 42-INCH RCP CIRCULAR CULVERT WITH FLARED END
- MODELING SUGGESTS VELOCITIES RANGE FROM 6 FPS DURING 1-YEAR EVENT UP TO 13 FPS DURING 100-YEAR EVENT
- PIPE SLOPE IS OVER TWICE THE SLOPE OF THE EXISTING STREAM
- LOW CONNECTIVITY TO STREAM (CULVERT ELEVATED ABOVE STREAM BED)
 - High undercutting and scour potential
 - Erosion in upstream and downstream channel segments

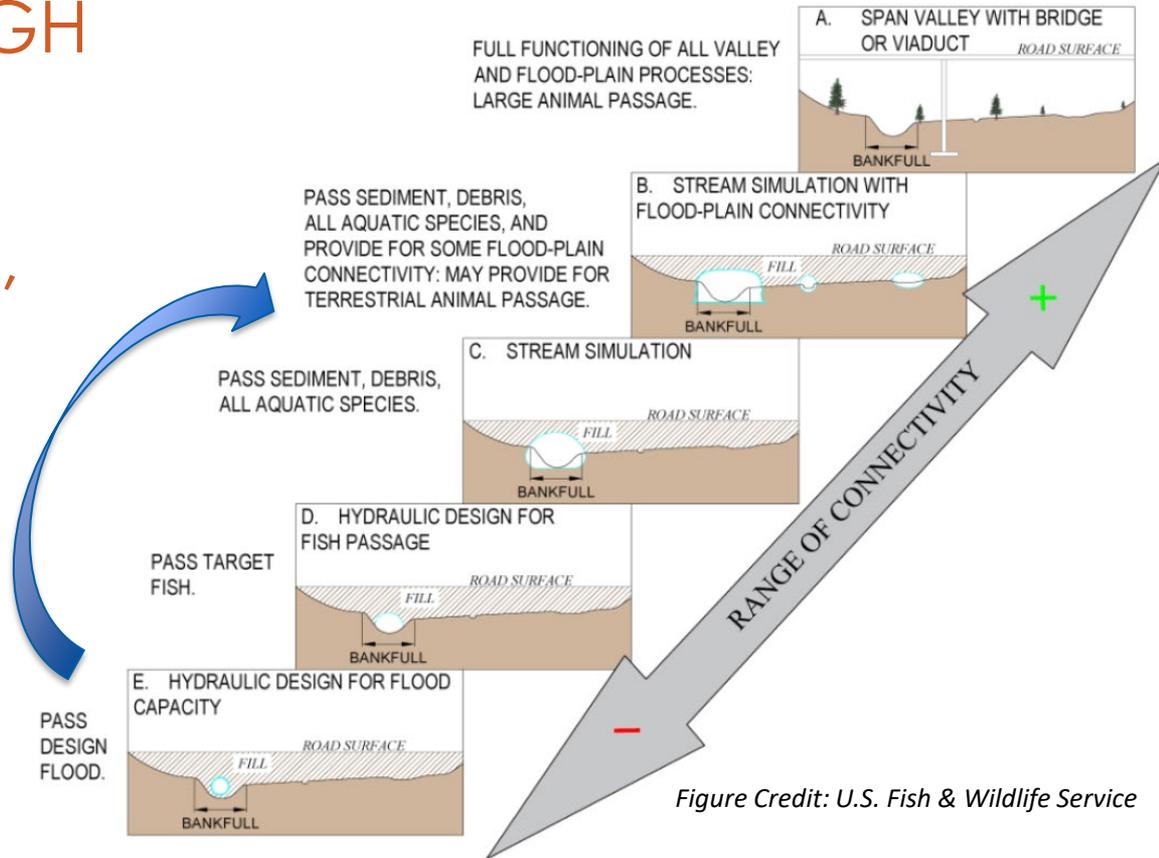
DESIGN CONSIDERATIONS

- GOAL IS TO REDUCE VELOCITIES THROUGH THE CULVERT, ENCOURAGE AQUATIC GROWTH, AND IMPROVE ECOLOGICAL FUNCTION

- Span bankfull width
- Allow conveyance of debris
- Improve sediment transport
- Improve channel stability
- Connectivity with stream

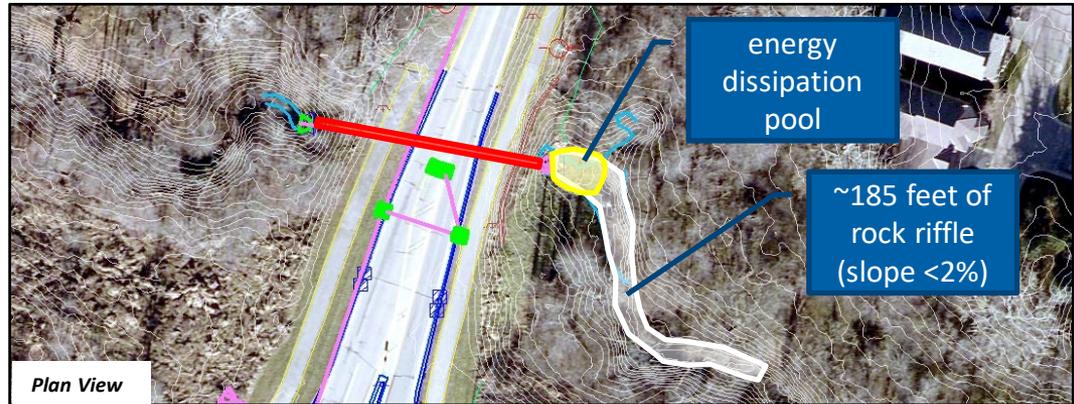
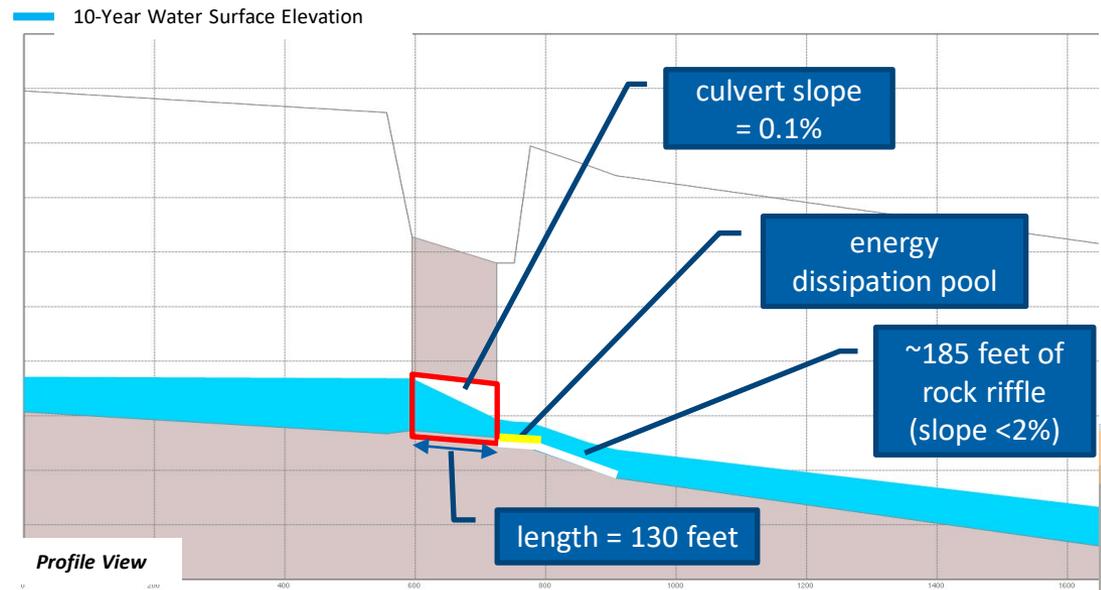
DESIGN INCLUDED IN GALPIN BLVD PROJECT

- 6' WIDE BY 4' HIGH BOX
 - 5' upstream opening
 - invert embedded 1.3' to naturalize the bed
- MODIFY EXISTING SANITARY SEWER
- MINIMIZES UPSTREAM AND DOWNSTREAM IMPACTS
- COST-EFFECTIVE
- INCREASES CONNECTIVITY WITH NATURAL STREAM
- IMPROVES FISH PASSAGE
- DEBRIS PASSAGE
- REDUCES VELOCITIES AND EROSION POTENTIAL AT CROSSING

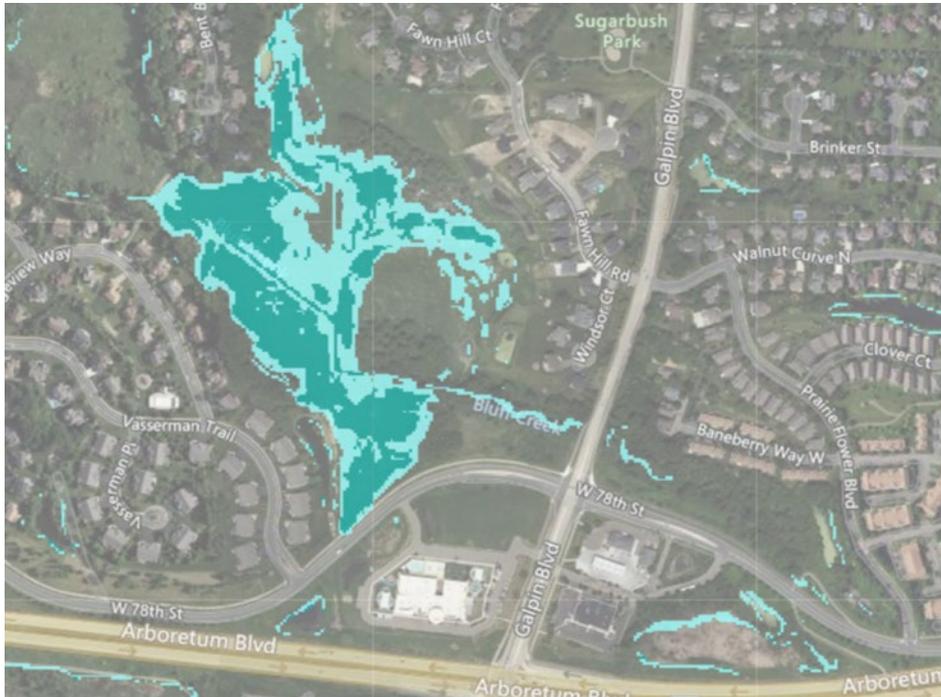
Reach B5A contains a restorable wetland on the Restorable Wetland Index, shown in blue and aqua

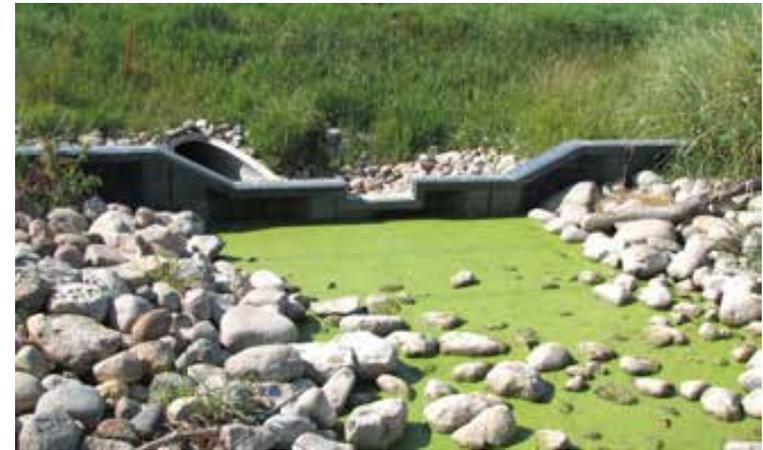
Example of a stage weir from the *Minnesota Wetland Restoration Guide* by the Minnesota Board of Water and Soil Resources (BWSR)

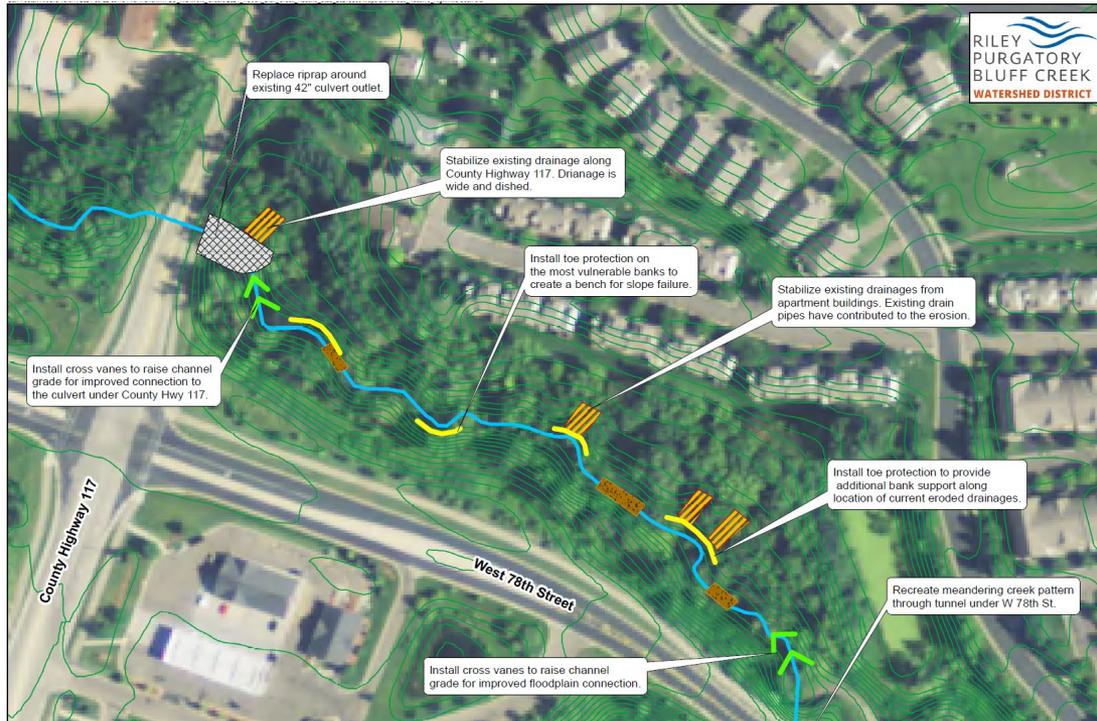
Constructed Feature

Cross Vane
-

Toe Protection
-

Stabilize Drainage
-

Rock Riffle
-

Riprap

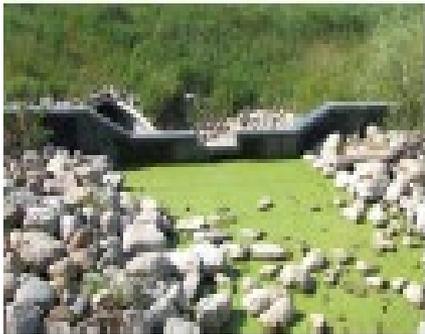
Control Structure to restore headwaters wetland hydrology

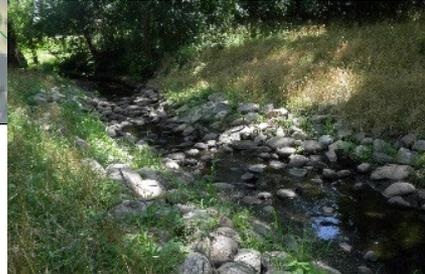
Rock Riffles create natural channel patterns, control stream bed elevations, provide habitat diversity

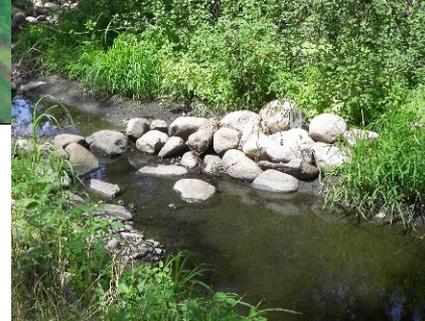
Cross Vanes control stream bed elevations, dissipate flows, provide pool habitat

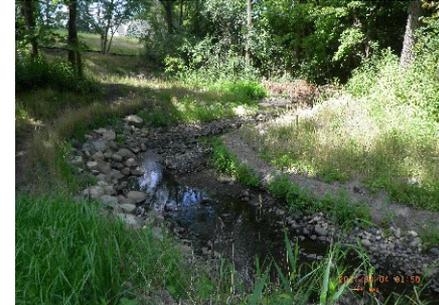
Floodplain Connectivity decreases erosion & provides habitat transitions
