Riley Creek

Riley Creek begins at lakes Lucy and Ann in Chanhassen and flows through three lakes - Susan, Rice Marsh, and Riley - before descending to the Minnesota River Valley. The creek has mild topography in its upper and middle watershed, but below Lake Riley the banks become steep.

Stream Water Quality Monitoring

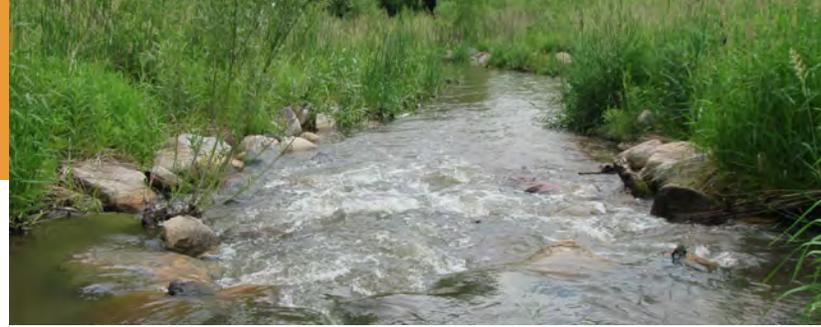
The three major types of data used in creek monitoring

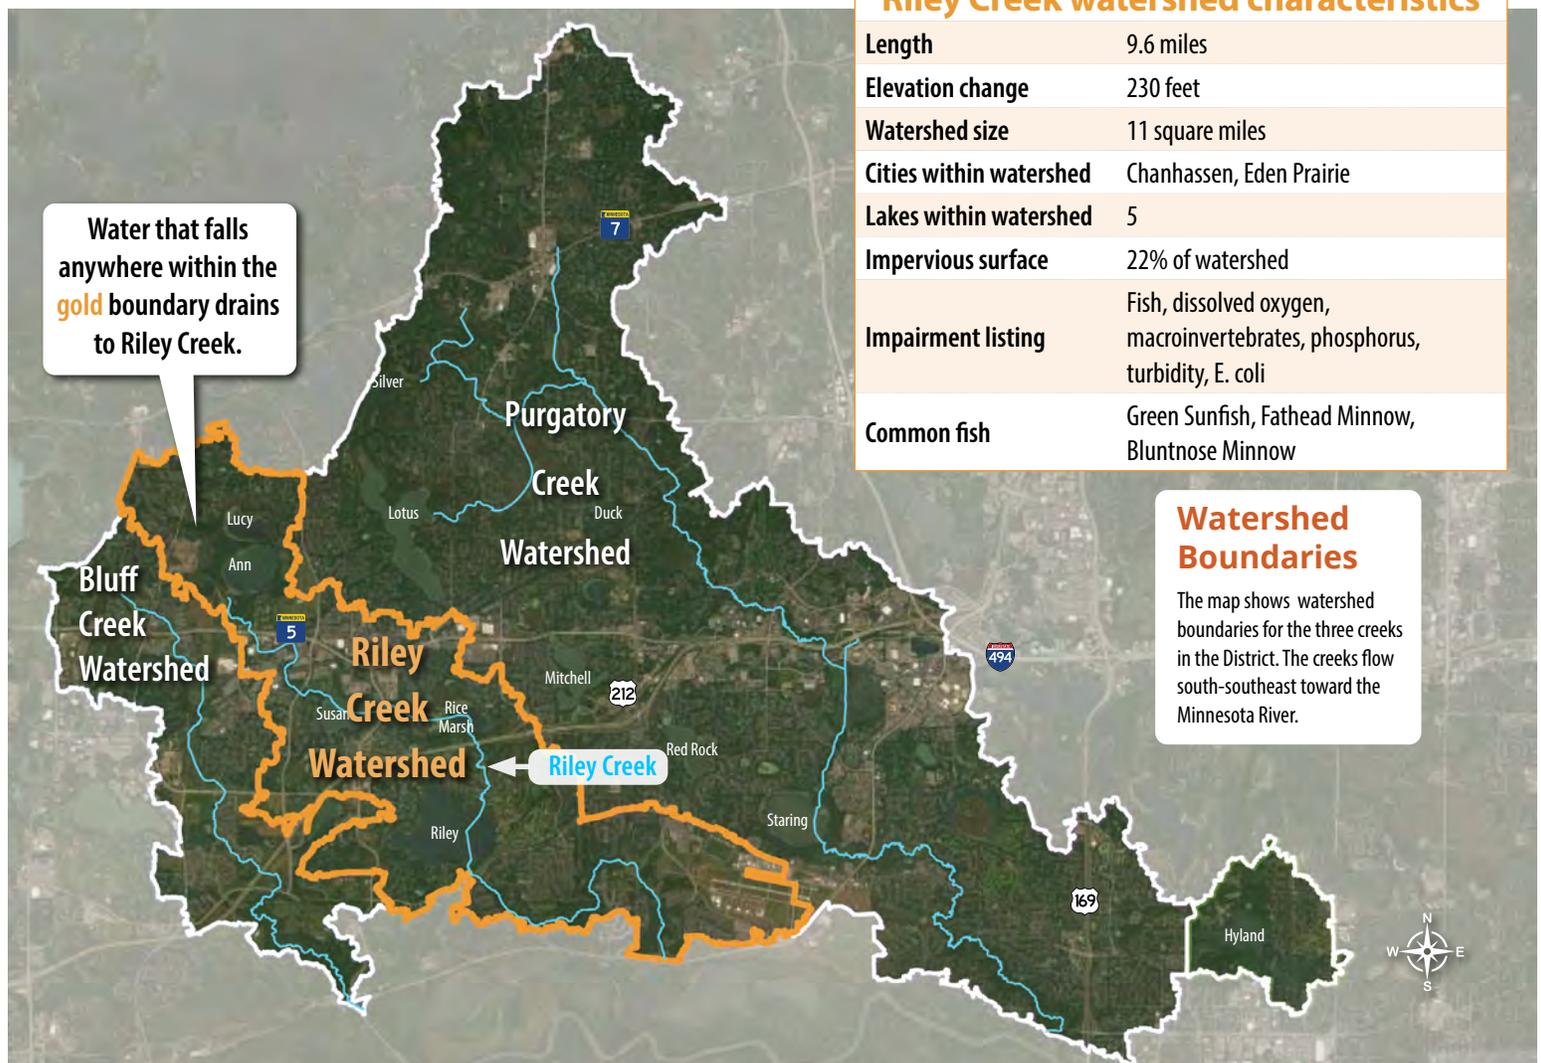
Watershed Boundaries

The map shows watershed boundaries for the three creeks in the District. The creeks flow south-southeast toward the Minnesota River.

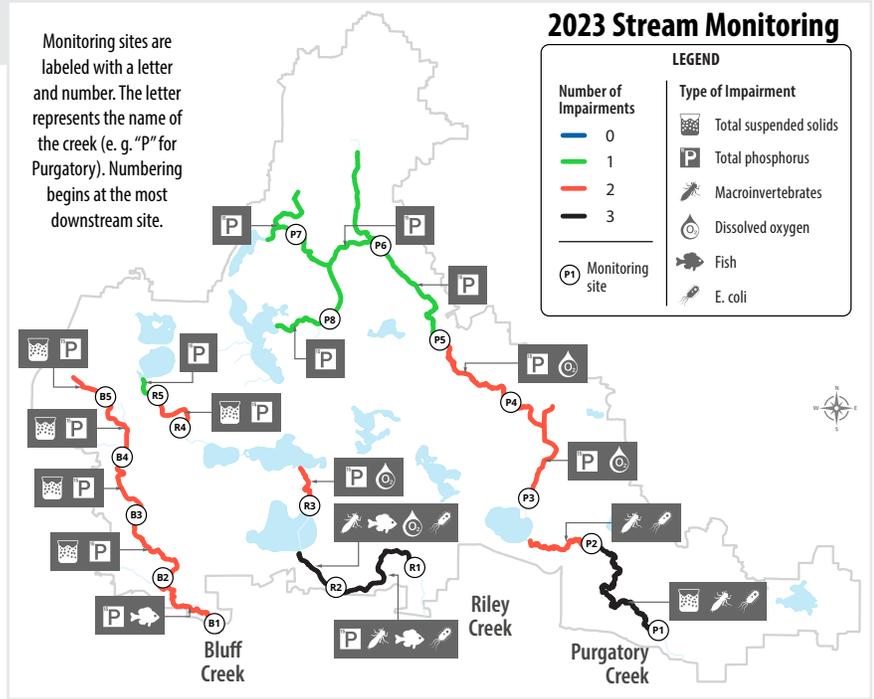
In 2023, District staff collected and analyzed water samples every two weeks, April through September, to determine the average water quality of Bluff, Riley, and Purgatory creeks. The District monitors six impairment categories based upon standards set by the Minnesota Pollution Control Agency (MPCA)

In 2023, the continued drought significantly impacted the streams. Of the 18 regular sampling sites, 14 went dry or became stagnant at some point. From 2022 to 2023, stream water quality was reduced slightly across the district. Excluding the dissolved oxygen impairment, the number of water quality standards exceeded overall increased slightly from 2021 to 2022. Similar to previous years, Total Phosphorus (TP) was the water quality standard causing the most impairments in 2023 with 15 of the 18 sites not meeting the standard.

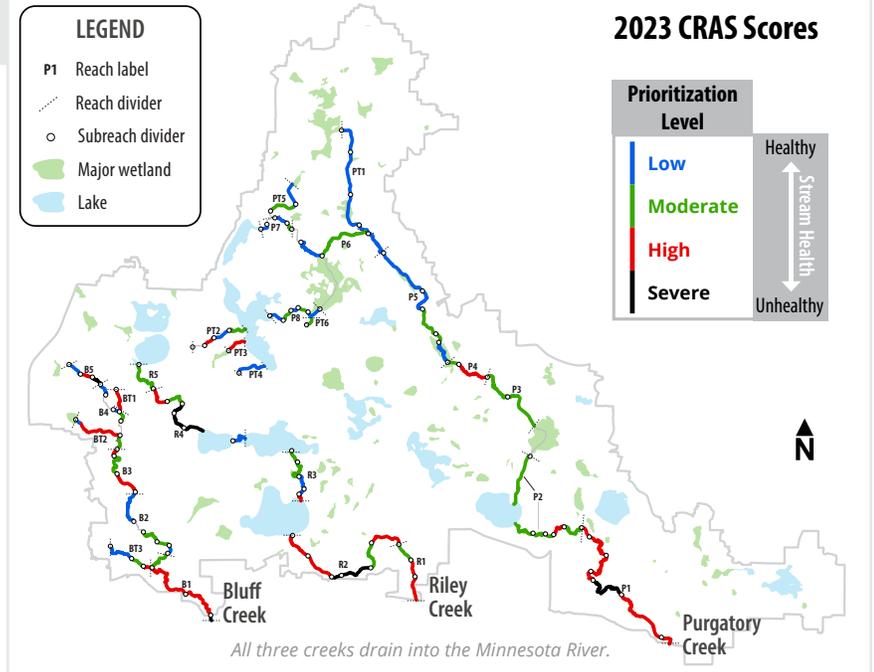
CRAS Scores for Stream Restoration Planning

The District developed the Creek Restoration Action Strategy (CRAS) to prioritize creek reaches, sub-reaches, or sites, in need of stabilization and/or restoration. The District identified eight categories of importance for project prioritization:

These categories were scored using methods developed for each category based on a combination of published studies and reports, erosion inventories, field visits, and scoring sheets from specific methodologies. Final tallies of scores for each category, using a two-tiered ranking system, were used to prioritize sites for restoration/ remediation.

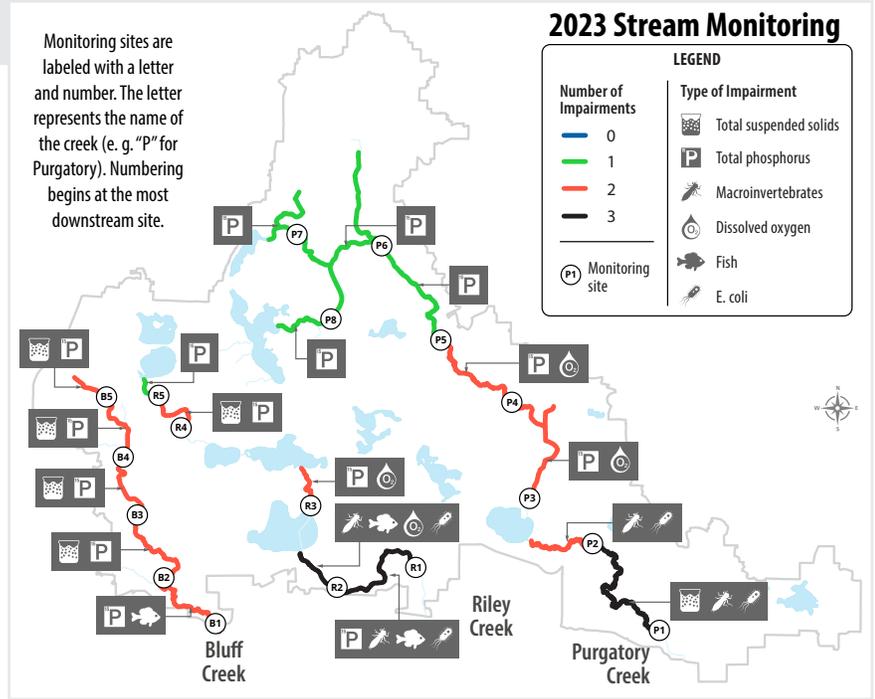
Stream Water Quality Monitoring

In 2023, District staff collected and analyzed water samples every two weeks, April through September, to determine the average water quality of Bluff, Riley, and Purgatory creeks. The District monitors six impairment categories based upon standards set by the Minnesota Pollution Control Agency (MPCA)

In 2023, the continued drought significantly impacted the streams. Of the 18 regular sampling sites, 14 went dry or became stagnant at some point. From 2022 to 2023, stream water quality was reduced slightly across the district. Excluding the dissolved oxygen impairment, the number of water quality standards exceeded overall increased slightly from 2021 to 2022. Similar to previous years, Total Phosphorus (TP) was the water quality standard causing the most impairments in 2023 with 15 of the 18 sites not meeting the standard.

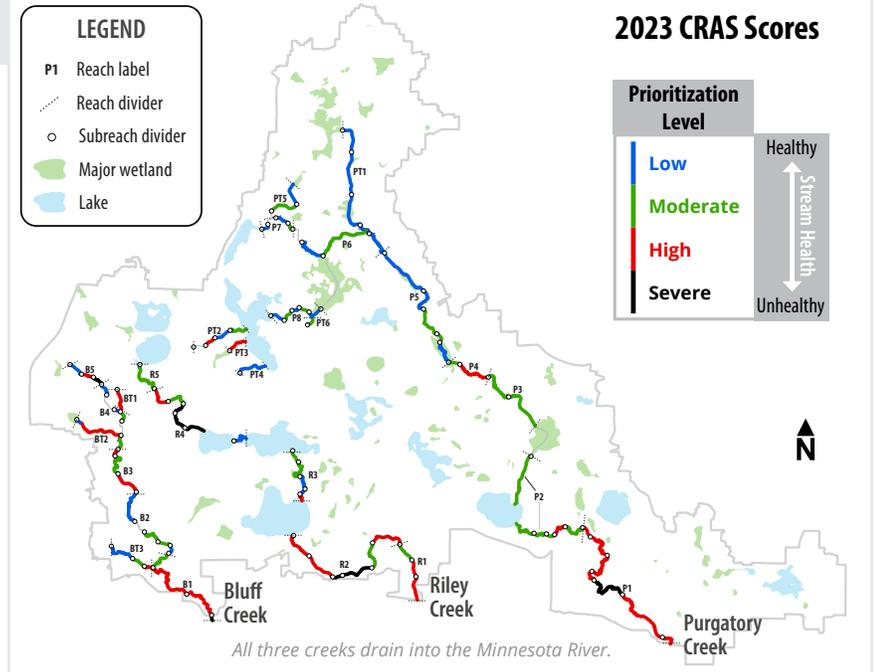
CRAS Scores for Stream Restoration Planning

The District developed the Creek Restoration Action Strategy (CRAS) to prioritize creek reaches, sub-reaches, or sites, in need of stabilization and/or restoration. The District identified eight categories of importance for project prioritization:

These categories were scored using methods developed for each category based on a combination of published studies and reports, erosion inventories, field visits, and scoring sheets from specific methodologies. Final tallies of scores for each category, using a two-tiered ranking system, were used to prioritize sites for restoration/remediation.

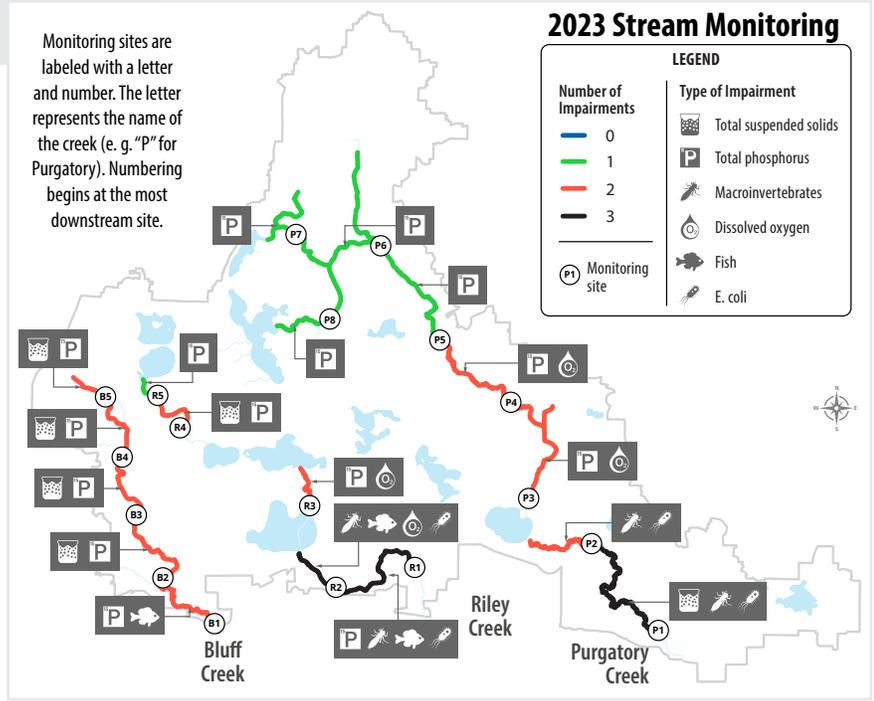
Stream Water Quality Monitoring

In 2023, District staff collected and analyzed water samples every two weeks, April through September, to determine the average water quality of Bluff, Riley, and Purgatory creeks. The District monitors six impairment categories based upon standards set by the Minnesota Pollution Control Agency (MPCA)

In 2023, the continued drought significantly impacted the streams. Of the 18 regular sampling sites, 14 went dry or became stagnant at some point. From 2022 to 2023, stream water quality was reduced slightly across the district. Excluding the dissolved oxygen impairment, the number of water quality standards exceeded overall increased slightly from 2021 to 2022. Similar to previous years, Total Phosphorus (TP) was the water quality standard causing the most impairments in 2023 with 15 of the 18 sites not meeting the standard.

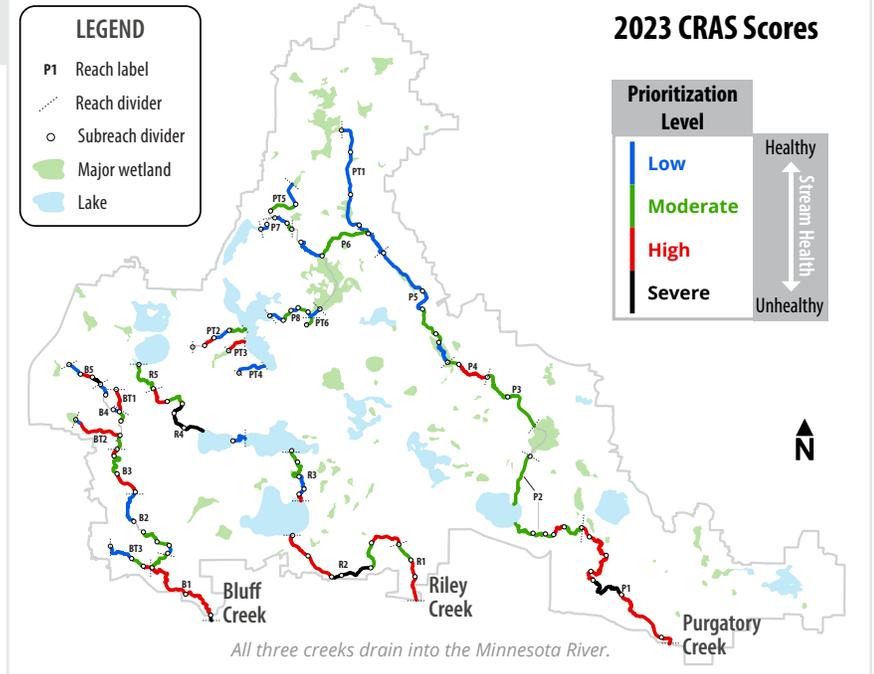
CRAS Scores for Stream Restoration Planning

The District developed the Creek Restoration Action Strategy (CRAS) to prioritize creek reaches, sub-reaches, or sites, in need of stabilization and/or restoration. The District identified eight categories of importance for project prioritization:

These categories were scored using methods developed for each category based on a combination of published studies and reports, erosion inventories, field visits, and scoring sheets from specific methodologies. Final tallies of scores for each category, using a two-tiered ranking system, were used to prioritize sites for restoration/remediation.

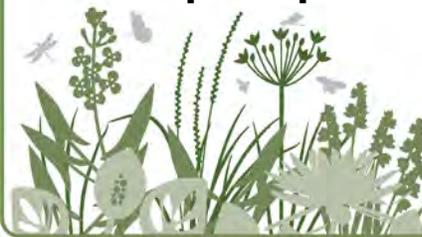
Native Aquatic Plant Diversity

How does **Lake Ann** compare to **other lakes** in the District in **number of native plant species?**

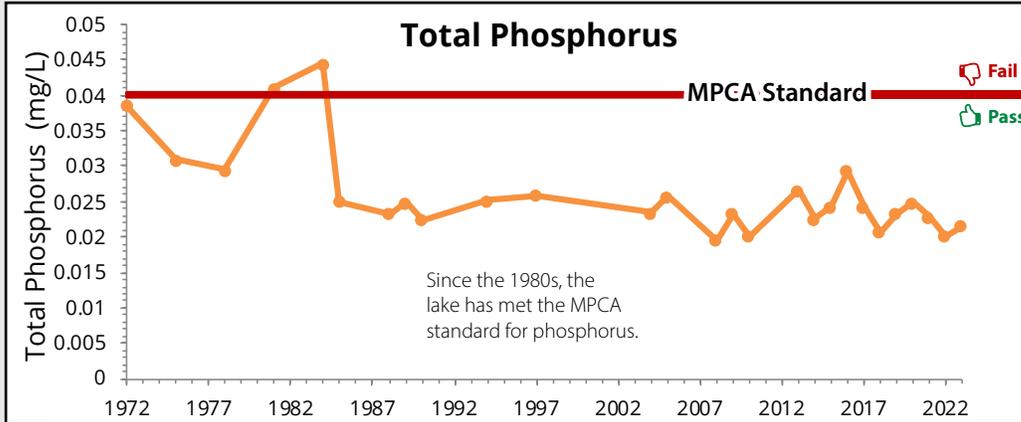
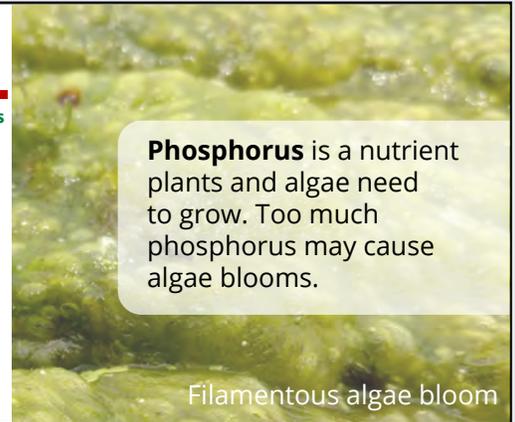
Trends Over Time: 1972-present

Phosphorus is a nutrient plants and algae need to grow. Too much phosphorus may cause algae blooms.

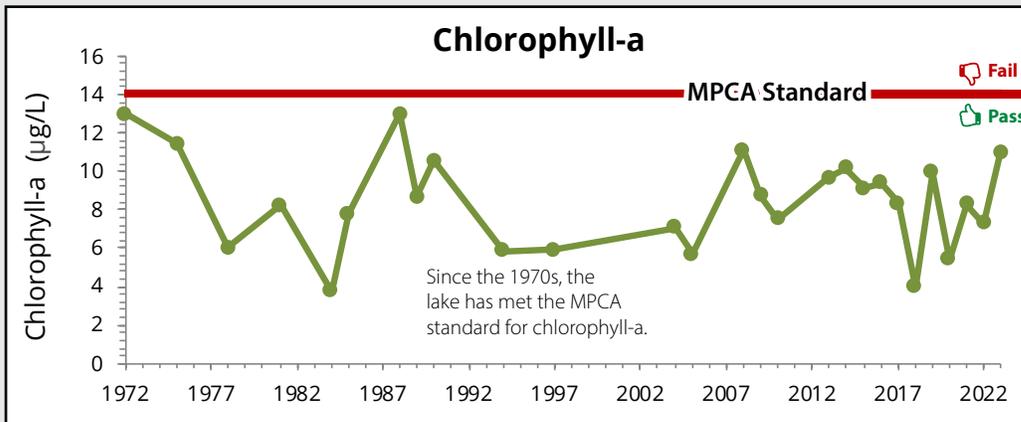
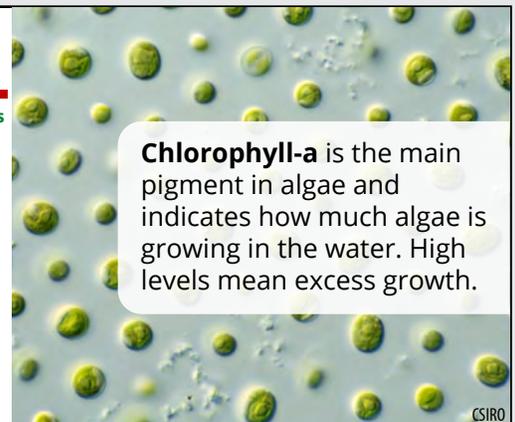
Chlorophyll-a is the main pigment in algae and indicates how much algae is growing in the water. High levels mean excess growth.

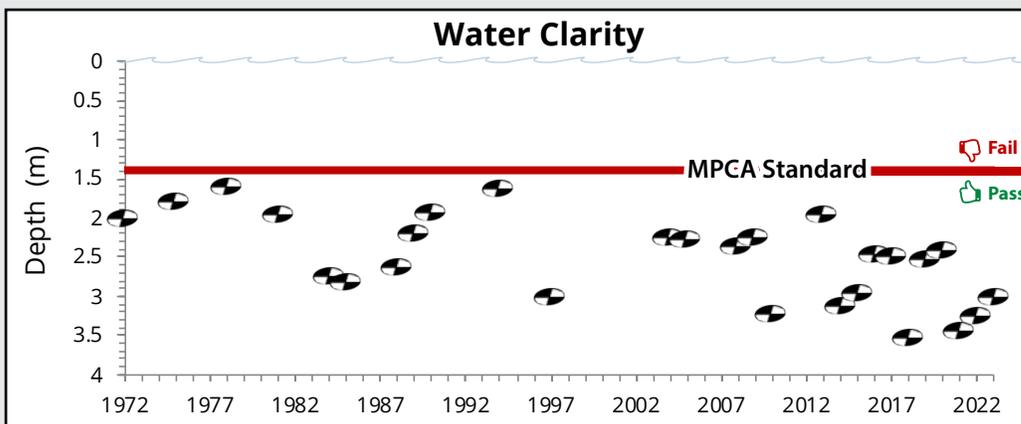
Water clarity is measured by lowering a Secchi Disk into the water. The depth at which the disk is no longer visible is the water's clarity measurement.

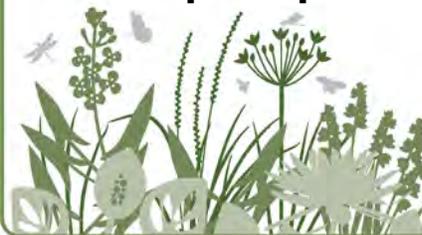
Native Aquatic Plant Diversity

How does **Duck Lake** compare to **other lakes** in the District in **number of native plant species?**

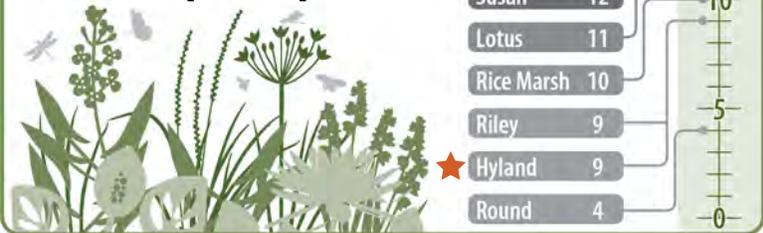
Native Aquatic Plant Diversity

How does **Hyland Lake** compare to **other lakes** in the District in **number of native plant species?**

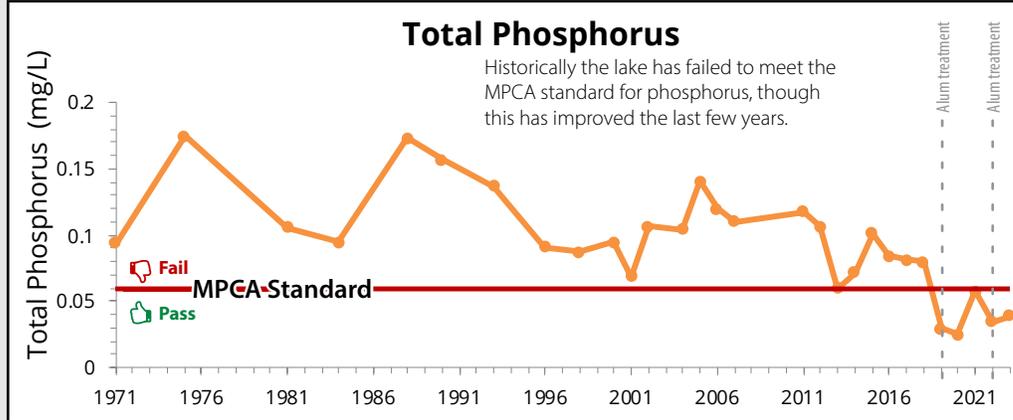
Trends Over Time: 1972-present

Hyland Lake received alum treatments in 2019 & 2022. Alum limits the availability of phosphorus in lakes to control algae growth & improve water clarity.

Phosphorus is a nutrient plants and algae need to grow. Too much phosphorus may cause algae blooms.

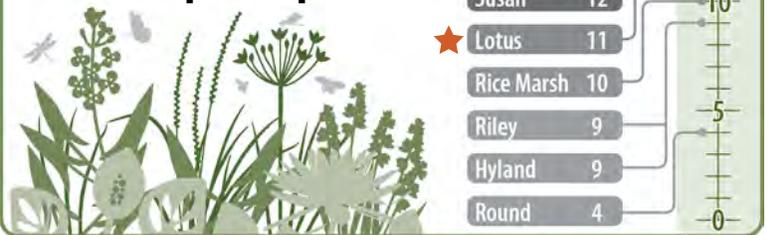
Native Aquatic Plant Diversity

How does **Lotus Lake** compare to **other lakes** in the District in **number of native plant species?**

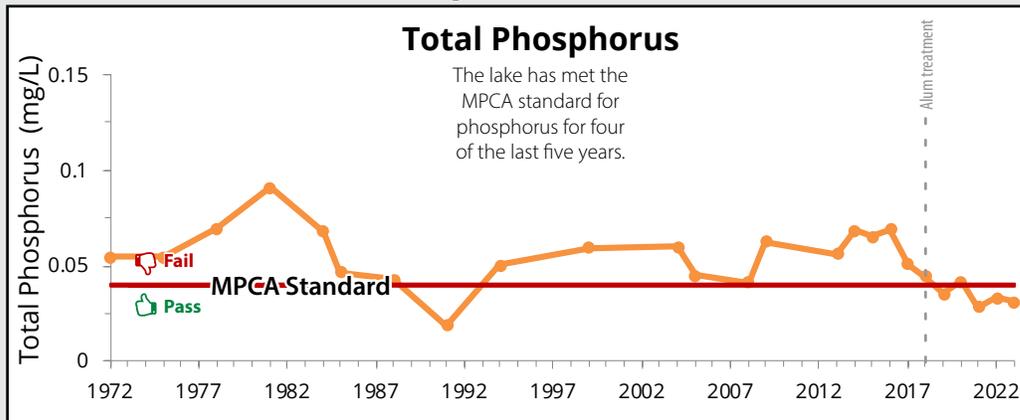
Trends Over Time: 1972-present

Lotus Lake received an alum treatment in 2018. Alum limits the availability of phosphorus in lakes to control algae growth & improve water clarity.

Phosphorus is a nutrient plants and algae need to grow. Too much phosphorus may cause algae blooms.

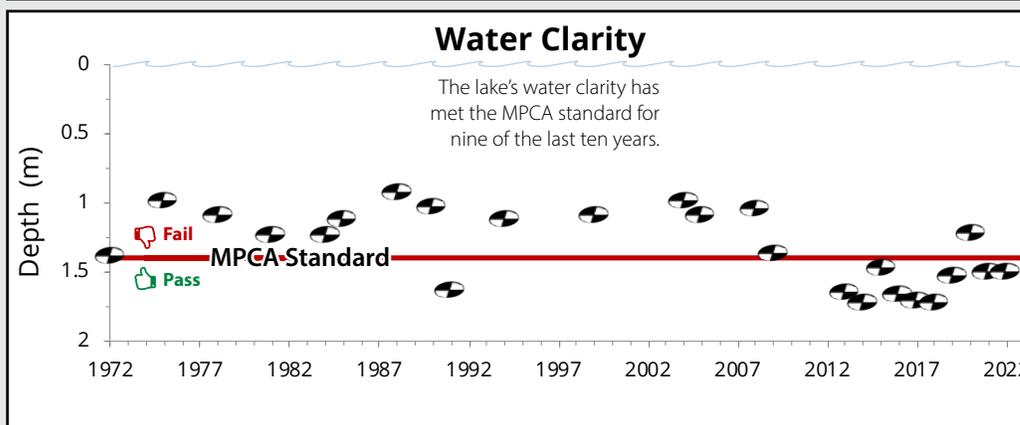
Water clarity is measured by lowering a Secchi Disk into the water. The depth at which the disk is no longer visible is the water's clarity measurement.

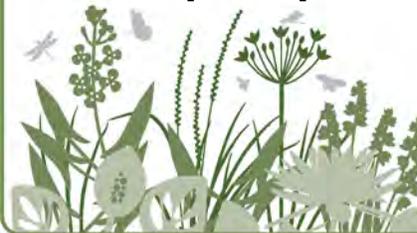
Native Aquatic Plant Diversity

How does **Red Rock Lake** compare to **other lakes** in the District in **number of native plant species?**

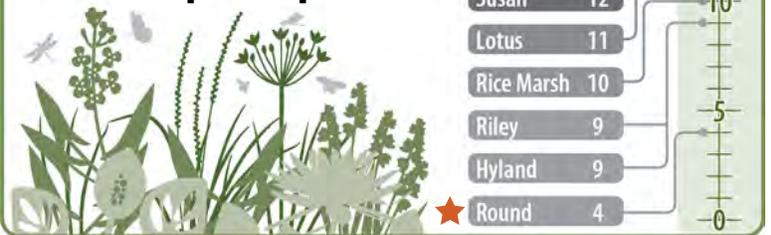
Native Aquatic Plant Diversity

How does **Round Lake** compare to **other lakes** in the District in **number of native plant species?**

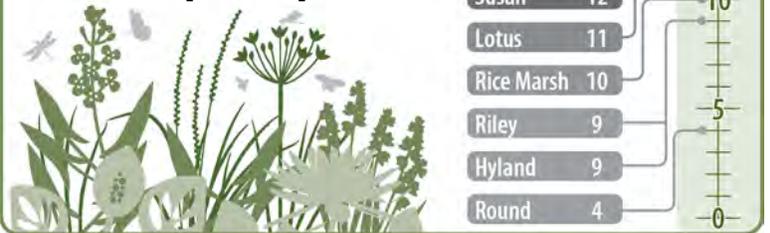
Native Aquatic Plant Diversity

How does **Staring Lake** compare to **other lakes** in the District in **number of native plant species?**

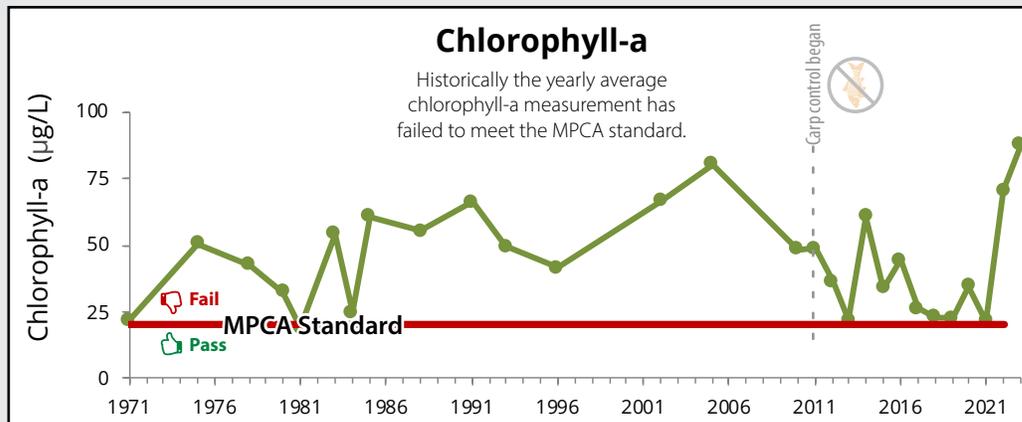
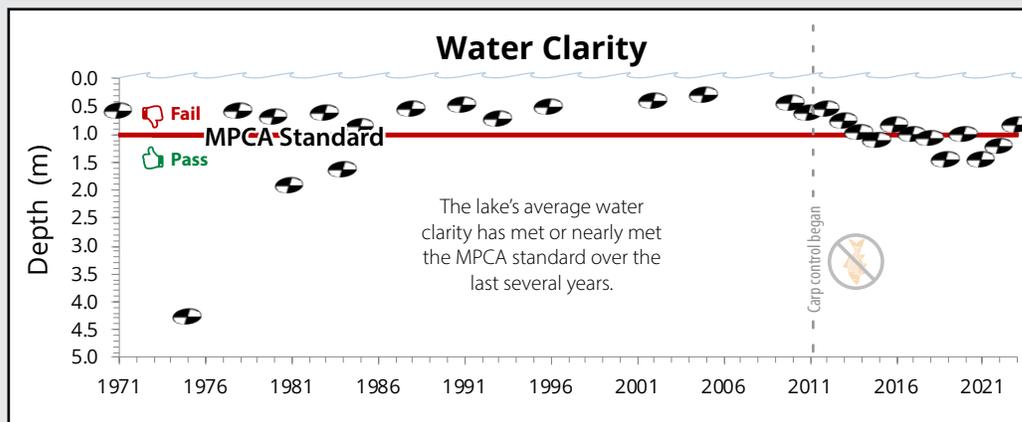
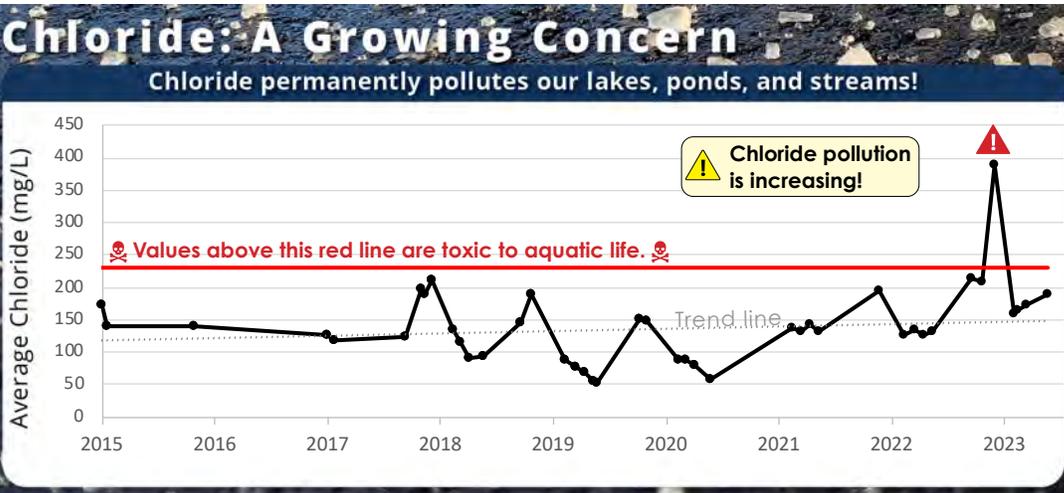
Trends Over Time: 1972-present

The graphs below show water quality trends over time with the red line representing the MPCA standard for shallow lakes. Over the last decade, **Staring Lake** has failed to consistently meet clean water standards set by the MPCA.
