Lower Riley Creek Corridor (Reach E and D3) Enhancement Plan

Prepared for
Riley Purgatory Bluff Creek Watershed District and the City of Eden
Prairie

Ecological Enhancement Plan
Lower Riley Creek Stabilization Project
March 2019

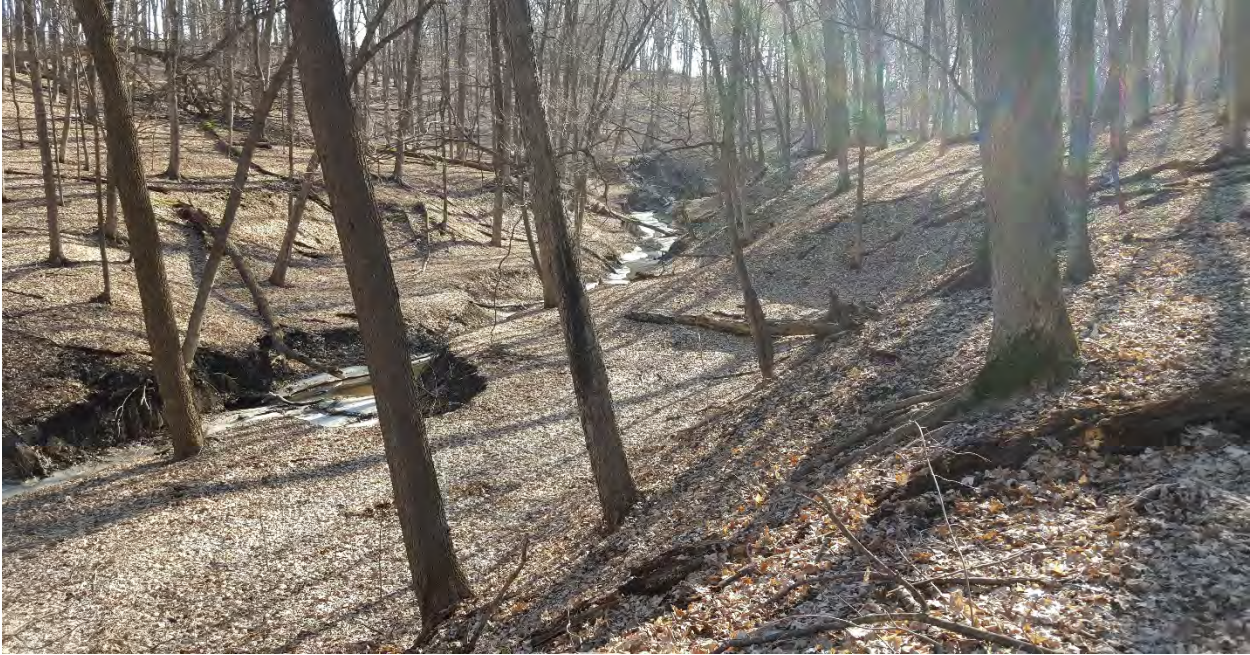
Figure 5-1 Native Hardwood Forest Community, upstream portion of Project

Forest in the upstream portions of the Project exhibits characteristics of a native hardwood forest community, with a nearly closed canopy and open understory (Figure 5-1). However, glossy buckthorn is prevalent in the downstream portion of the Project area, with trees ranging from approximately three to eight feet in height, and saplings comprising a significant portion of the understory (Figure 5-2). Canada thistle is also found in the Project area, primarily in locations where small openings in the forest canopy allow for more sunlight in the understory layer.

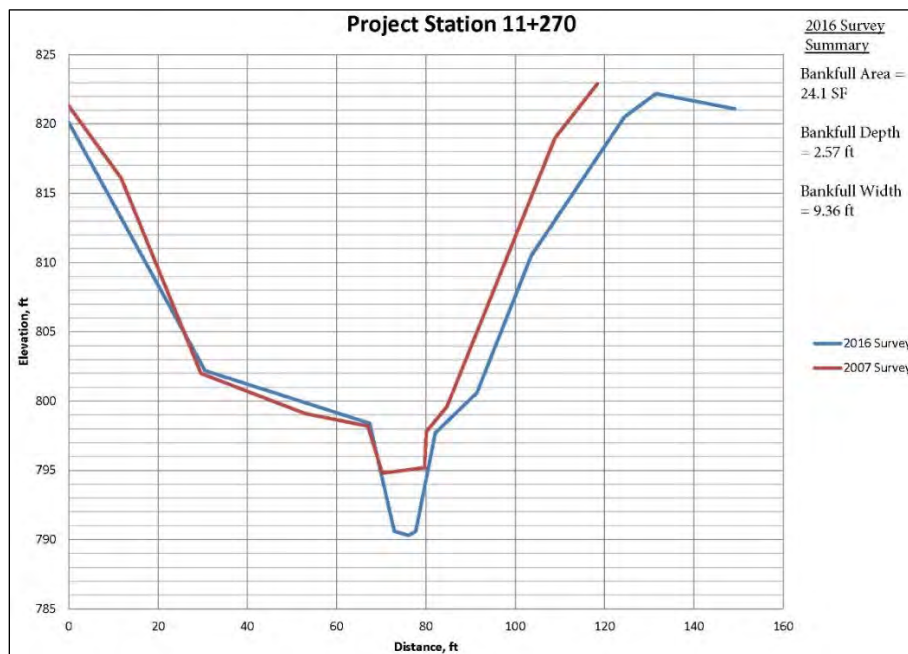
Figure 5-3 Reach E Cross Section Comparison Example

Stream survey data was collected in 2016 and compared to similar data collected in 2007 to verify the stream geomorphic changes during this time period. The 2007 survey

was conducted during the winter months and included limited data in the upstream portions of the reach below the ice. However, the points available below the ice clearly show that the channel bed has lowered in the upper portions of the reach (approximately 2,500 feet of the reach) while remaining fairly unchanged in the lower section. This survey data correlates with field observations of active erosion and head cutting in the upper section of the study reach. A comparison of cross sections (Figure 5-3) also shows that the channel has lowered since the 2007 survey as it is currently both deeper and wider.

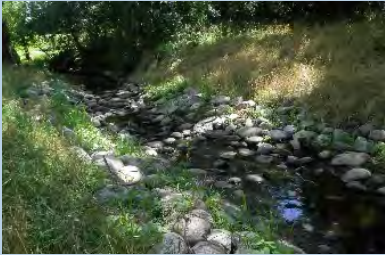
Design Element	Purpose	Ecological Benefit
<p>Rock Riffles</p>

<p>Gravel or cobble-sized material installed in the stream bed to create natural flow patterns and to control stream bed elevations.</p>	<p>The variety in flow and channel substrate size provides habitat diversity for aquatic species.</p>
<p>Cross Vanes</p>

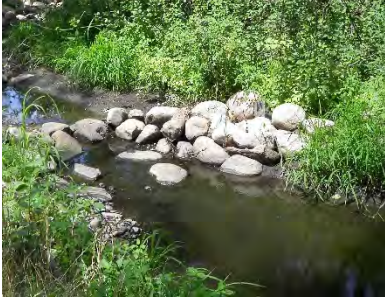
<p>Boulders buried in the stream bed and extending partially (“vanes”) or entirely across the stream (“cross vanes”) to achieve one or more of the following goals: re-direct flows away from banks, encourage sediment deposition in selected areas, and control stream bed elevations.</p>	<p>Scour pools develop over time near the vane, which provide habitat diversity for species that prefer pools to faster flowing in-channel habitat.</p>
<p>Scarp and Scarp Toe Stabilization</p>	<p>Vertical cedar pilings placed one foot on center along the toe of the actively eroding scarp and extending approximately 2 feet above the channel bed. Salvaged trees are installed longitudinally on the landward side of the cedar pilings. The combined structure reduces further erosion of the scarp toe and provide a bench for scarp material to deposit, eventually reducing the slope of the scarp and allowing for the scarp revegetation.</p>

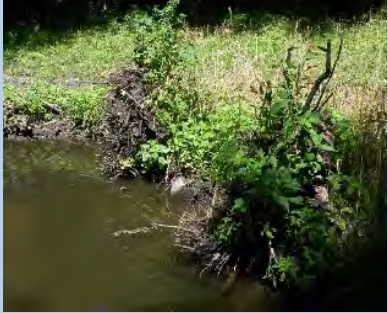
Design Element	Purpose	Ecological Benefit
<p>Root Wads</p>

<p>Tree trunks with the root ball attached, installed either singly (root wads) or in conjunction with additional large woody debris and toe wood to Increase bank roughness and resistance to erosion, re-direct flows away from banks, and provide a bench for establishment of riparian vegetation</p>	<p>Creates undercut/overhanging bank habitat features.</p>
<p>VRSS/Toe Wood Bank Stabilization</p>

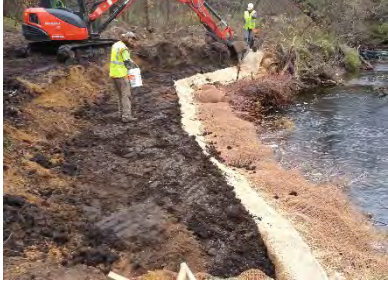
<p>Soil lifts created with a combination of root wads and long-lasting, biodegradable fabric and vegetated to stabilize steep slopes and encourage establishment of root systems for further stabilization.</p>	<p>Creates undercut/overhanging bank habitat features.</p>
<p>Floodplain Connectivity</p>

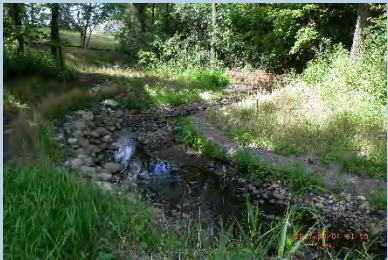
<p>Active floodplain/vegetated bench—modifications made to the stream cross section to increase floodplain connectivity and decrease erosive stress during flood flows; for this project, constructed by raising the channel bed.</p>	<p>Provides a smooth transition between in-channel, riparian, and upland habitat.</p>

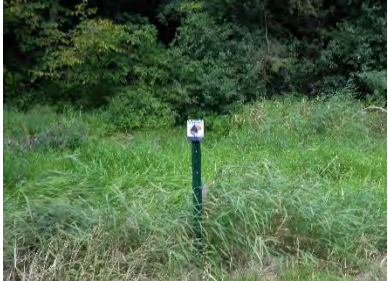
<p>Vegetation/Buffer</p>

<p>Established along a stream bank or overbank area to stabilize bare soils and increase resistance to fluvial erosion.</p>	<p>Using trees, shrubs, and a seed mix of grass and forbs provides a diverse array of vegetation strata and habitat types. Allows for more naturalized aesthetics, with emphasis on native species.</p>
